Basevan.com General Inspection

| VCITIOIC UCIAIIS | |
|---|---|
| Vehicle registration | WJ19ZTR |
| Make | Fiat |
| Model | Ducato |

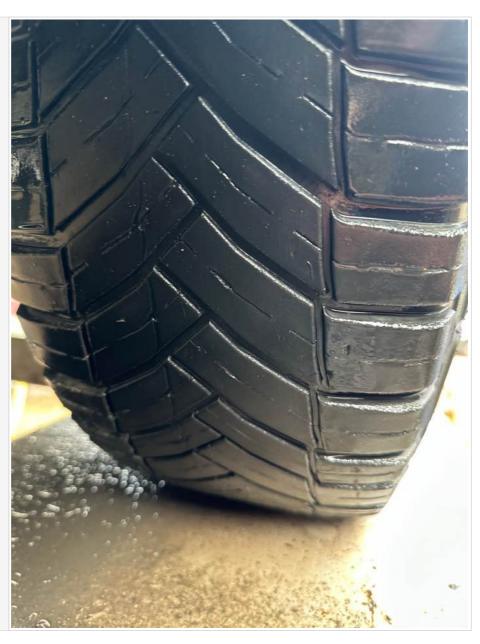
Off side front

| Age (month/year) Manufactured | 05/24 |
|---|---|
| Wearing / Perishing (inner) | Replace soon |
| Wearing / Perishing (outer) | Replace soon |
| tread depth (mm) | 3 |

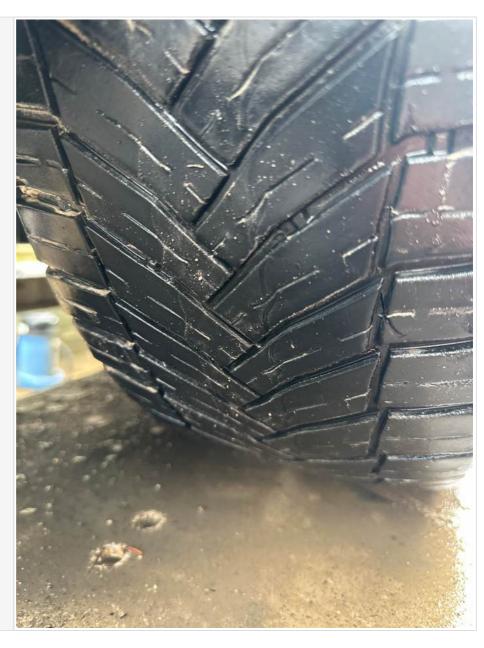
Near side front

| Age (month/year) Manufactured | 21/23 |
|---|---|
| Wearing / Perishing (inner) | Medium |
| Wearing / Perishing (outer) | Medium |
| tread depth (mm) | 4 |

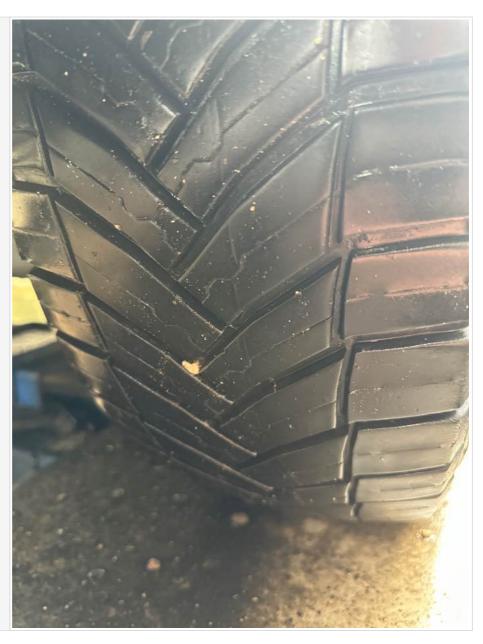
near side rear

| Age (month/year) Manufactured | 36/23 |
|---|---|
| Wearing / Perishing (inner) | none |
| Wearing / Perishing (outer) | None |
| tread depth (mm) | 8 |

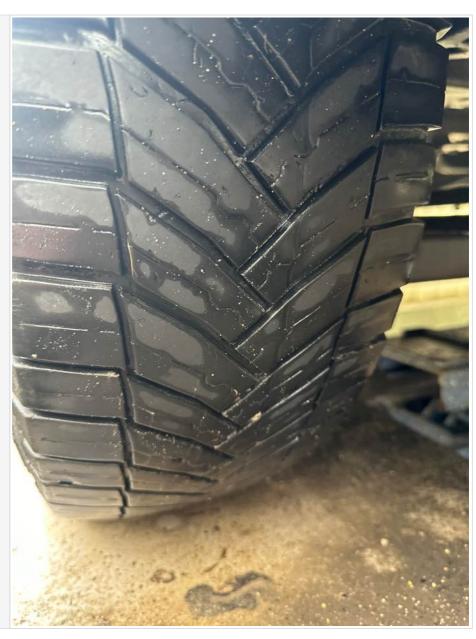
Off side rear

| Age (month/year) Manufactured | 36/23 |
|---|---|
| Wearing / Perishing (inner) | Slight |
| Wearing / Perishing (outer) | Slight |
| tread depth (mm) | 6 |
