Basevan.com General Inspection

| verilde details | |
|---|---|
| Vehicle registration | LJ15LJZ |
| Make | Vauxhall |
| Model | Movano |

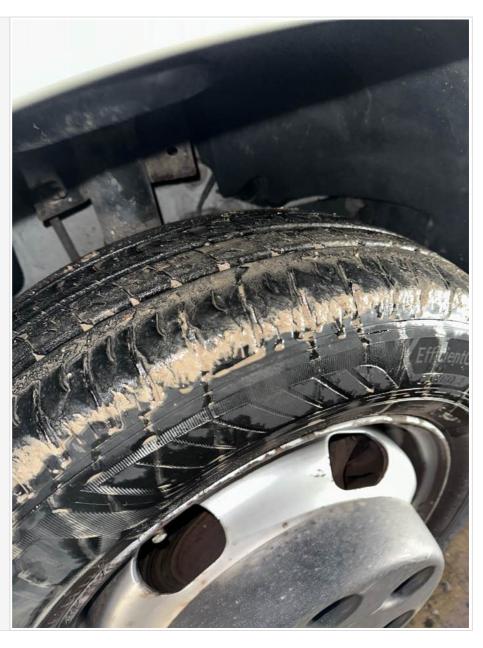
Off side front

| Age (month/year) Manufactured | 25/21 |
|---|---|
| tread depth (mm) | 5 |
| General comments | good tyre |

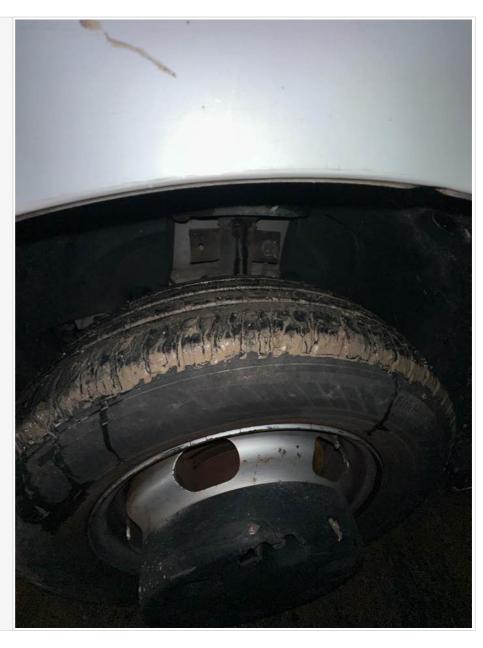
Near side front

| Age (month/year) Manufactured | 25/21 |
|---|---|
| tread depth (mm) | 5 |
| General comments | good tyre |

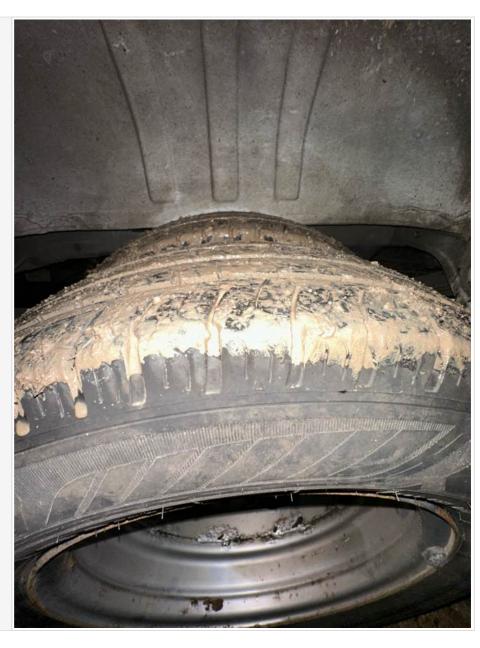
near side rear

| Age (month/year) Manufactured | 21/19 |
|---|---|
| tread depth (mm) | 7 |
| General comments | great condition |

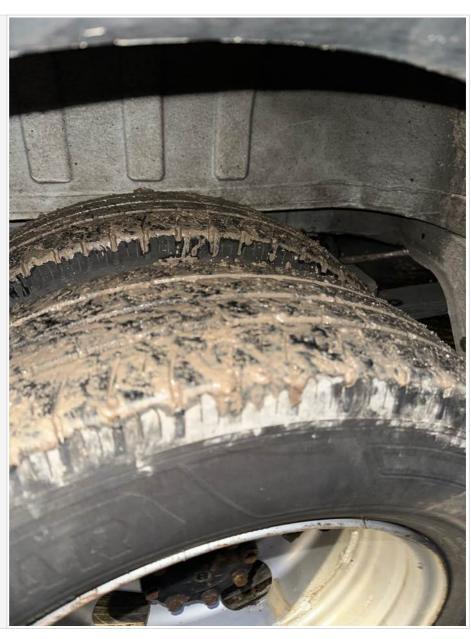
Off side rear

| Age (month/year) Manufactured | 21/19 |
|---|---|
| tread depth (mm) | 7 |
| General comments | great tyre |

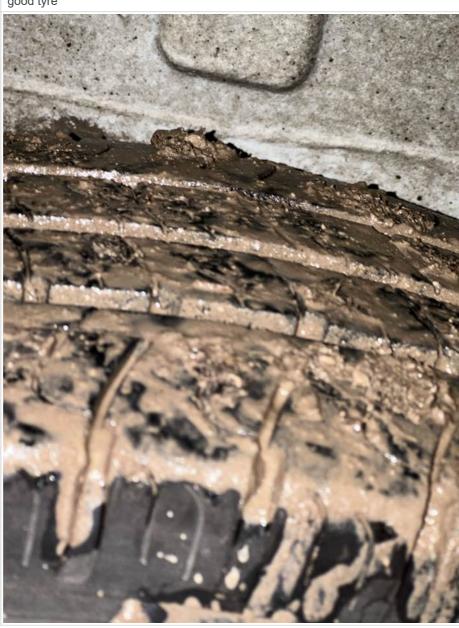
off side Inner (for twin wheel vans)

| tread depth (mm) | 7 |
| General comments | good tyre |

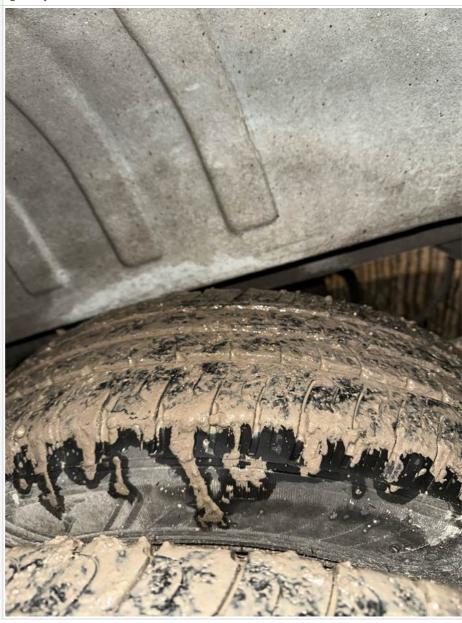
near side Inner (for twin wheel vans)

| Wearing / Perishing (inner) | none |
|---|---|
| tread depth (mm) | 6 |
| General comments | great tyre |

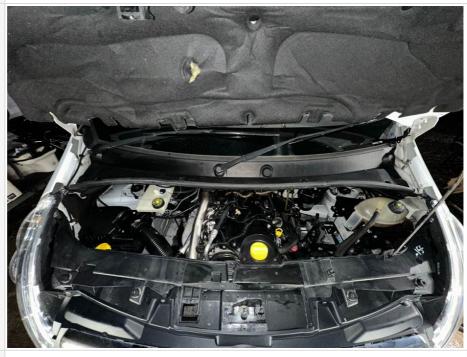
Engine bay photo

Comment mechanically very good, normal for a movano :)
