Basevan.com General Inspection

Vehicle registration	YN15FZY
Vehicle chassis no.	VF3YDTMFC12771616
Miles (if in km, multiply by 0.62)	118337
Make	Peugeot
Model	Boxer
Transmission	Manual, 6 speed
Factory immobiliser installed	Yes
Speed limiter installed	Yes
Drive configuration	FWD
Gross Vehicle Weight (kg)	3500
Towing capacity	2500
Tow bar installed	No

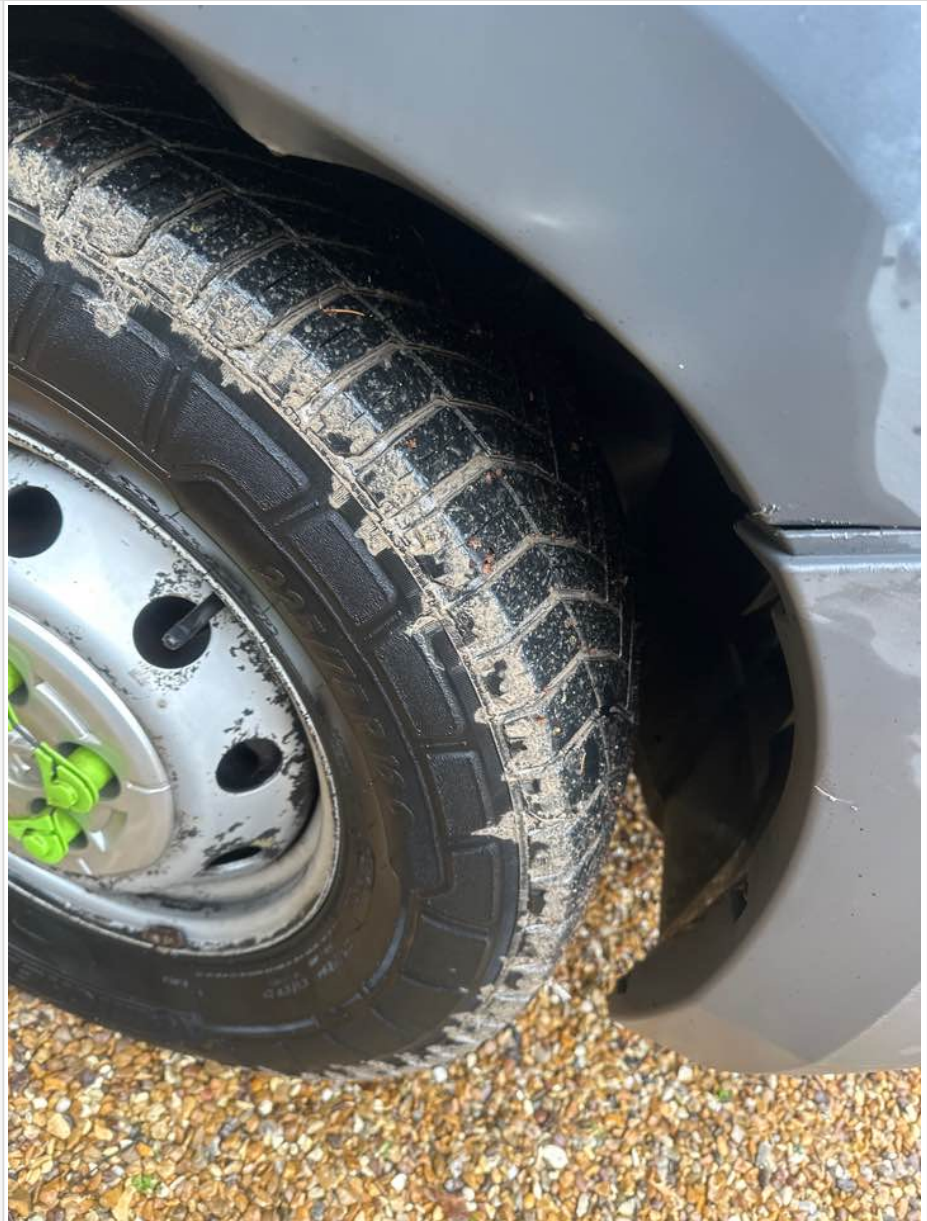
Off side front

Age (month/year) Manufactured	06/20
Make, brand.	Michelin
Tyre size	225/75/R16
Pressure 1	
Pressure 2	
Wearing / Perishing (inner)	none
Wearing / Perishing (outer)	None
tread depth (mm)	6
General comments	good tyre, top range

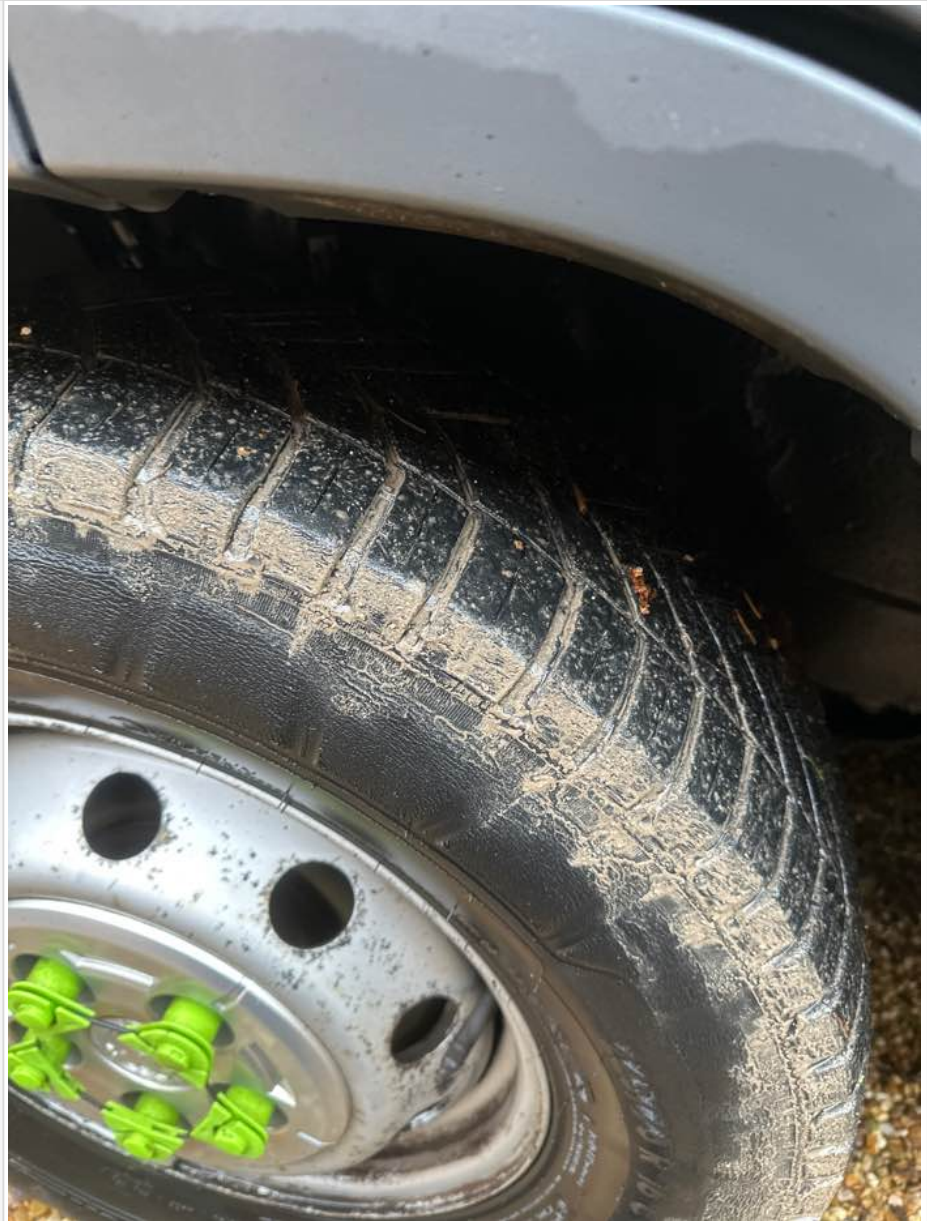
Near side front

Age (month/year) Manufactured	06/20
Make, brand.	Michelin
Tyre size	225/75/R16
Pressure 1	
Pressure 2	
Wearing / Perishing (inner)	none
Wearing / Perishing (outer)	None
tread depth (mm)	5
General comments	good tyre too of range

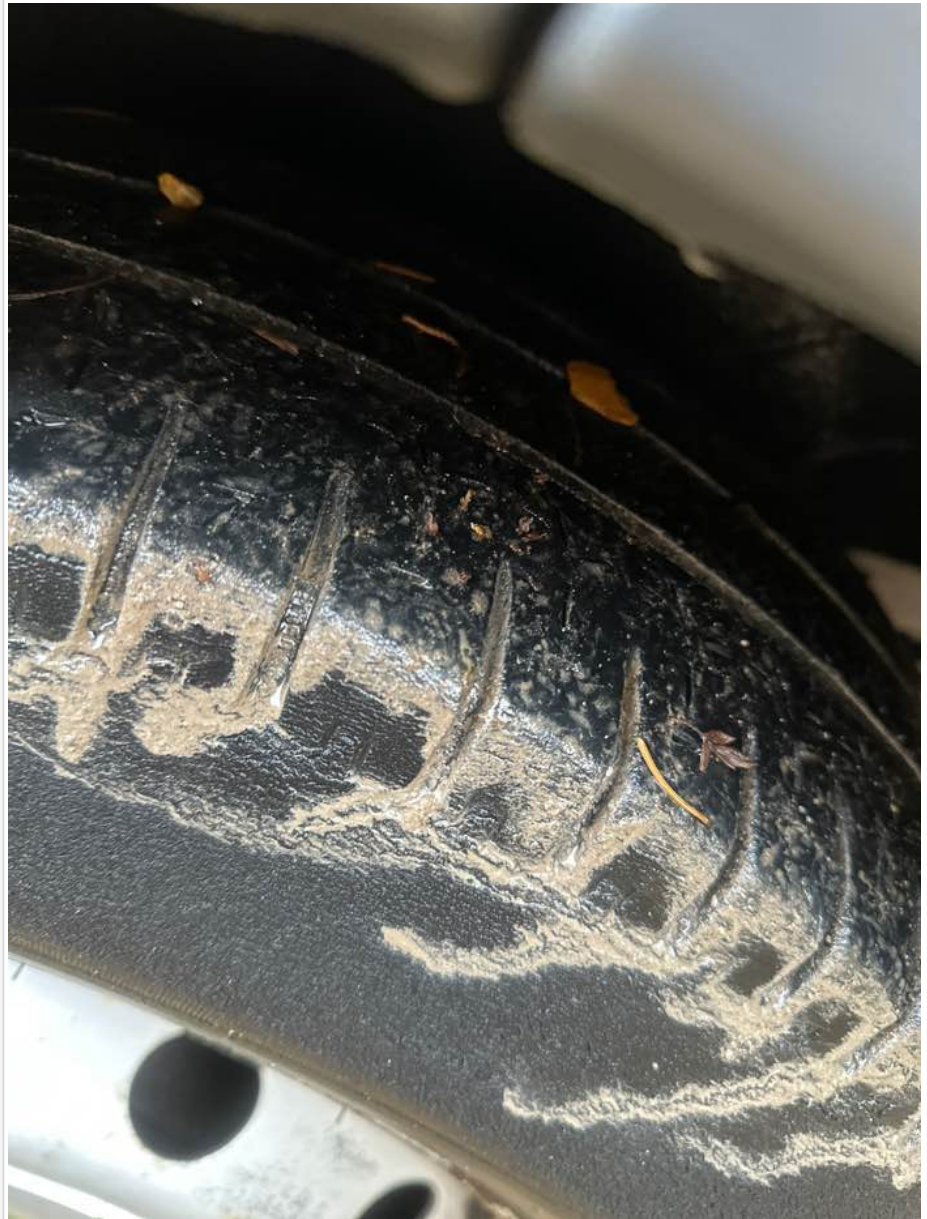
near side rear

Age (month/year) Manufactured	15/17
Make, brand.	Michelin
Tyre size	225/75/R16
Pressure 1	
Pressure 2	
Wearing / Perishing (inner)	none
Wearing / Perishing (outer)	None
tread depth (mm)	4
General comments	life left in tyre, kerb rashing

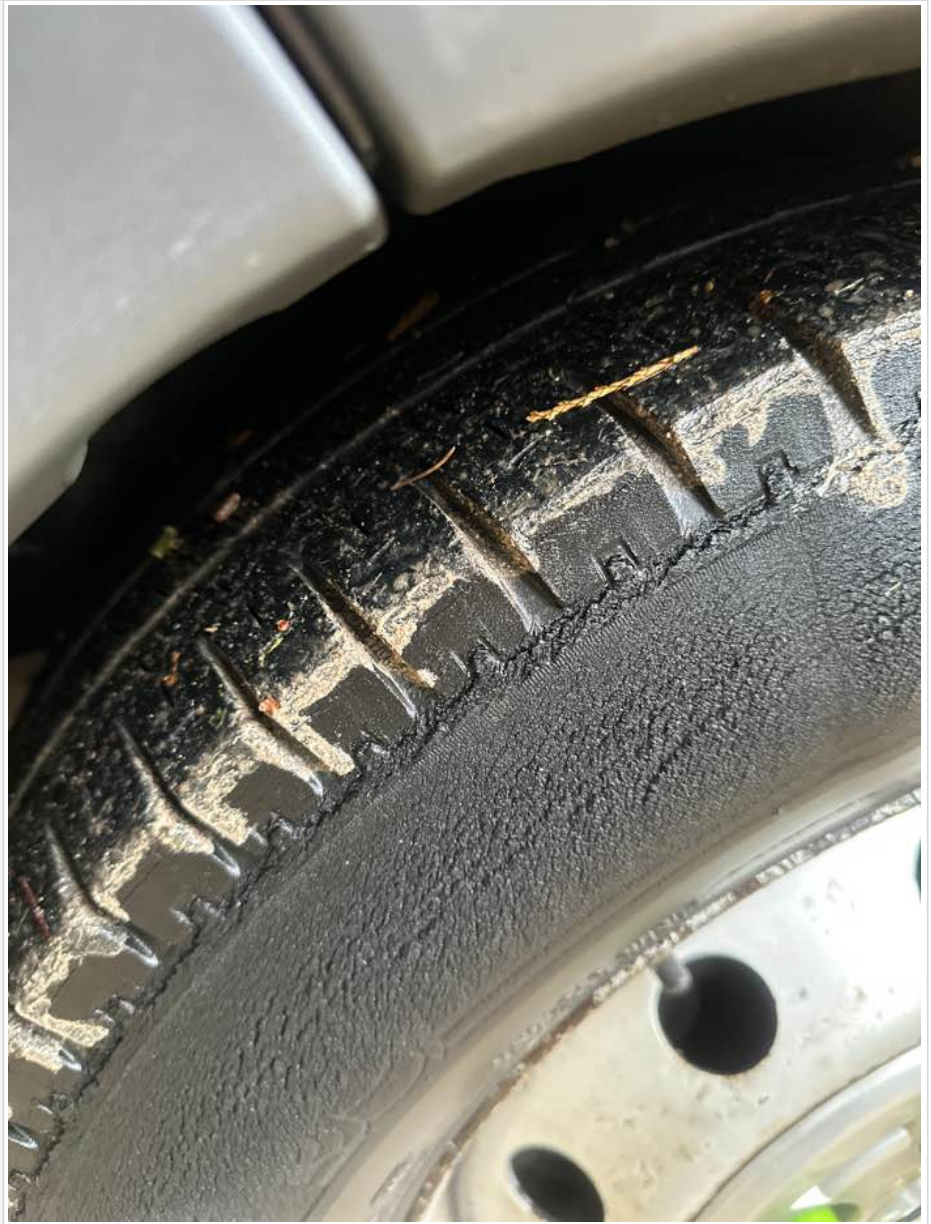
Off side rear

Age (month/year) Manufactured	01/17
Make, brand.	Michelin
Tyre size	225/75/R16
Pressure 1	
Pressure 2	
Wearing / Perishing (inner)	none
Wearing / Perishing (outer)	None
tread depth (mm)	4
General comments	good tyre but kerb rashed

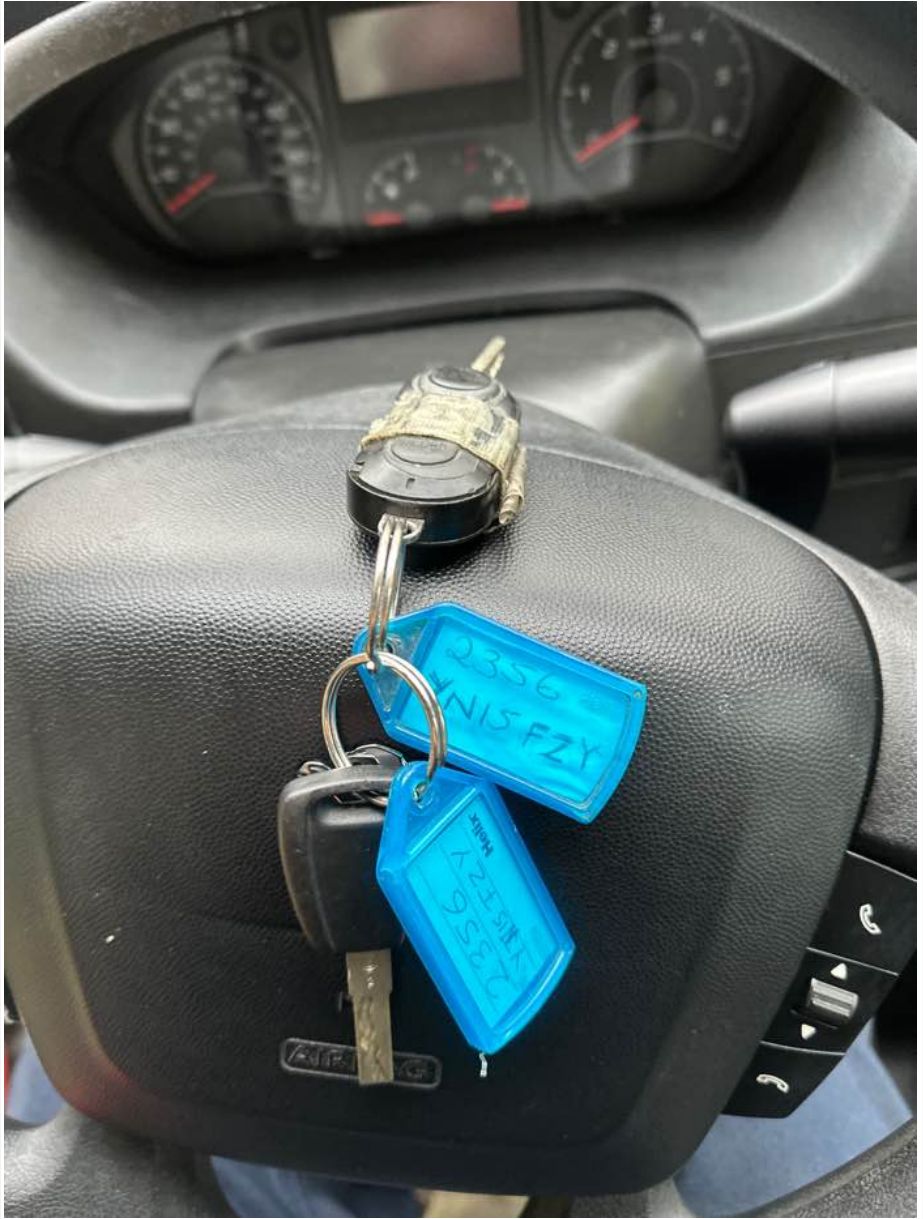
Comment	works as should

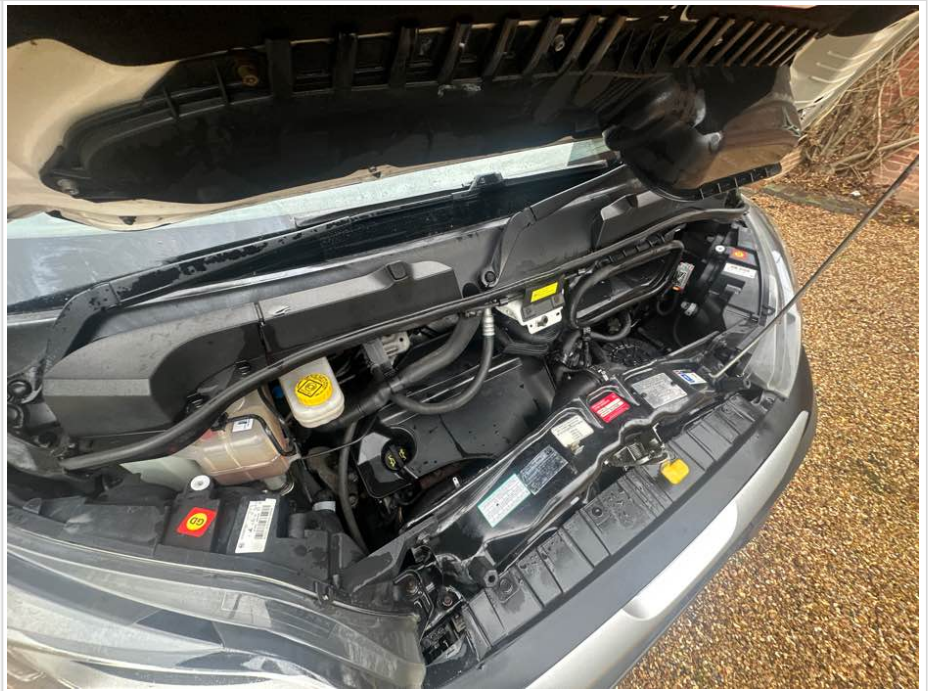
<p>Engine bay photo</p>

<p>Comment</p>	<p>mechanically good</p>
