Basevan.com General Inspection

Vehicle registration	FN14 TKF
Vehicle chassis no.	ZCFC35C200D512052
Miles (if in km, multiply by 0.62)	128224
Make	IveCo
Model	Daily
Transmission	Manual, 6 speed
Factory immobiliser installed	Yes
Speed limiter installed	No
Drive configuration	RWD
Gross Vehicle Weight (kg)	3500
Towing capacity	3500kg
Tow bar installed	Yes

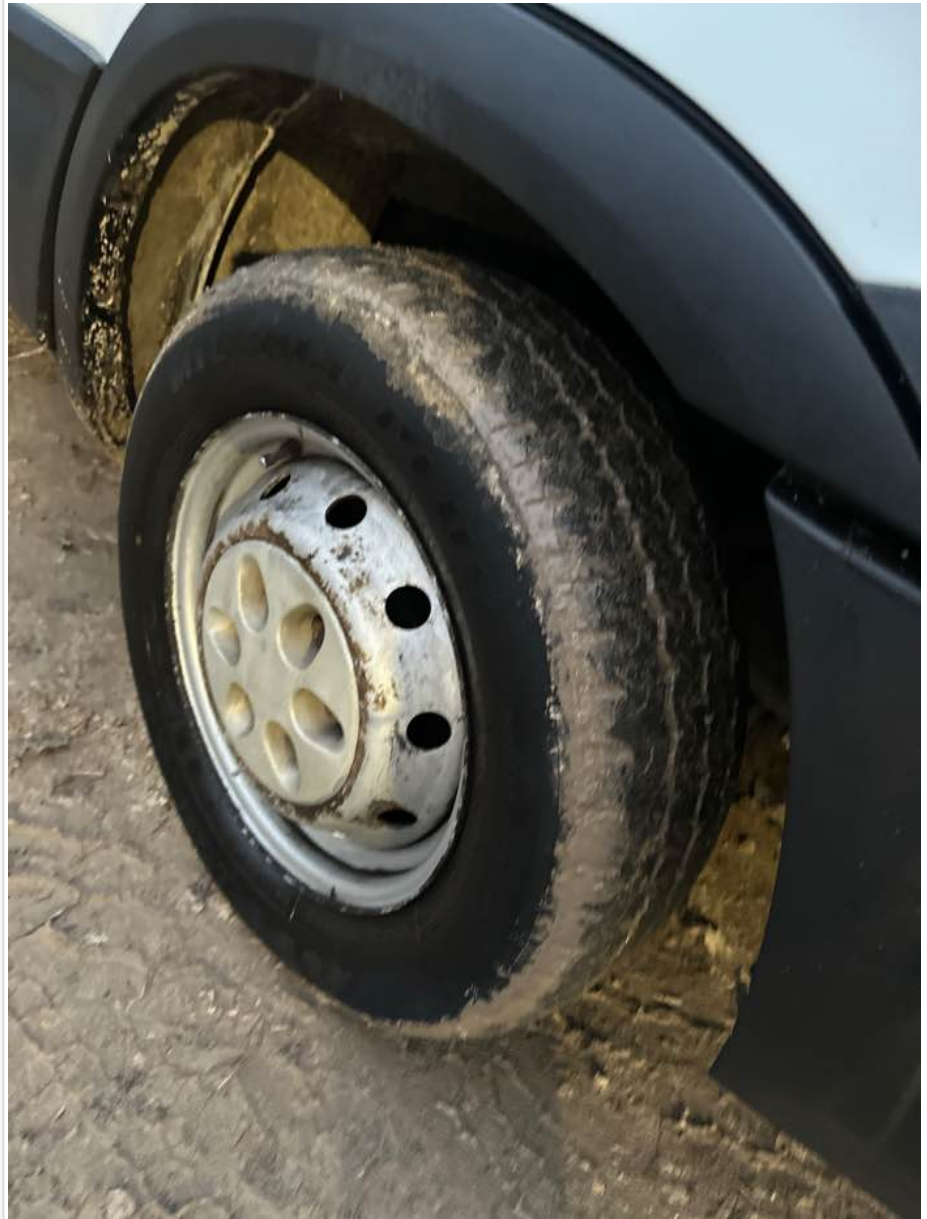
Off side front

Age (month/year) Manufactured	37/21
Make, brand.	Budget
Tyre size	225/65/R16
Pressure 1	
Pressure 2	
Wearing / Perishing (inner)	none
Wearing / Perishing (outer)	None
tread depth (mm)	5
General comments	life left on tyre

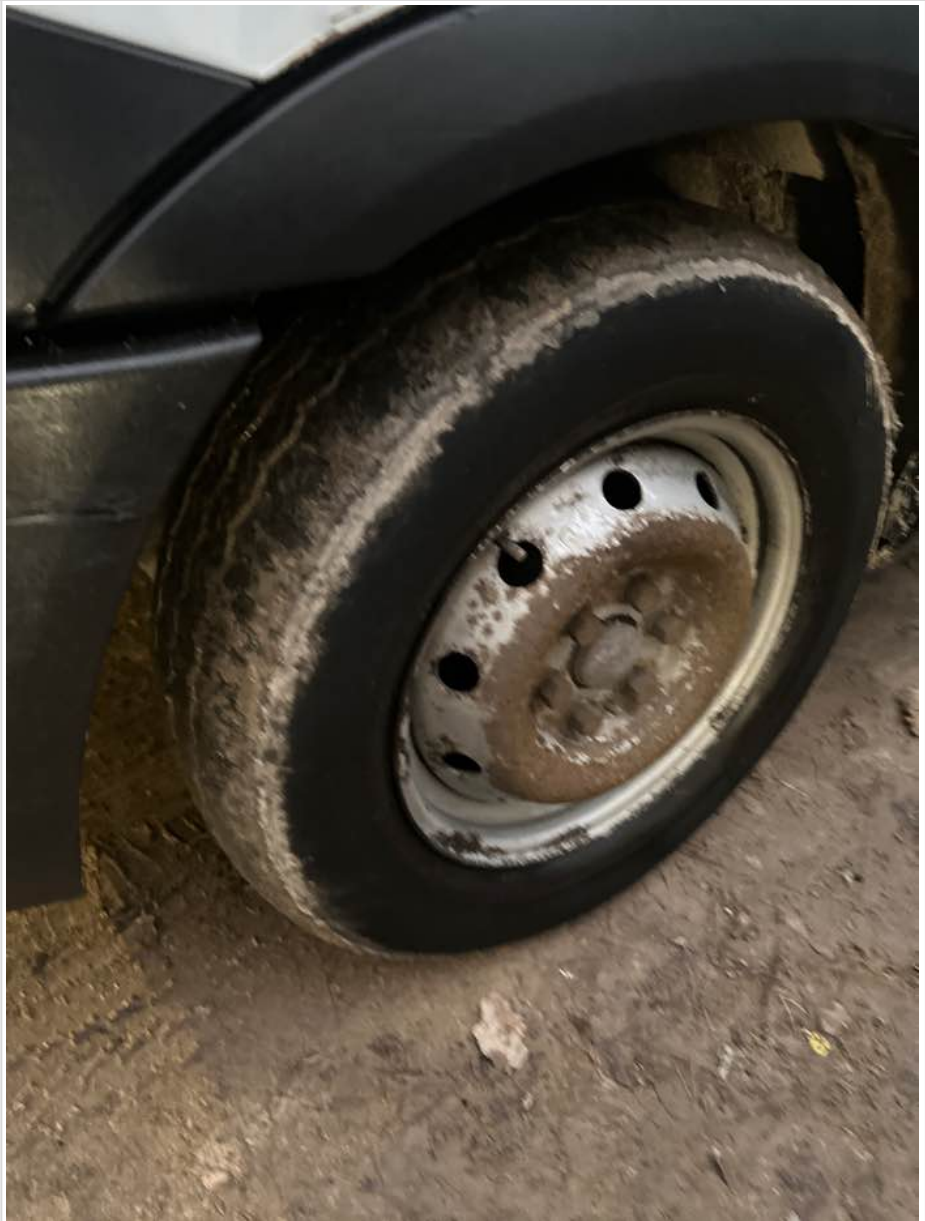
Near side front

Age (month/year) Manufactured	40/21
Make, brand.	Budget
Tyre size	225/65/R16
Pressure 1	
Pressure 2	
Wearing / Perishing (inner)	none
Wearing / Perishing (outer)	None
tread depth (mm)	5
General comments	life left in tyre

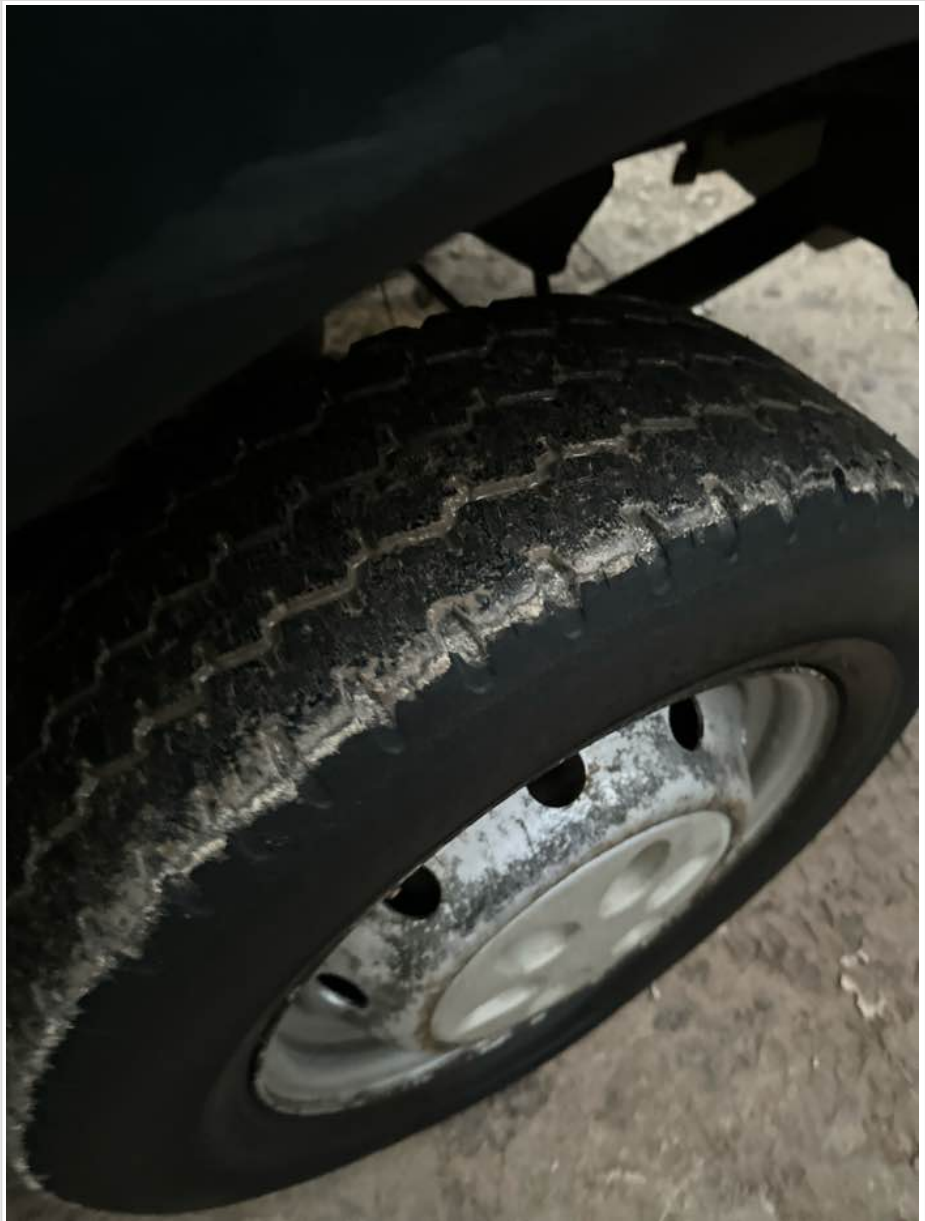
near side rear

Age (month/year) Manufactured	38/21
Make, brand.	Budget
Tyre size	225/65/R16
Pressure 1	
Pressure 2	
Wearing / Perishing (inner)	none
Wearing / Perishing (outer)	None
tread depth (mm)	6
General comments	good life in tyre

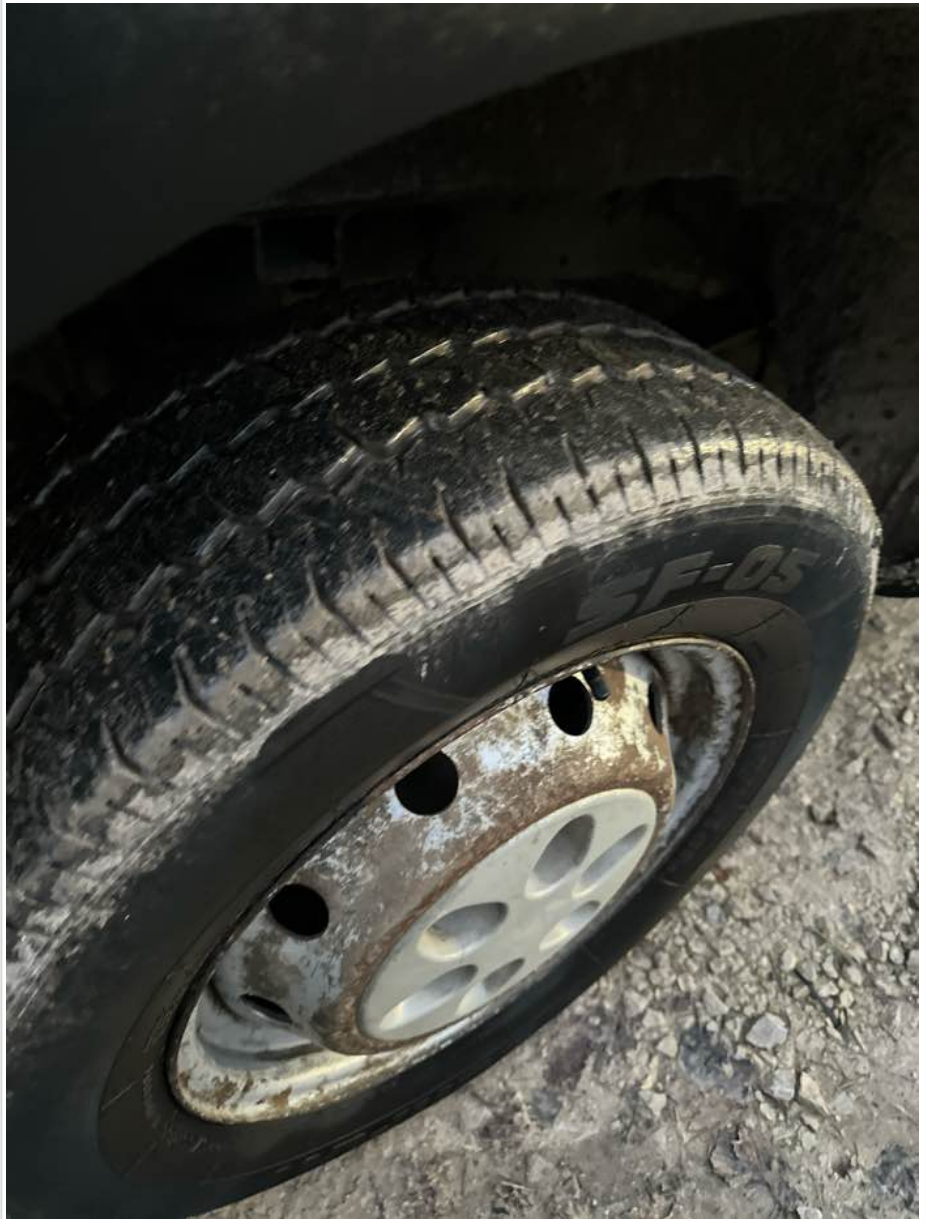
Off side rear

Age (month/year) Manufactured	40/21
Make, brand.	Budget
Tyre size	225/65/R16
Pressure 1	
Pressure 2	
Wearing / Perishing (inner)	none
Wearing / Perishing (outer)	None
tread depth (mm)	7
General comments	lots of tread

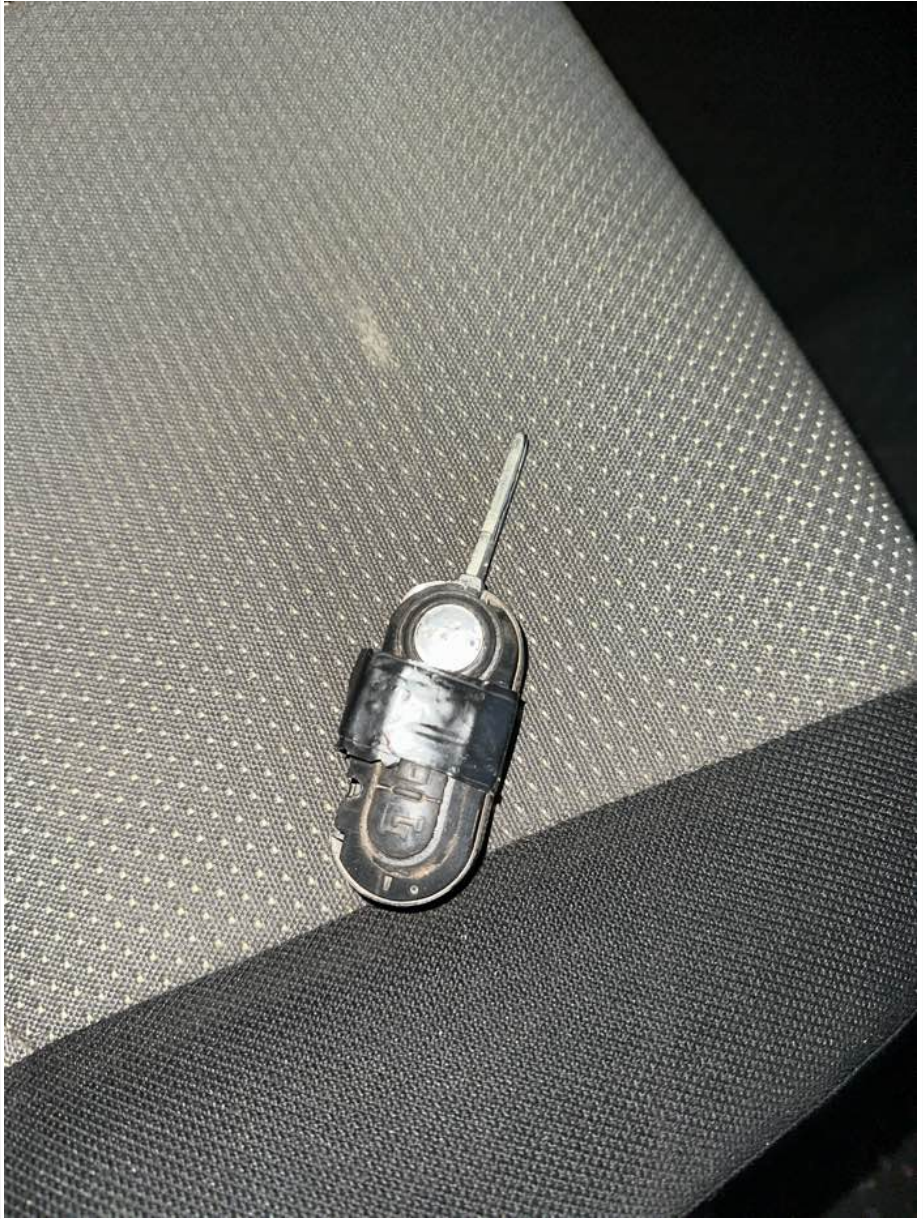
Comment	works as intended, but side door handle damaged

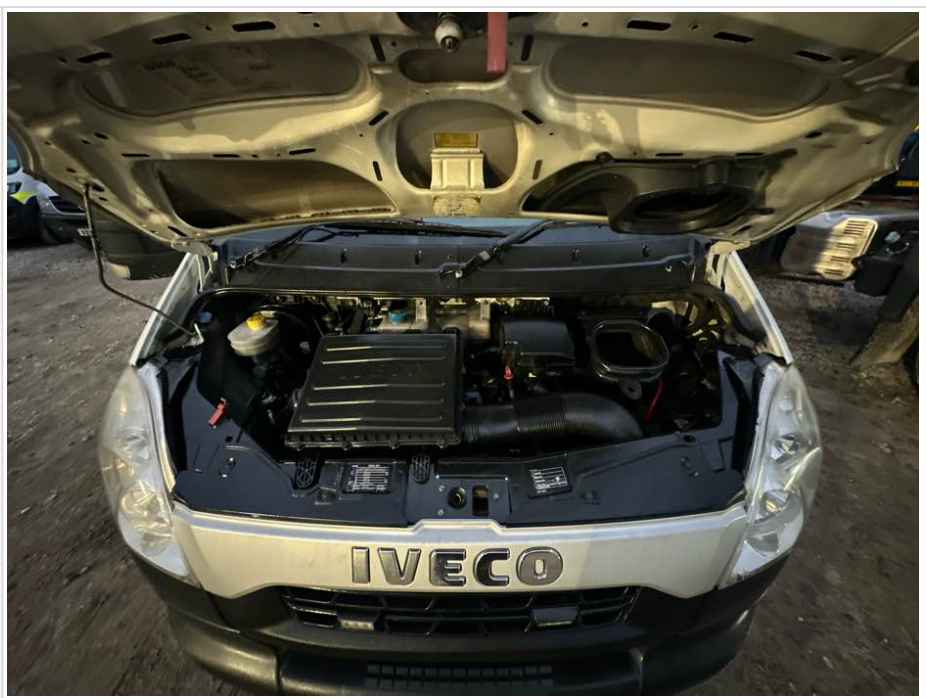
<p>Engine bay photo</p>

<p>Comment</p>	<p>mechanically nice</p>
