Basevan.com General Inspection

Name of inspector	Wallis
Date of inspection	22/01/2025
Signature

Vehicle registration	CN06CWF
Vehicle chassis no.	WDB9036622R949859
Miles (if in km, multiply by 0.62)	99,677
Make	Mercedes
Model	Sprinter
Transmission	Automatic
Factory immobiliser installed	Yes
Speed limiter installed	N/A
Drive configuration	RWD
Gross Vehicle Weight (kg)	3500
Towing capacity	2,800
Tow bar installed	No

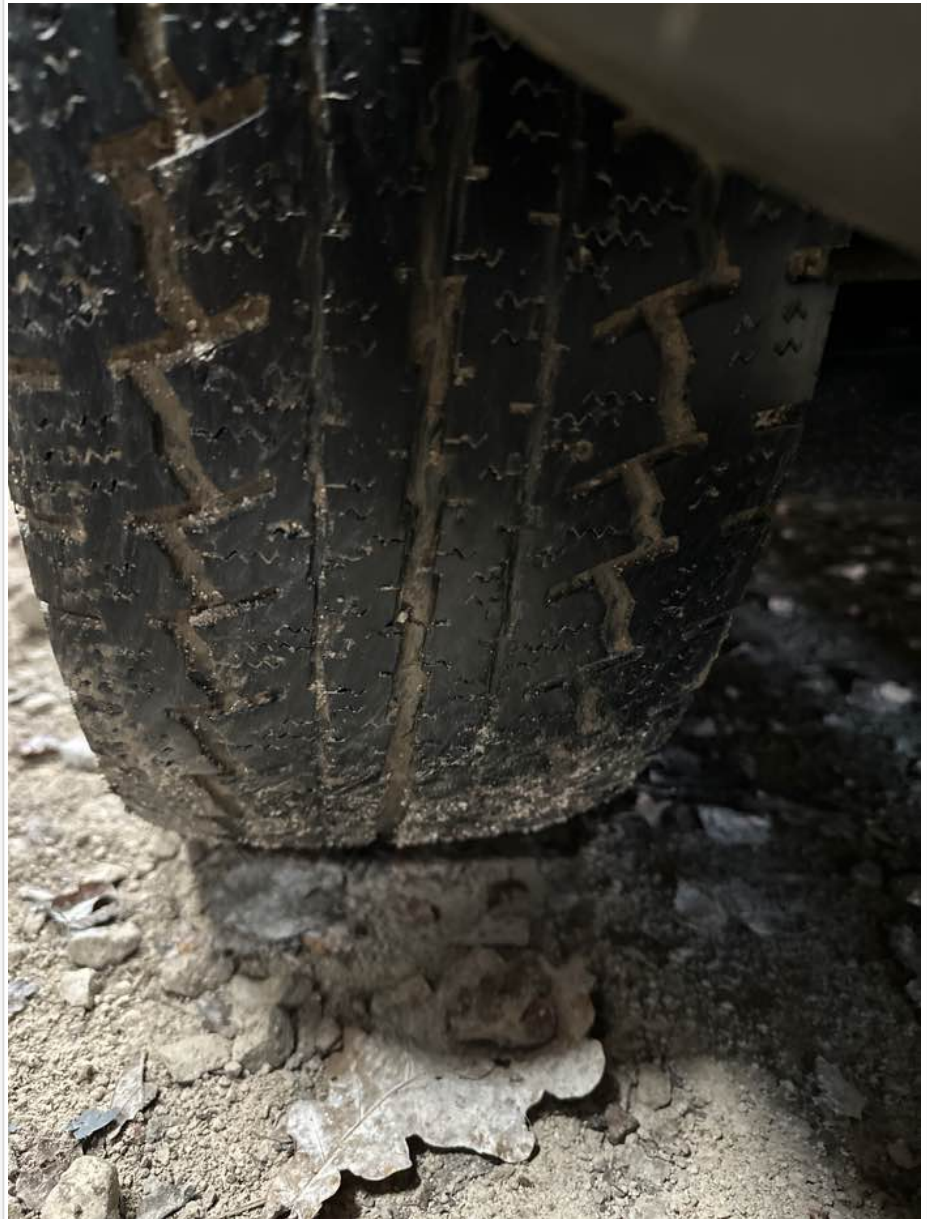
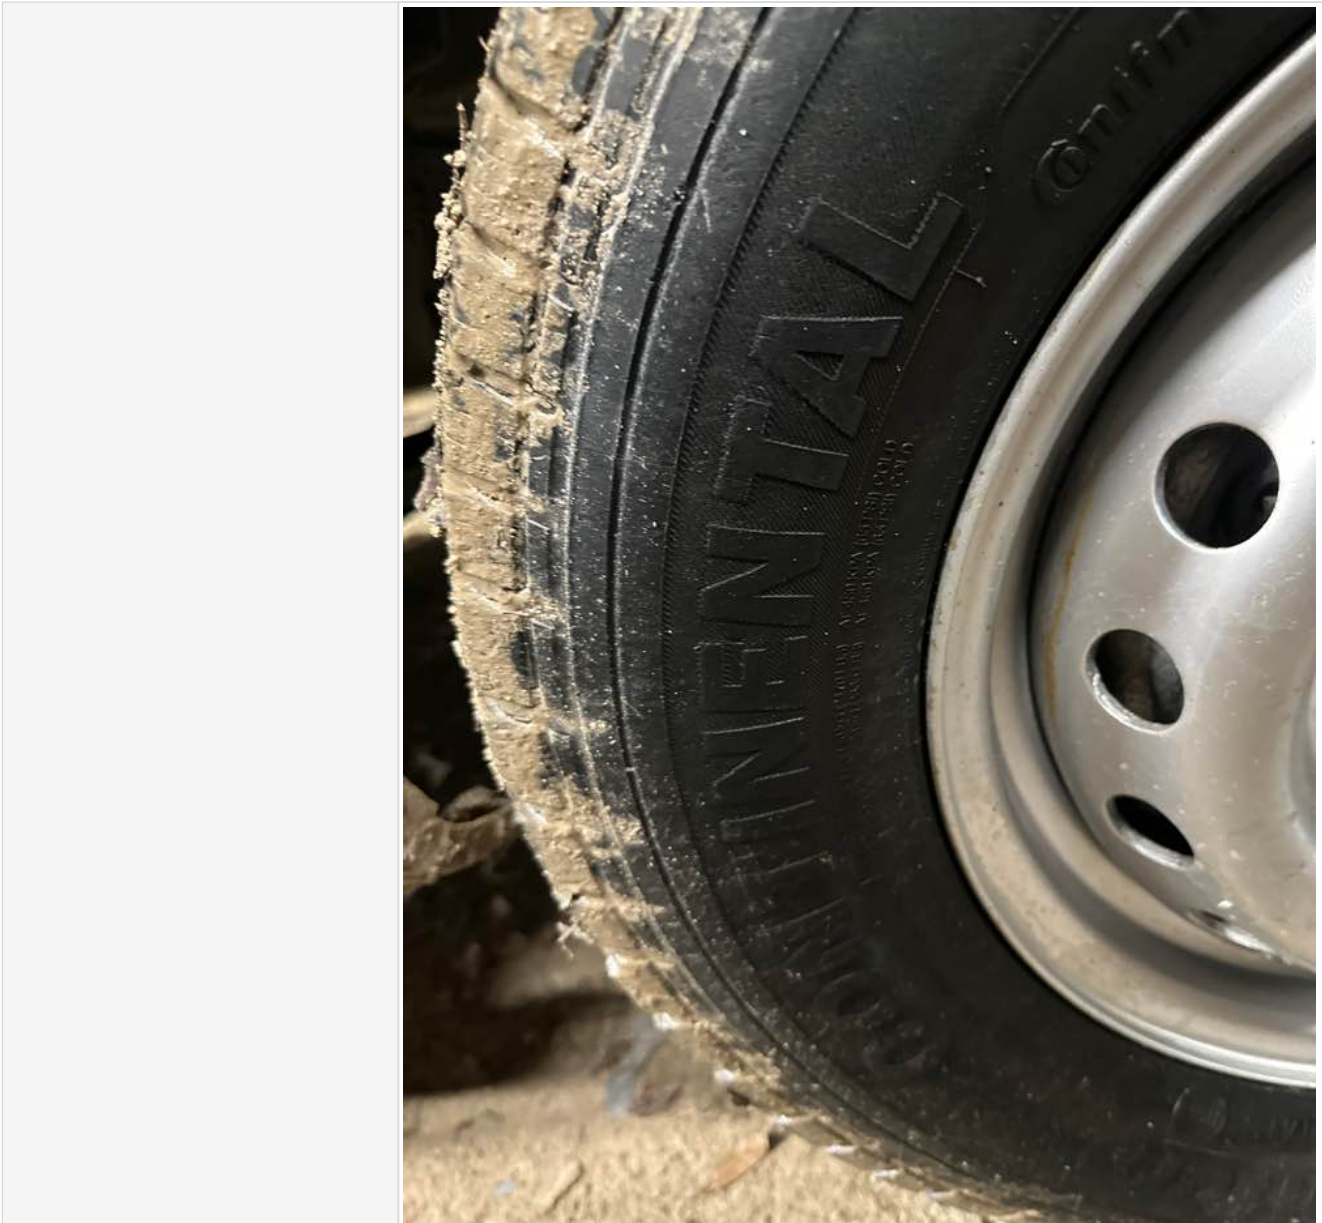
Off side front

Age (month/year) Manufactured	16/06
Make, brand.	Continental
Tyre size	Not here (see comment)
Pressure 1	46
Pressure 2	
Wearing / Perishing (inner)	Medium
Wearing / Perishing (outer)	Medium
tread depth (mm)	5
General comments	225/70R15

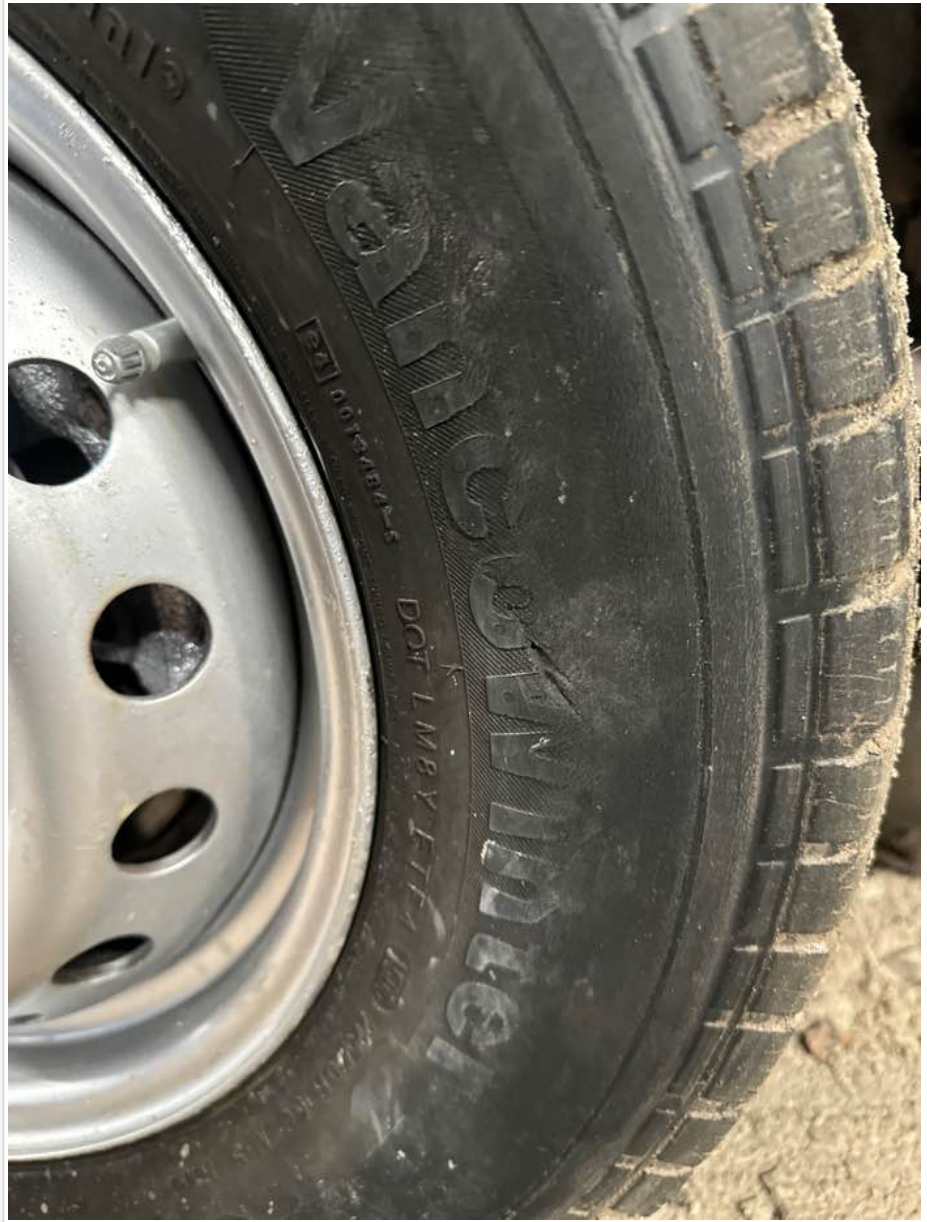
Near side front

Age (month/year) Manufactured	15/06
Make, brand.	Continental
Tyre size	Not here (see comment)
Pressure 1	48
Pressure 2	
Wearing / Perishing (inner)	Medium
Wearing / Perishing (outer)	Medium
tread depth (mm)	5
General comments	225/70R15

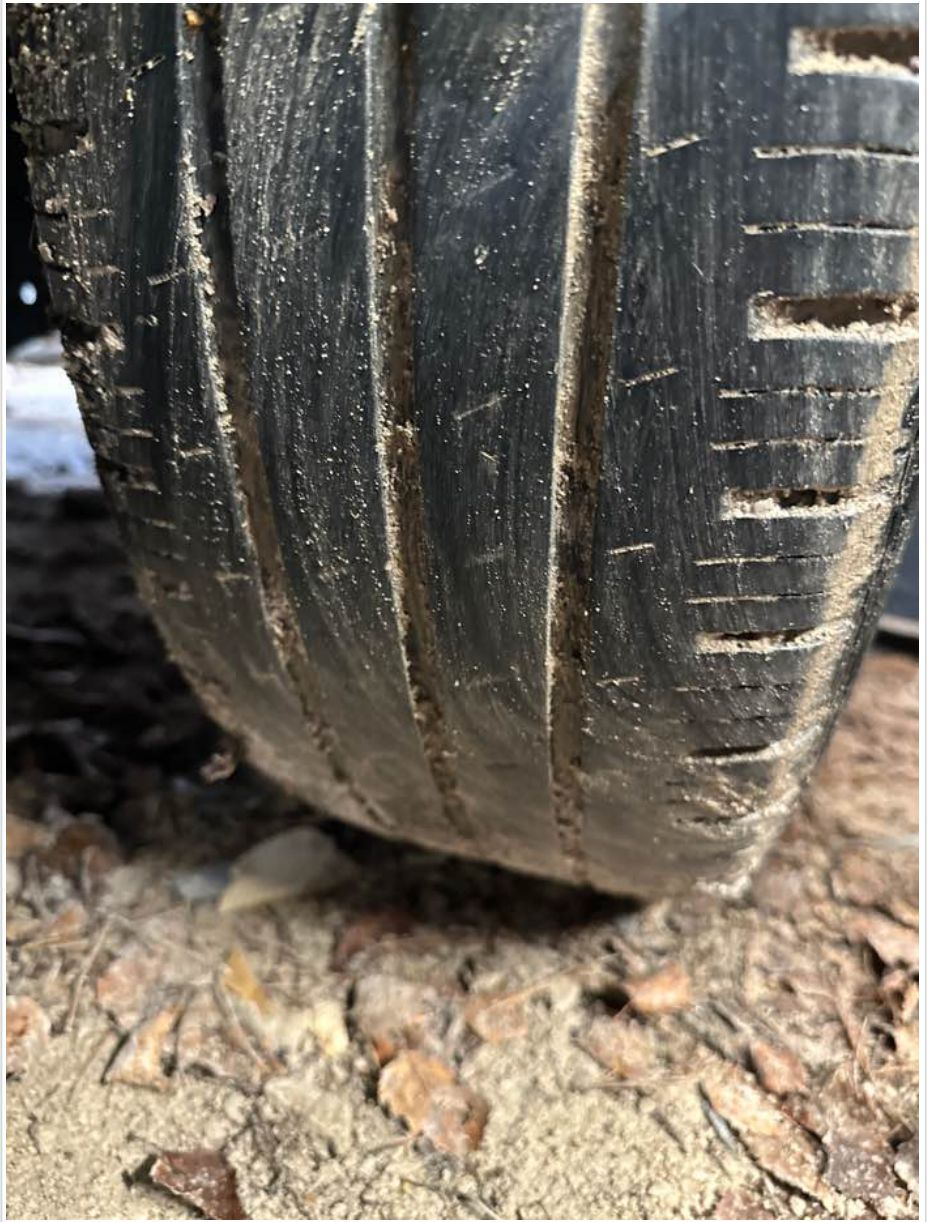
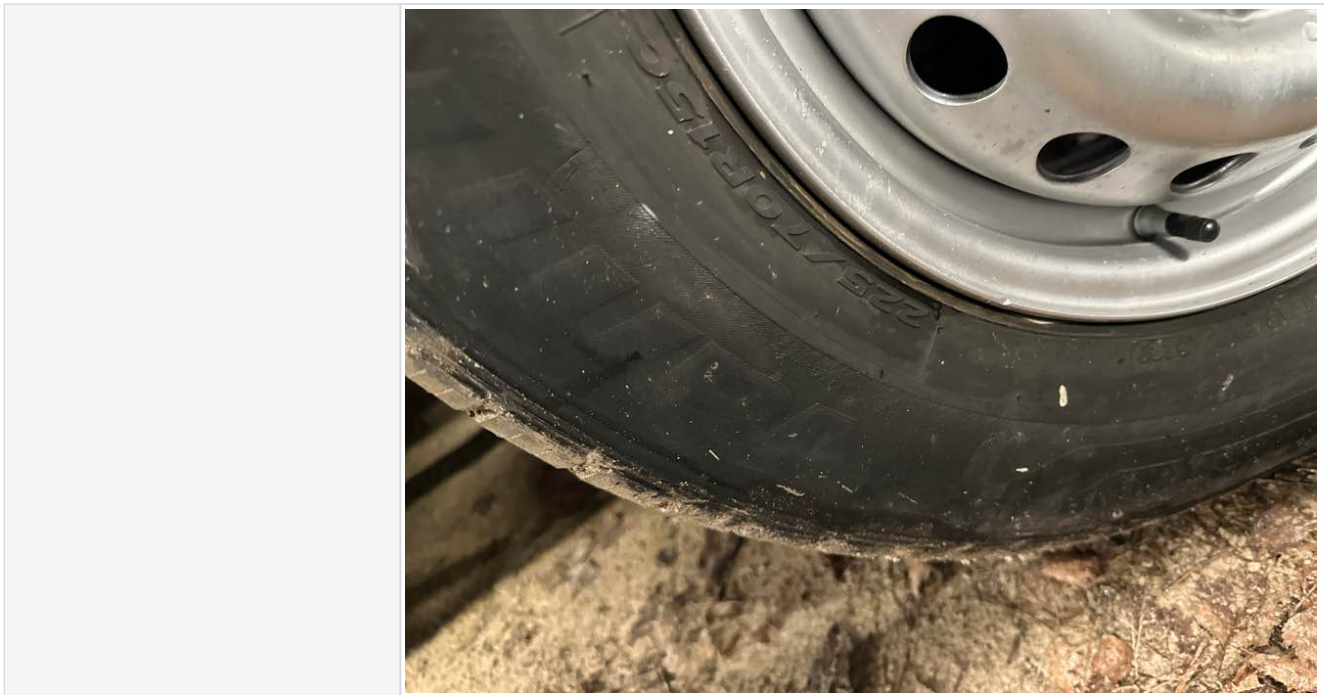
near side rear

Age (month/year) Manufactured	32/20
Make, brand.	Hankook
Tyre size	Not here (see comment)
Pressure 1	60
Pressure 2	
Wearing / Perishing (inner)	Medium
Wearing / Perishing (outer)	Medium
tread depth (mm)	4
General comments	225/70R15

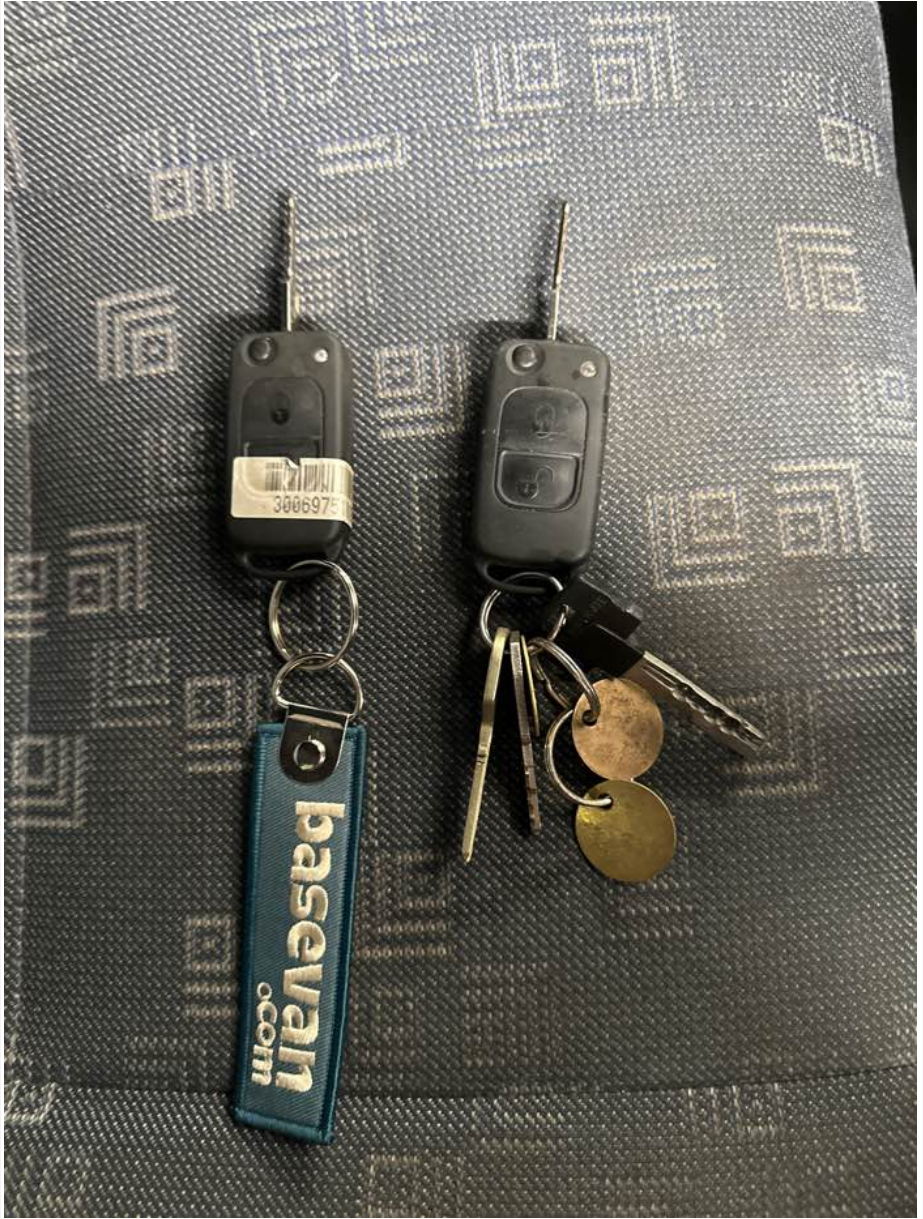
Select the following doors that lock.	N/S SL, N/S Rear, O/S Rear
Method of locking	Key
In conclusion can all the doors be locked in some way and thus the vehicle can be left unattended at night safely?	No
How many keys present at time of inspection?

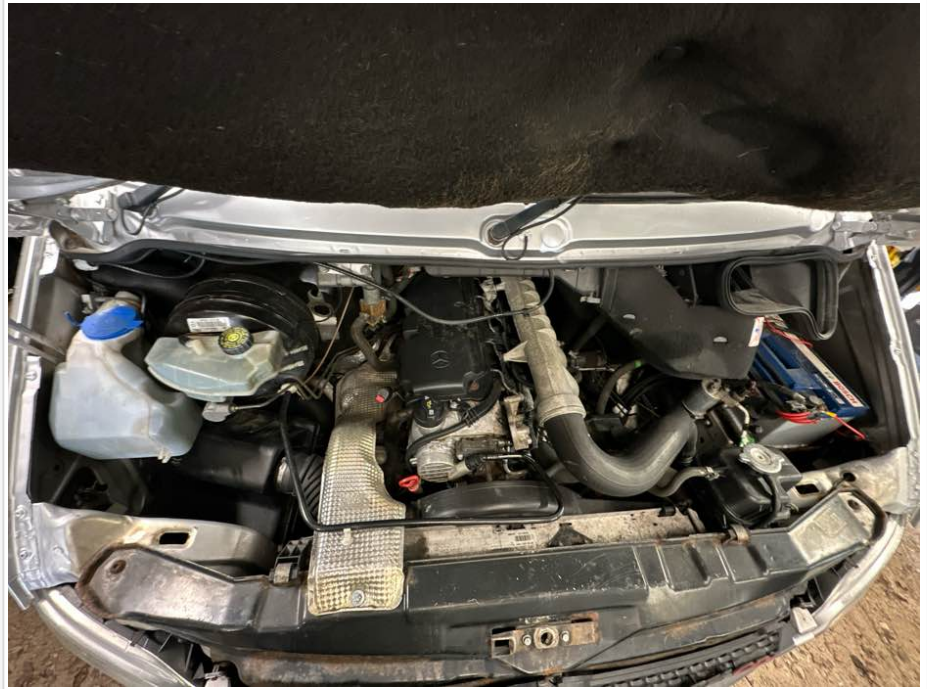
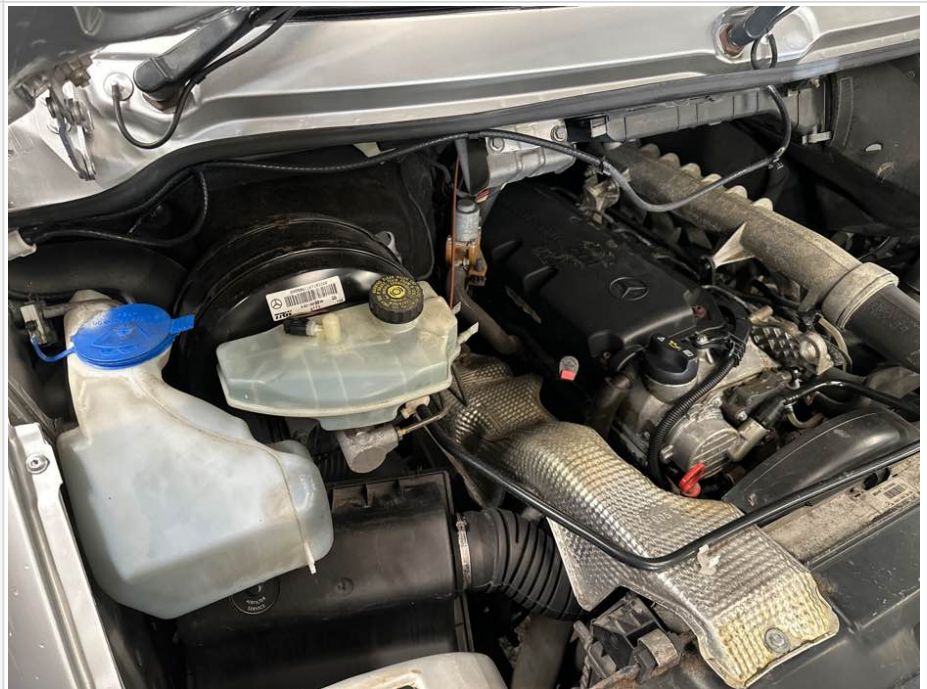
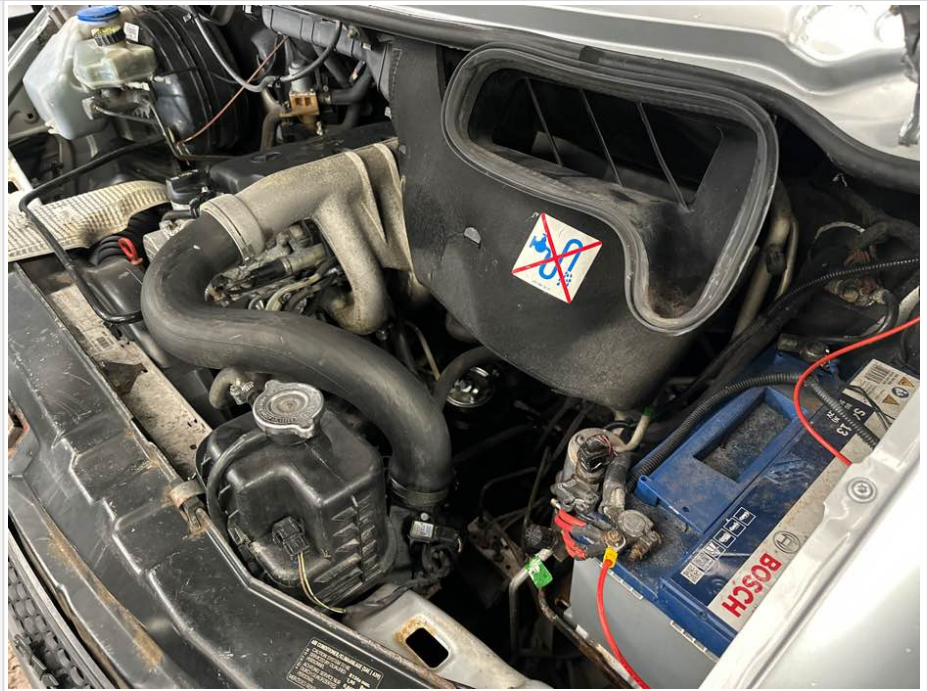
Engine bay photo

Fuel level	1/2 Full
Oil level	Full
Oil conditon	Clean
Start up, chassis battery check	Started without jump pack
Start-up from cold	2 seconds
Exhaust smoke from cold	Normal
Output Voltage of Alternator test	14
Chain or Belt driven engine?	Chain
If belt any proof of change?	N/A
Coolant condition	Clean
Coolant level	Full
Anti-freeze temperature check	
Washer fluid	Full
Brake fluid	Full
Power steering fluid	Maximum
Dashboard warning light	No warning lights
OBD Scan results
