Basevan.com General Inspection

Vehicle registration	MX05 GXU
Vehicle chassis no.	ZCFC297100D267680
Miles (if in km, multiply by 0.62)	26957mi
Make	Iveco
Model	Daily
Transmission	Manual, 5 speed
Factory immobiliser installed	Yes
Speed limiter installed	No
Drive configuration	RWD
Gross Vehicle Weight (kg)	3200
Towing capacity	2800kg
Tow bar installed	No

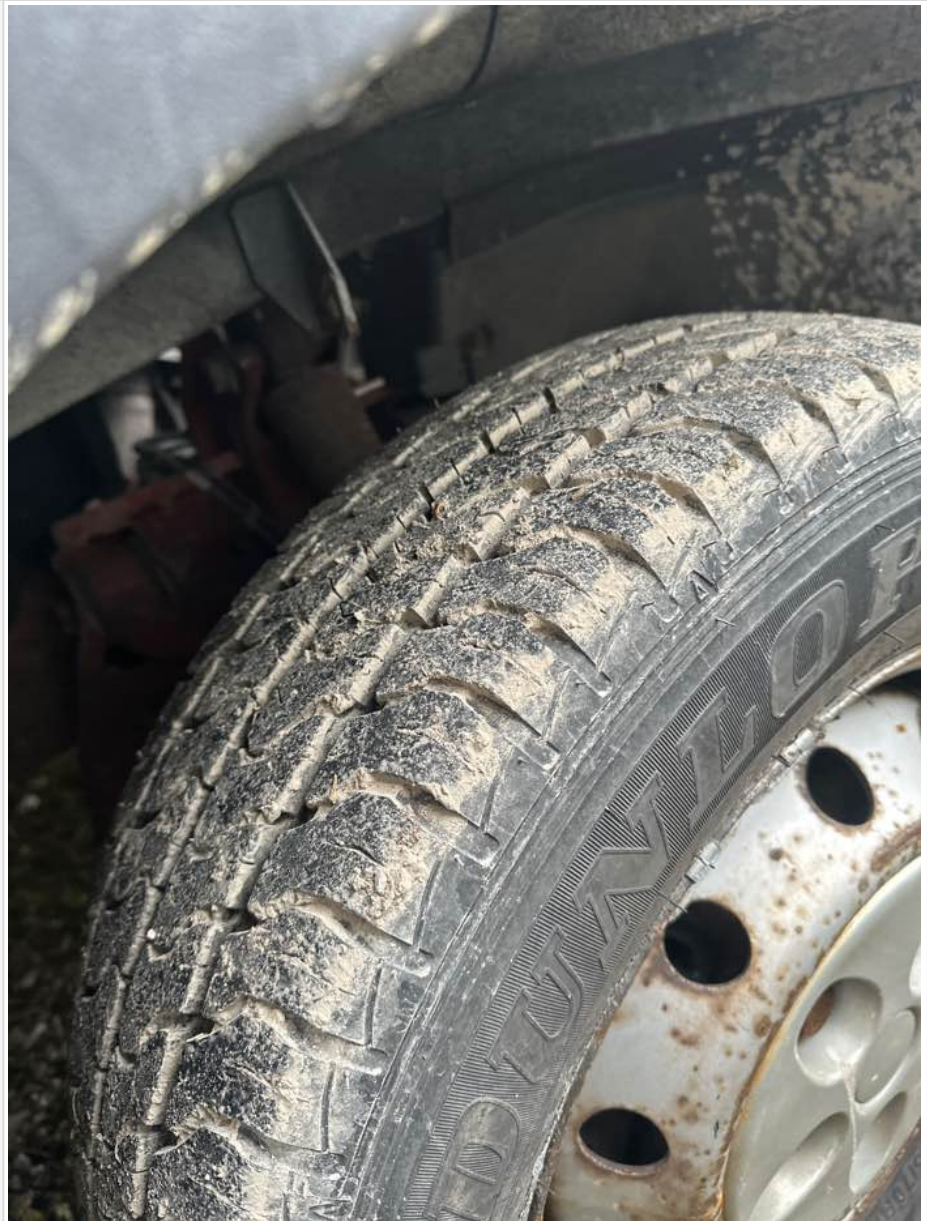
Off side front

Age (month/year) Manufactured	18:19
Make, brand.	Dunlop
Tyre size	Not here (see comment)
Pressure 1	
Pressure 2	
Wearing / Perishing (inner)	none
Wearing / Perishing (outer)	None
tread depth (mm)	7
General comments	205/70/15- great tyre

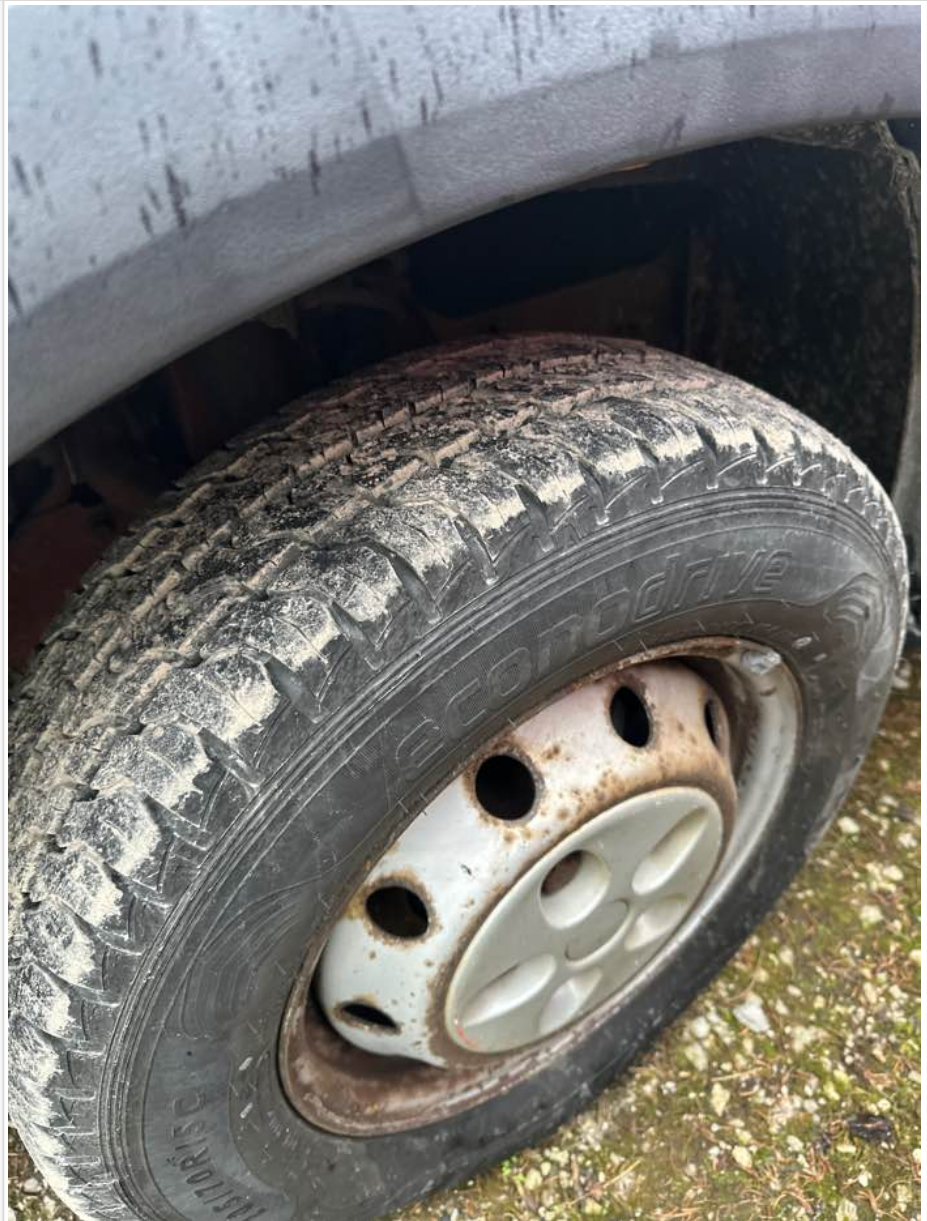
Near side front

Age (month/year) Manufactured	18:19
Make, brand.	Dunlop
Tyre size	Not here (see comment)
Pressure 1	
Pressure 2	
Wearing / Perishing (inner)	none
Wearing / Perishing (outer)	None
tread depth (mm)	7
General comments	205/70/15- great tyre

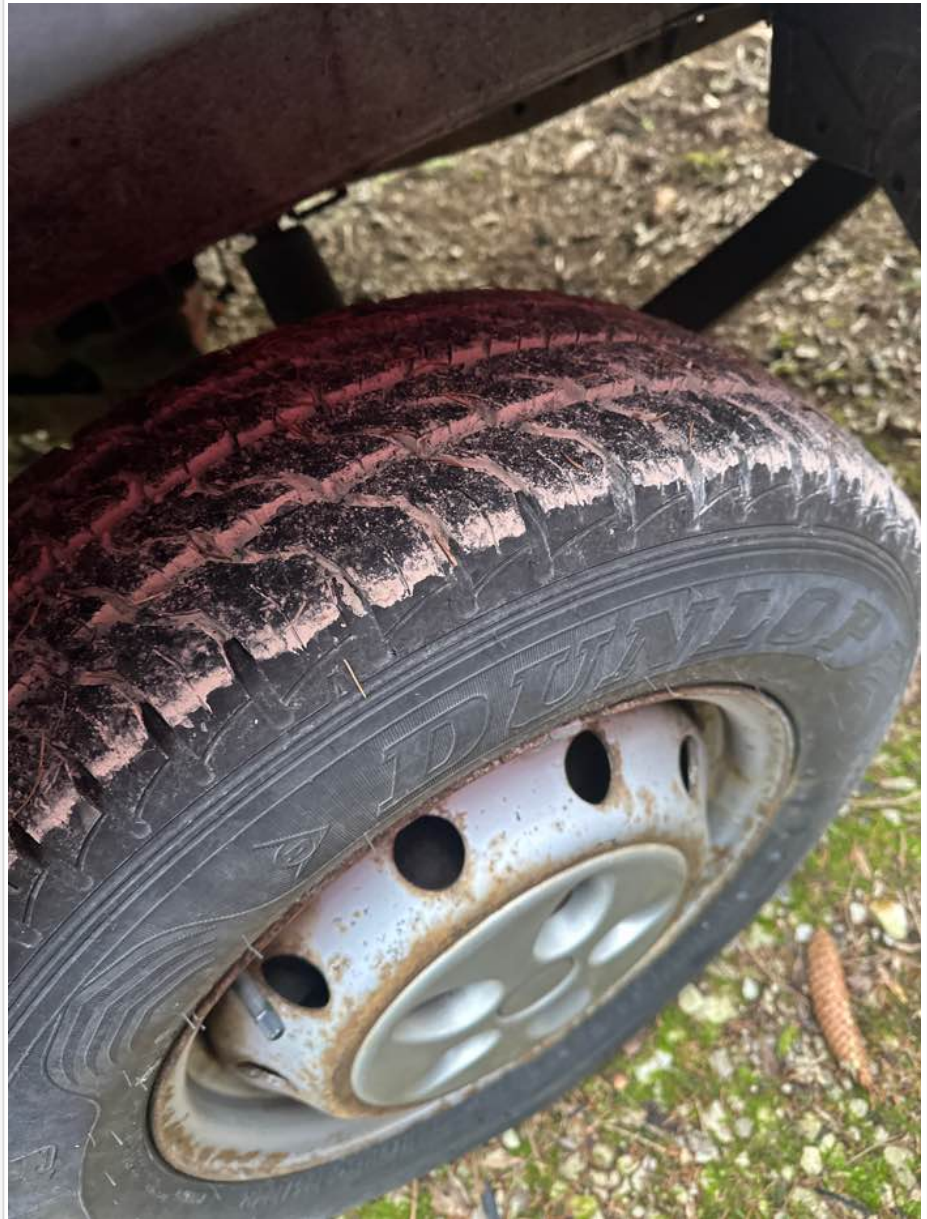
near side rear

Age (month/year) Manufactured	18/19
Make, brand.	Dunlop
Tyre size	Not here (see comment)
Pressure 1	
Pressure 2	
Wearing / Perishing (inner)	none
Wearing / Perishing (outer)	None
tread depth (mm)	7
General comments	205/70/15- great tyre

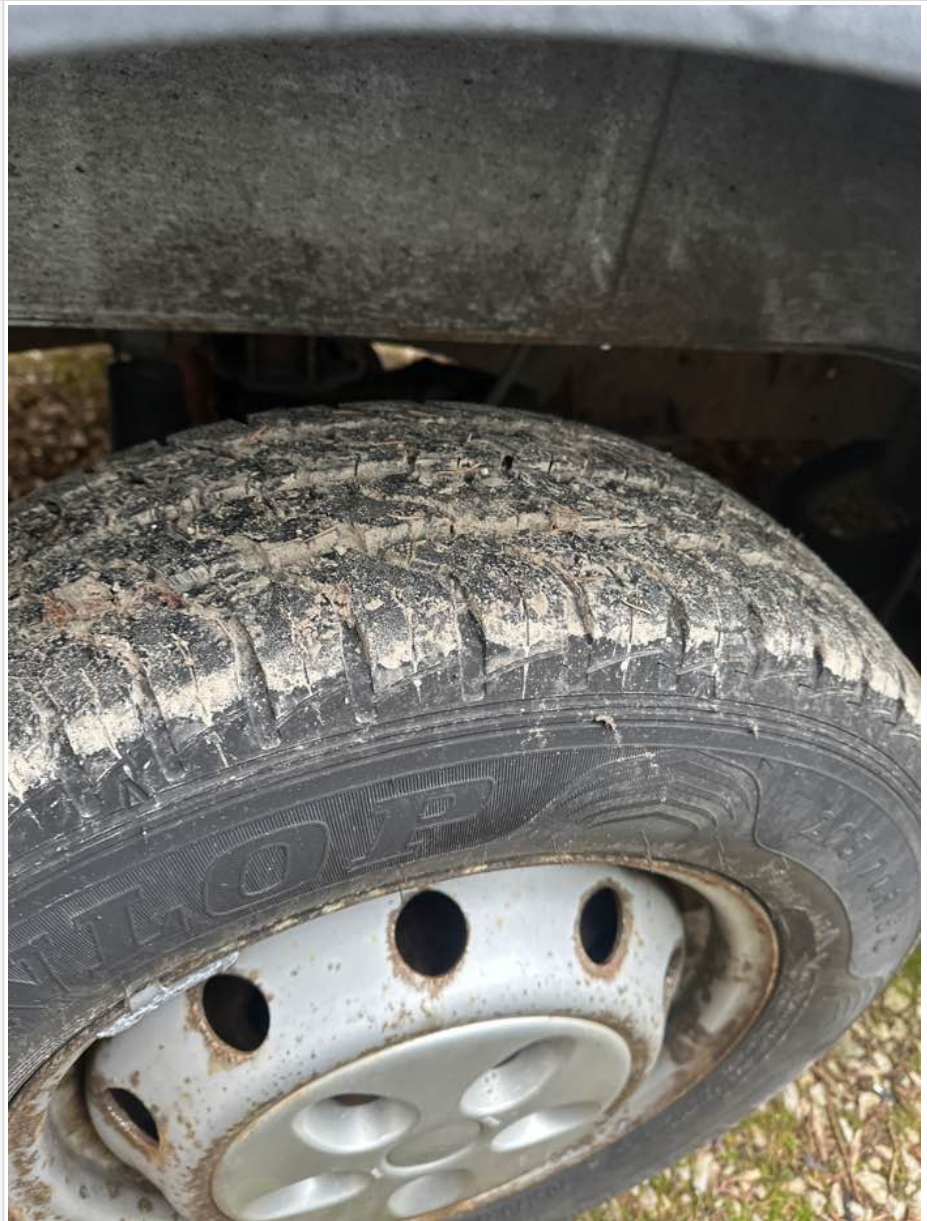
Off side rear

Age (month/year) Manufactured	18/19
Make, brand.	Dunlop
Tyre size	Not here (see comment)
Pressure 1	
Pressure 2	
Wearing / Perishing (inner)	none
Wearing / Perishing (outer)	None
tread depth (mm)	7
General comments	205/70/15- great tyre

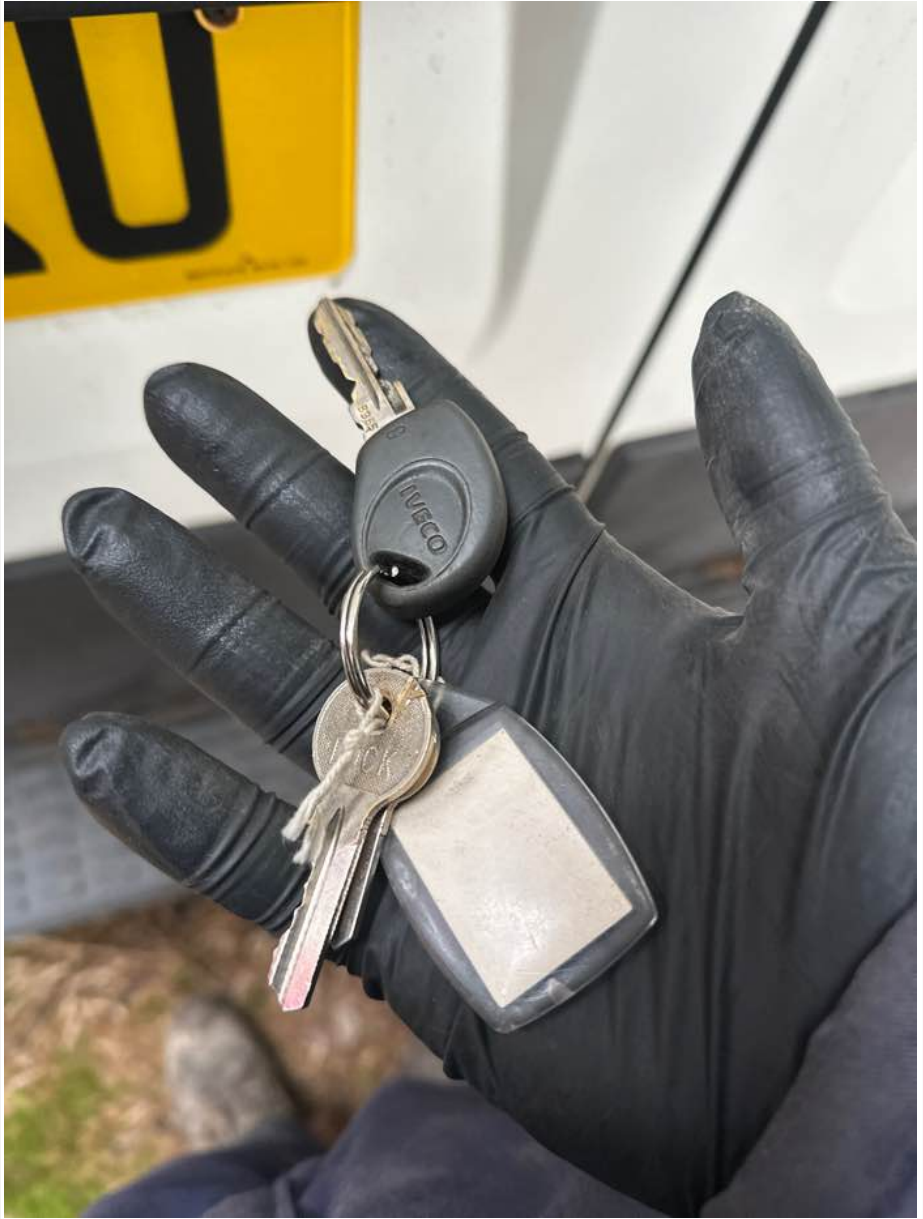
Select the following doors that lock.	N/S Front, O/S Front, N/S SL, N/S Rear, O/S Rear
Method of locking	Key
In conclusion can all the doors be locked in some way and thus the vehicle can be left unattended at night safely?	Yes
How many keys present at time of inspection?

Comment	works as intended

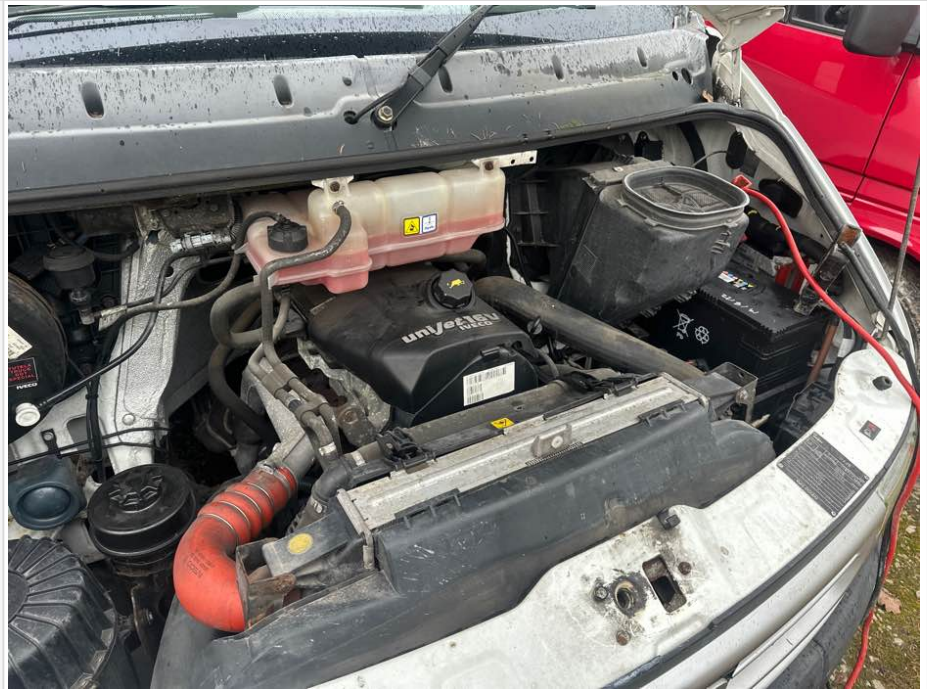
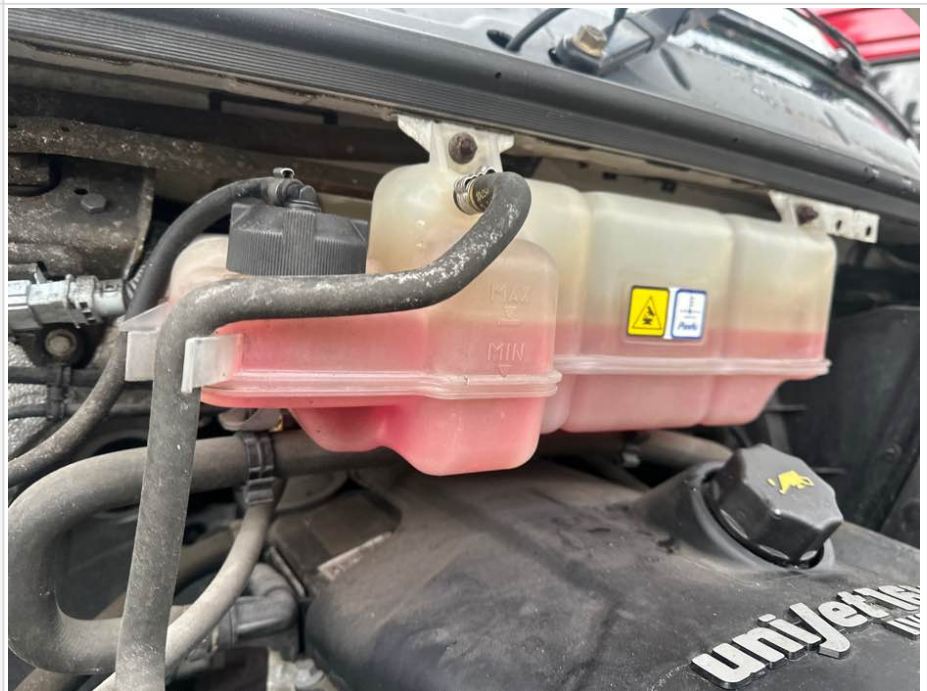
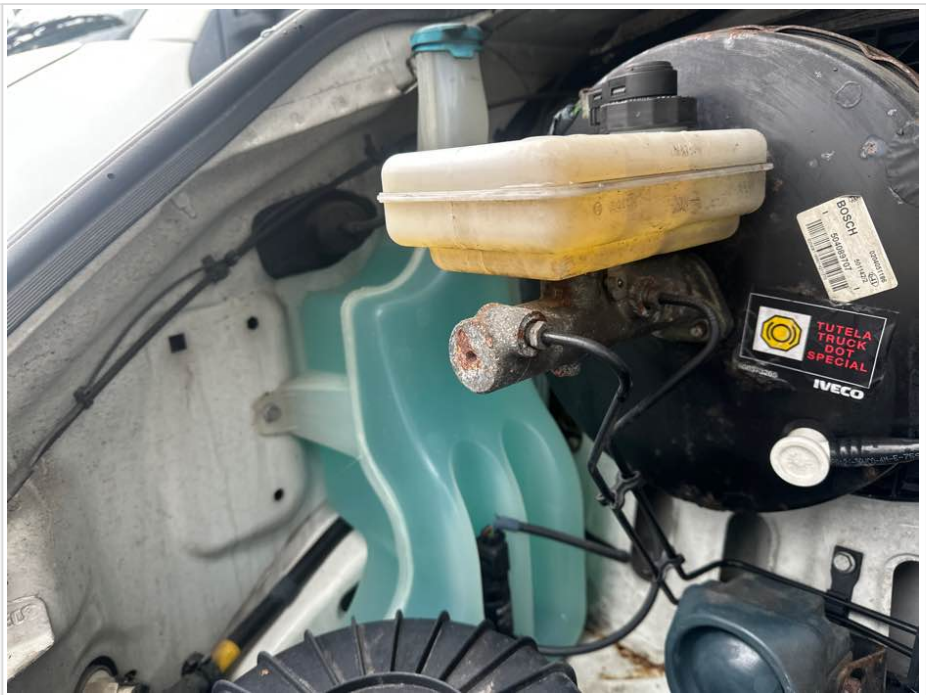
Engine bay photo

Fuel level	1/2 Full
Oil level	Medium
Oil conditon	Clean
Start up, chassis battery check	Started, but required boost pack, Chassis battery requires charging
Start-up from cold	Instant
Exhaust smoke from cold	Normal
Output Voltage of Alternator test	13.6
Chain or Belt driven engine?	Belt
If belt any proof of change?	n/a
Coolant condition	Clean
Coolant level	Full
Anti-freeze temperature check	-15
Washer fluid	Full
Brake fluid	Full
Power steering fluid	Maximum
Dashboard warning light	No warning lights
OBD Scan results

Comment	mechanically great, nice mileage!
