## Basevan.com General Inspection

Name of inspector	Rupert Beeston
Date of inspection	26/01/2025
Signature

Vehicle registration	GN08OTA
Vehicle chassis no.	WV1ZZZ2EZ86024141
Miles (if in km, multiply by 0.62)	128,595
Make	VW
Model	Crafter CR50 2.5 MANUAL LWB
Transmission	6 speed
Factory immobiliser installed	Yes
Speed limiter installed	No
Drive configuration	RWD
Gross Vehicle Weight (kg)	5000
Towing capacity	2000
Tow bar installed	No

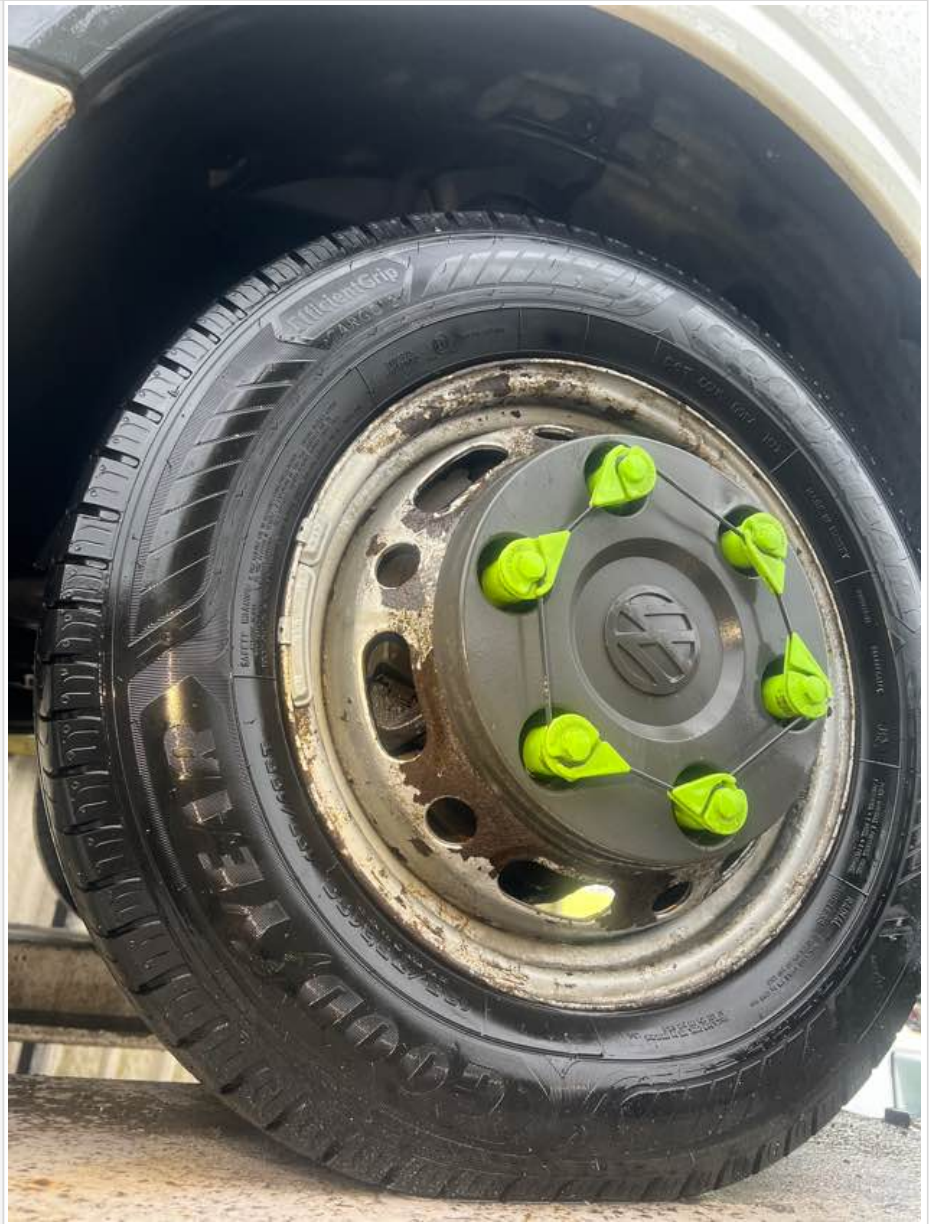
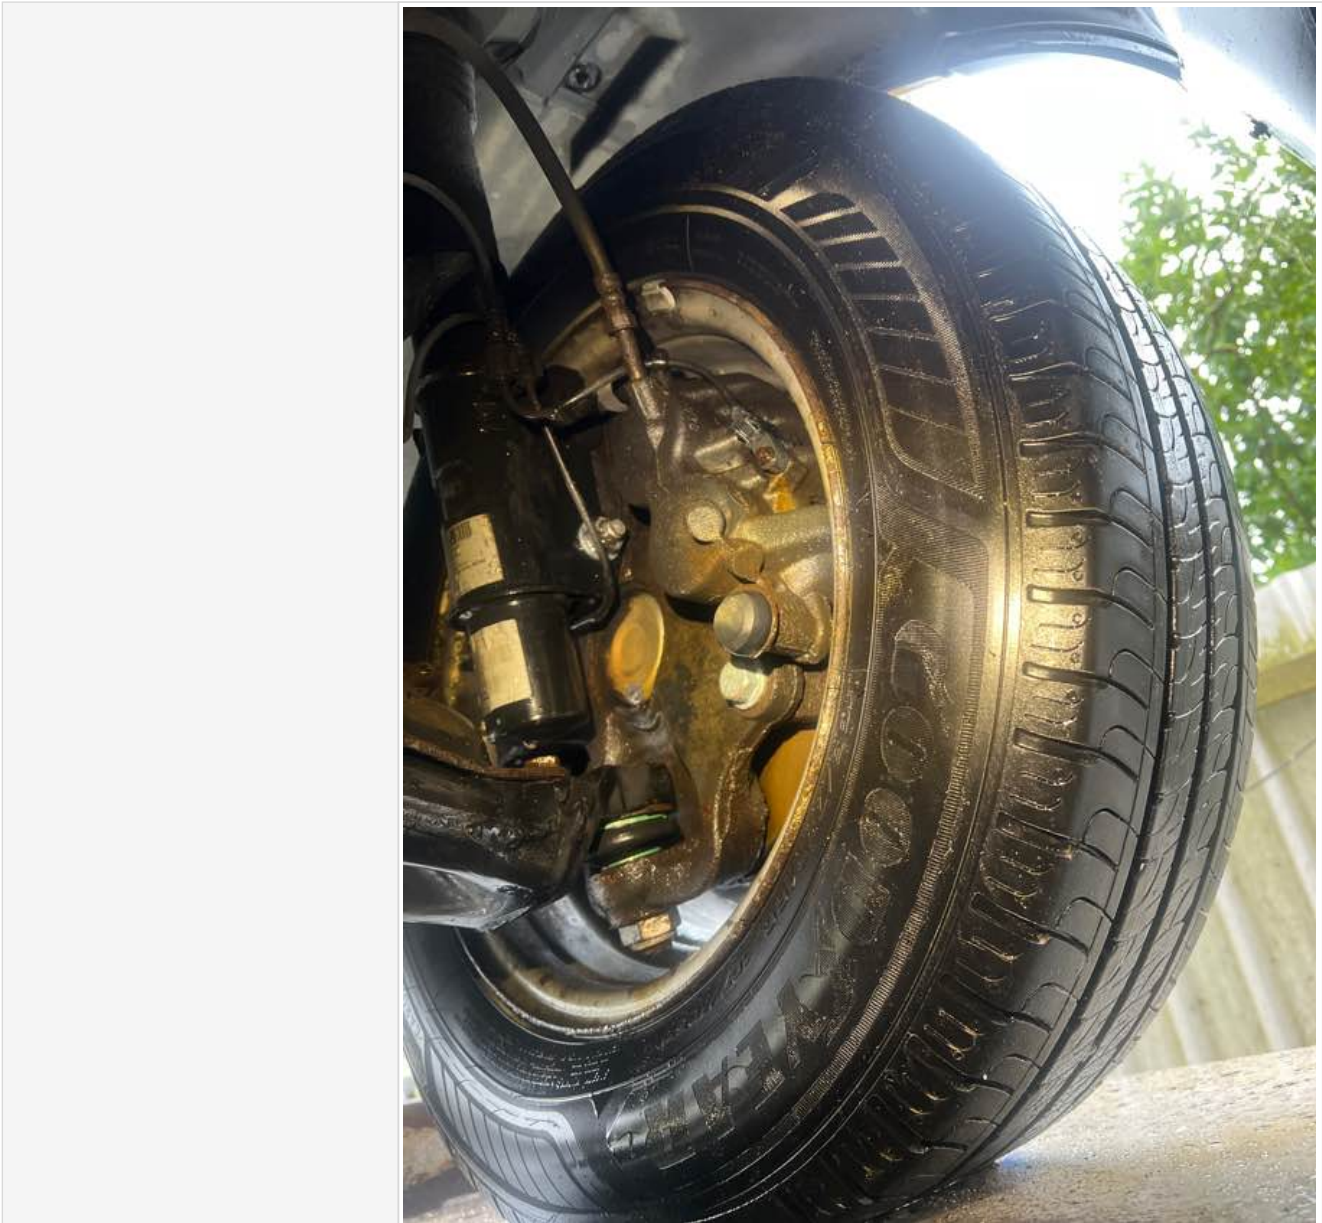
### Off side front

Age (month/year) Manufactured	14/23
Make, brand.	Good Year
Tyre size	195/75/R16
Pressure 1	
Pressure 2	
Wearing / Perishing (inner)	none
Wearing / Perishing (outer)	None
tread depth (mm)	8
General comments	Like new

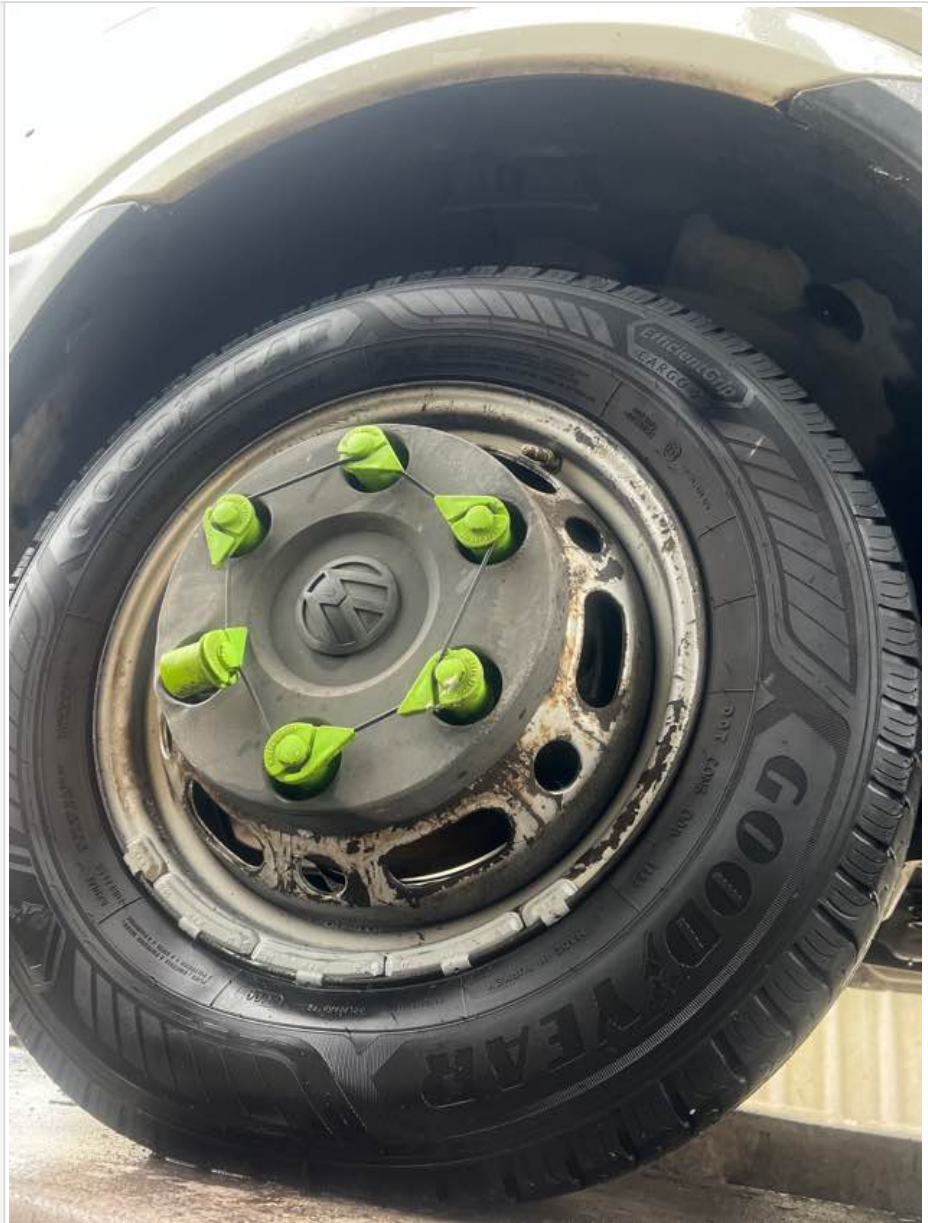
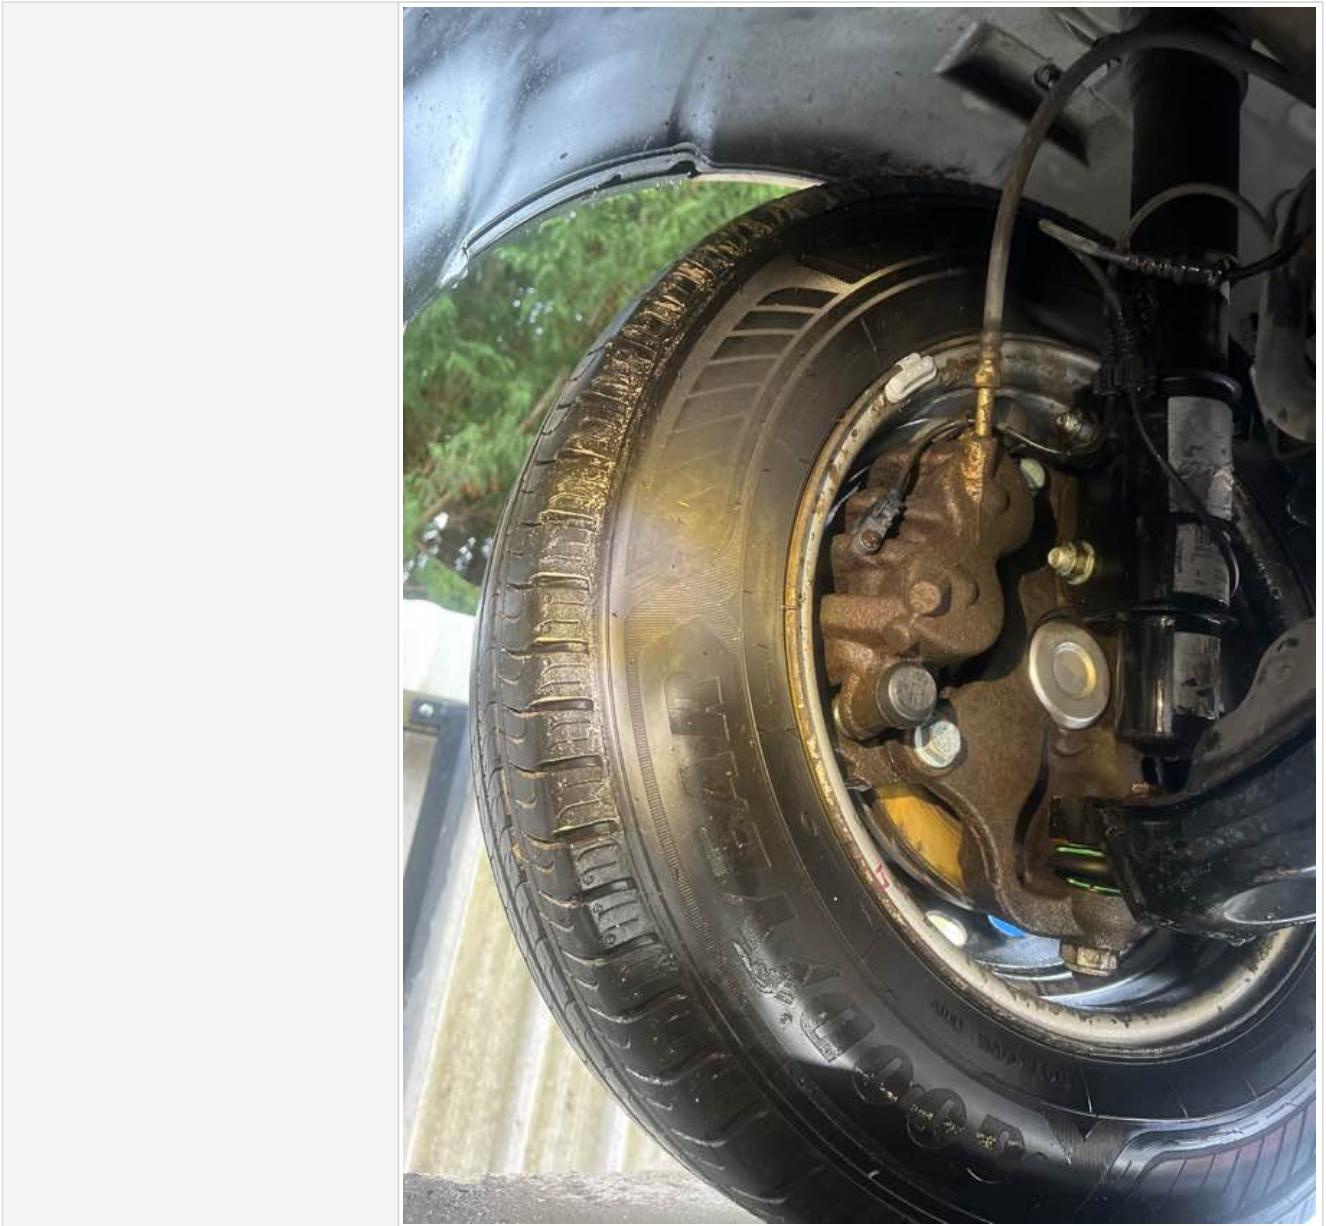
### Near side front

Age (month/year) Manufactured	14/23
Make, brand.	Good Year
Tyre size	195/75/R16
Pressure 1	
Pressure 2	
Wearing / Perishing (inner)	none
Wearing / Perishing (outer)	None
tread depth (mm)	8
General comments

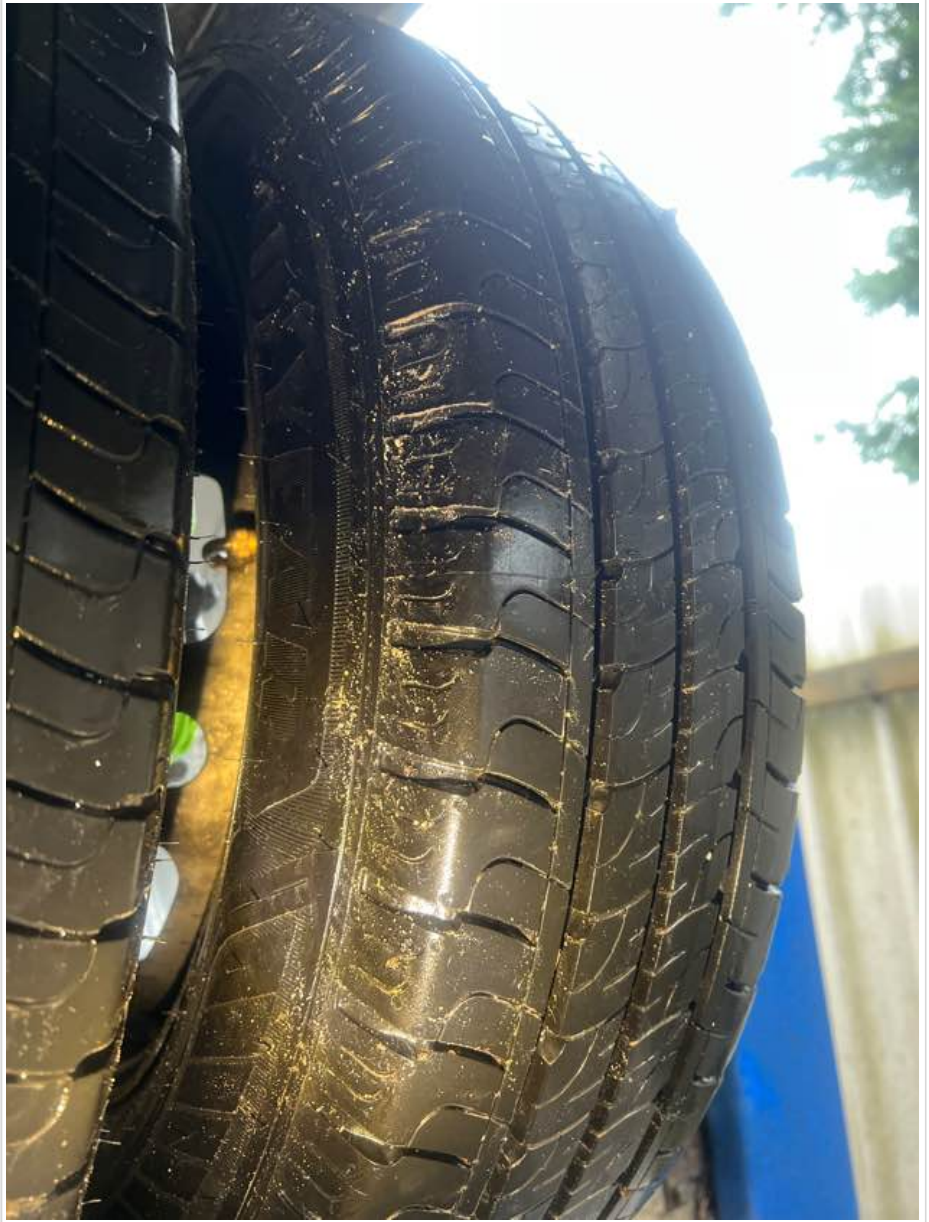
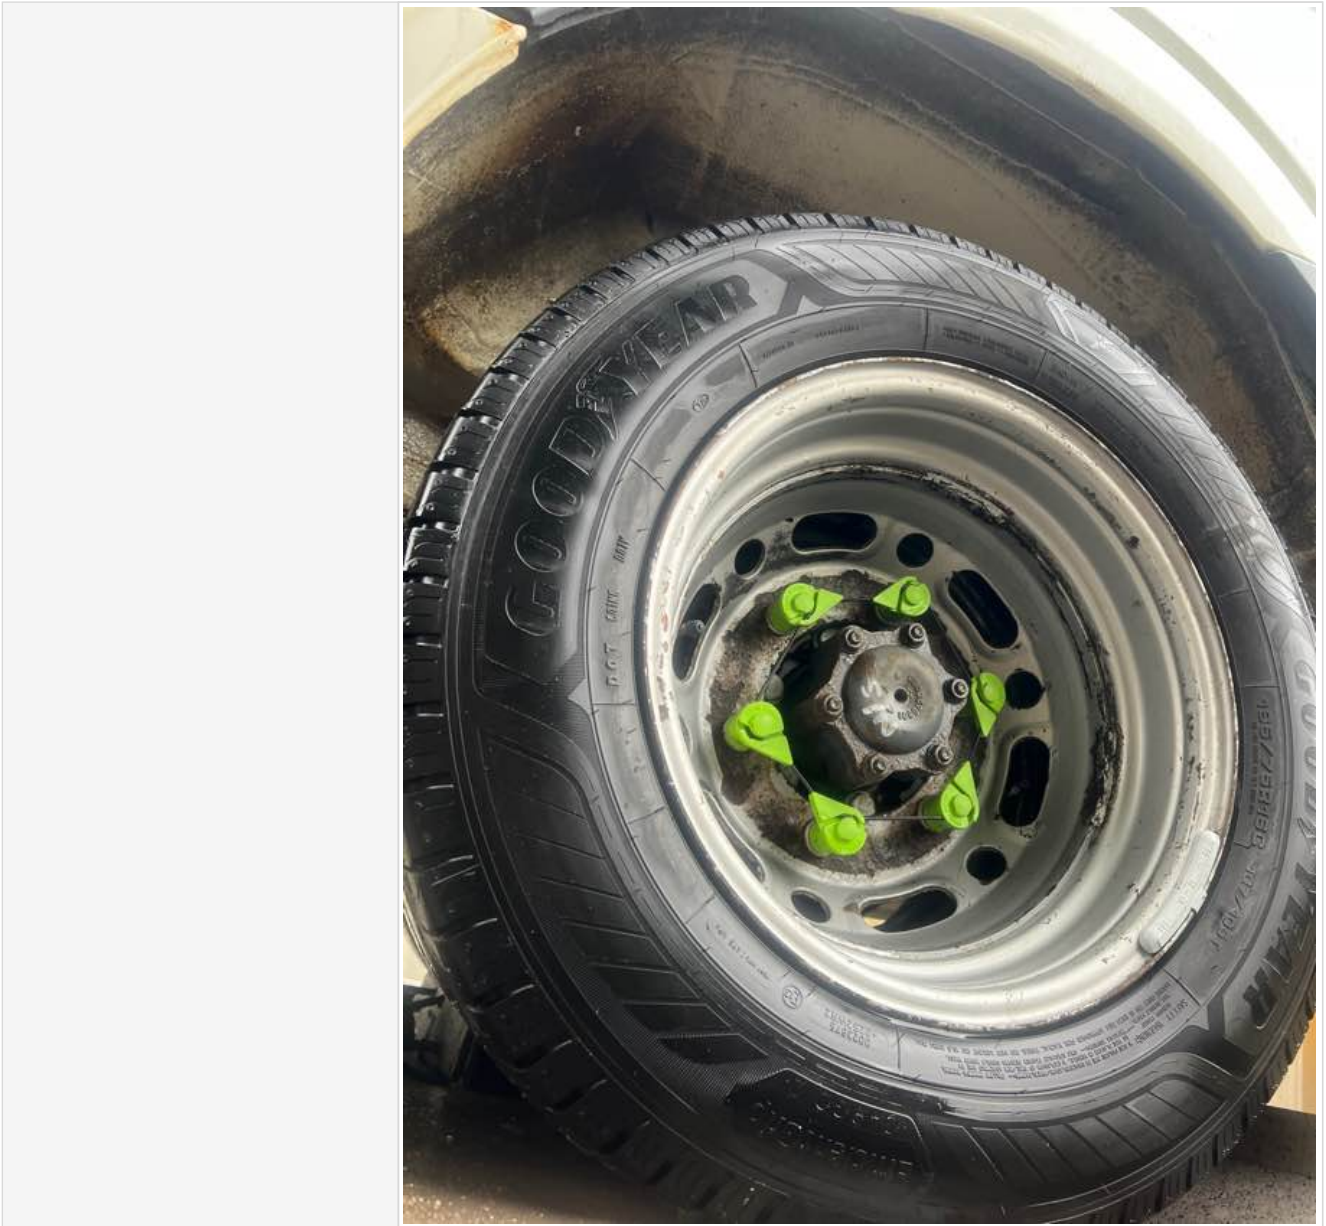
### near side rear

Age (month/year) Manufactured	14/23
Make, brand.	Good Year
Tyre size	195/75/R16
Pressure 1	
Pressure 2	
Wearing / Perishing (inner)	none
Wearing / Perishing (outer)	None
tread depth (mm)	8
General comments

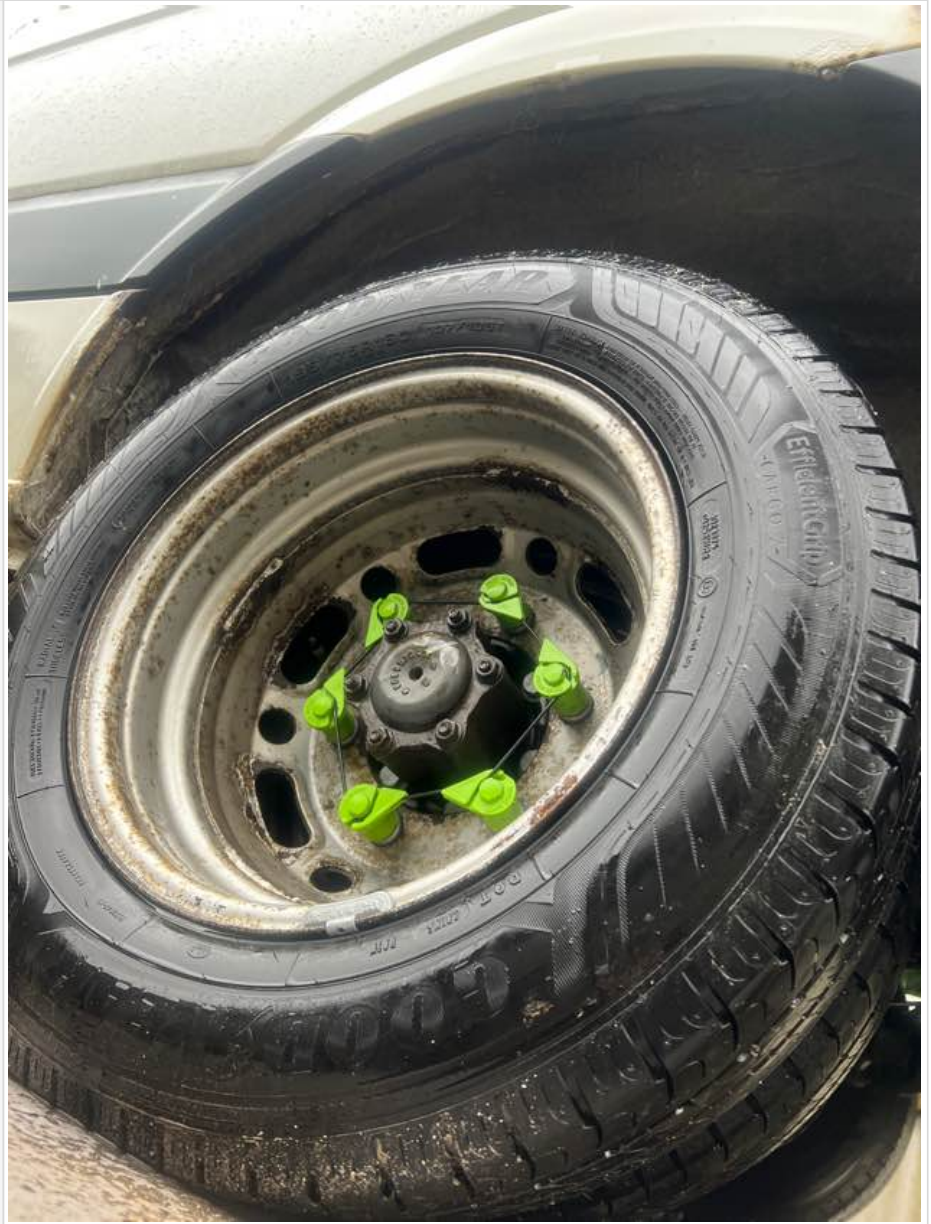
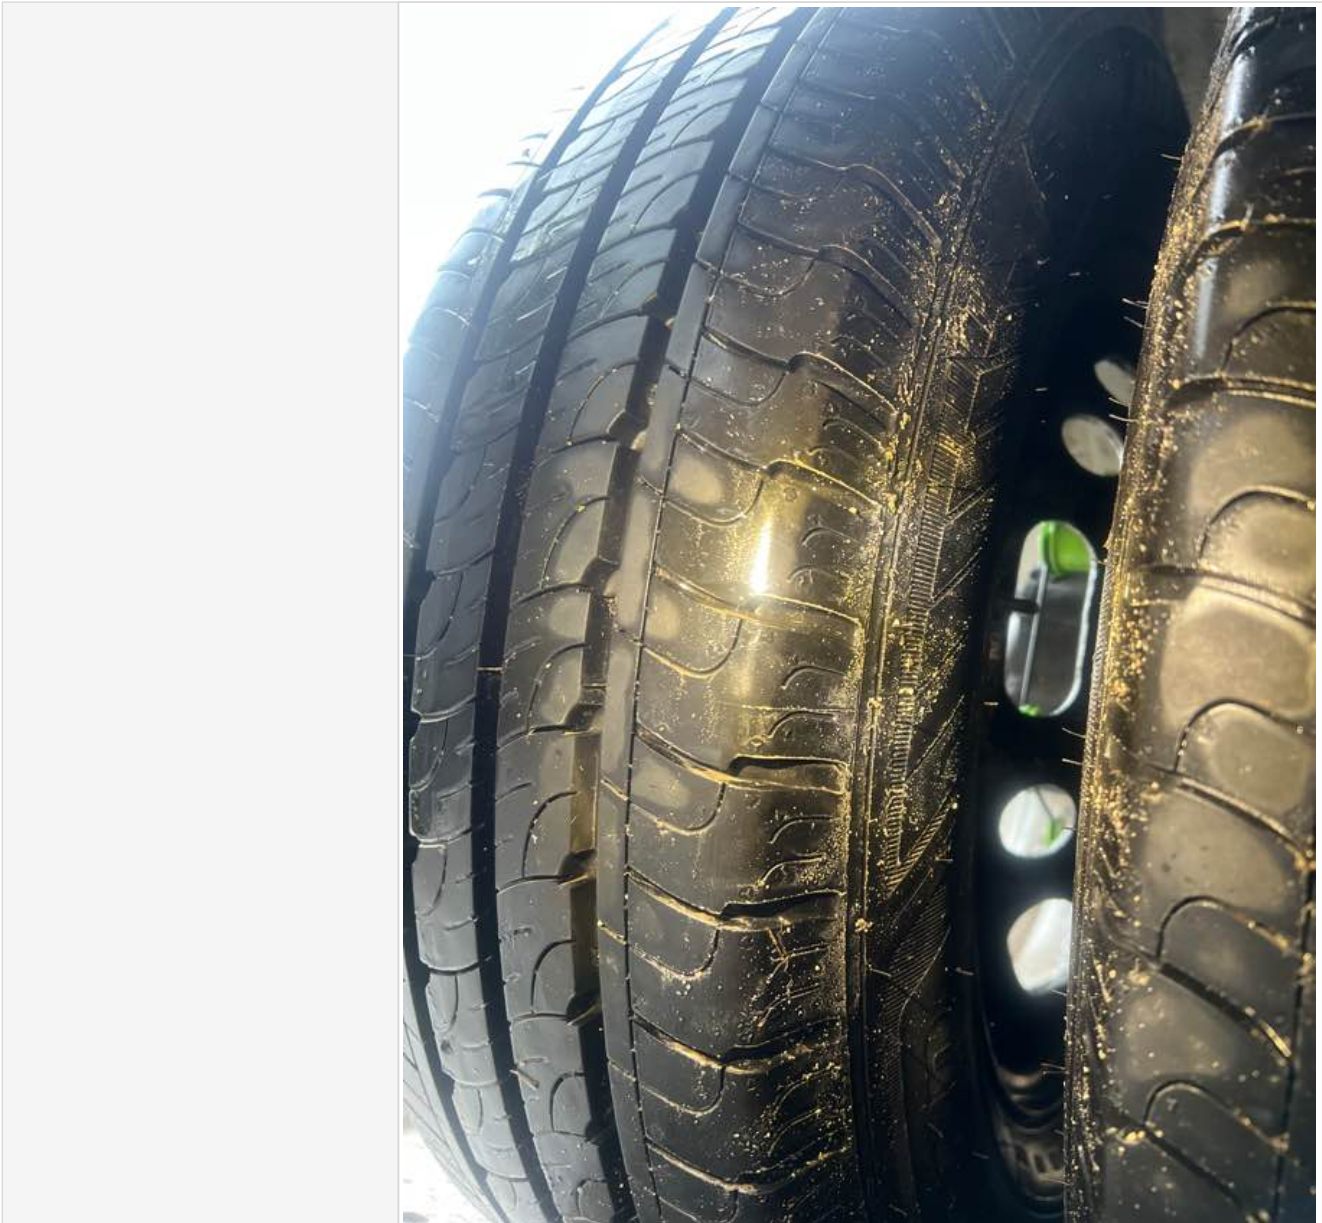
### Off side rear

Age (month/year) Manufactured	
Make, brand.	Good Year
Tyre size	195/75/R16
Pressure 1	
Pressure 2	
Wearing / Perishing (inner)	none
Wearing / Perishing (outer)	None
tread depth (mm)	8
General comments

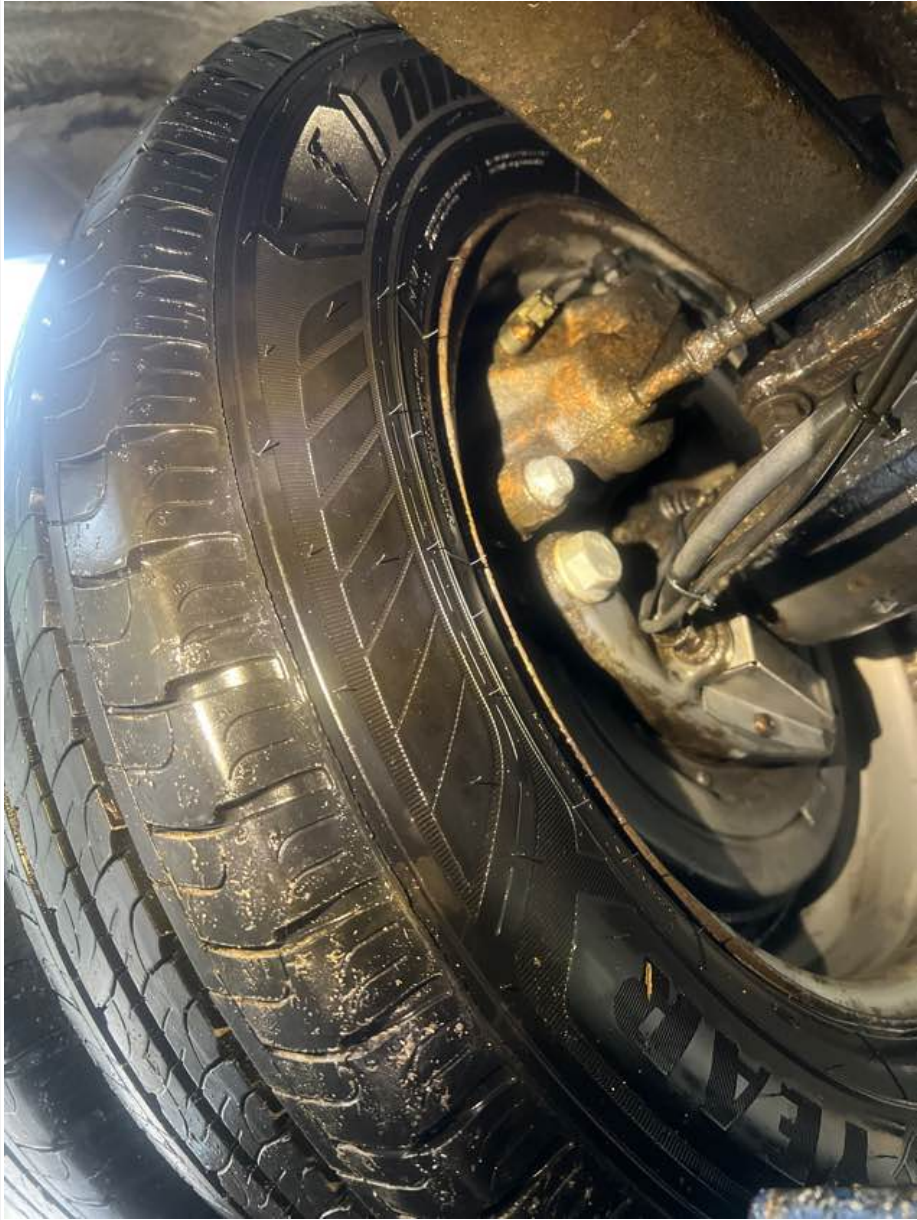
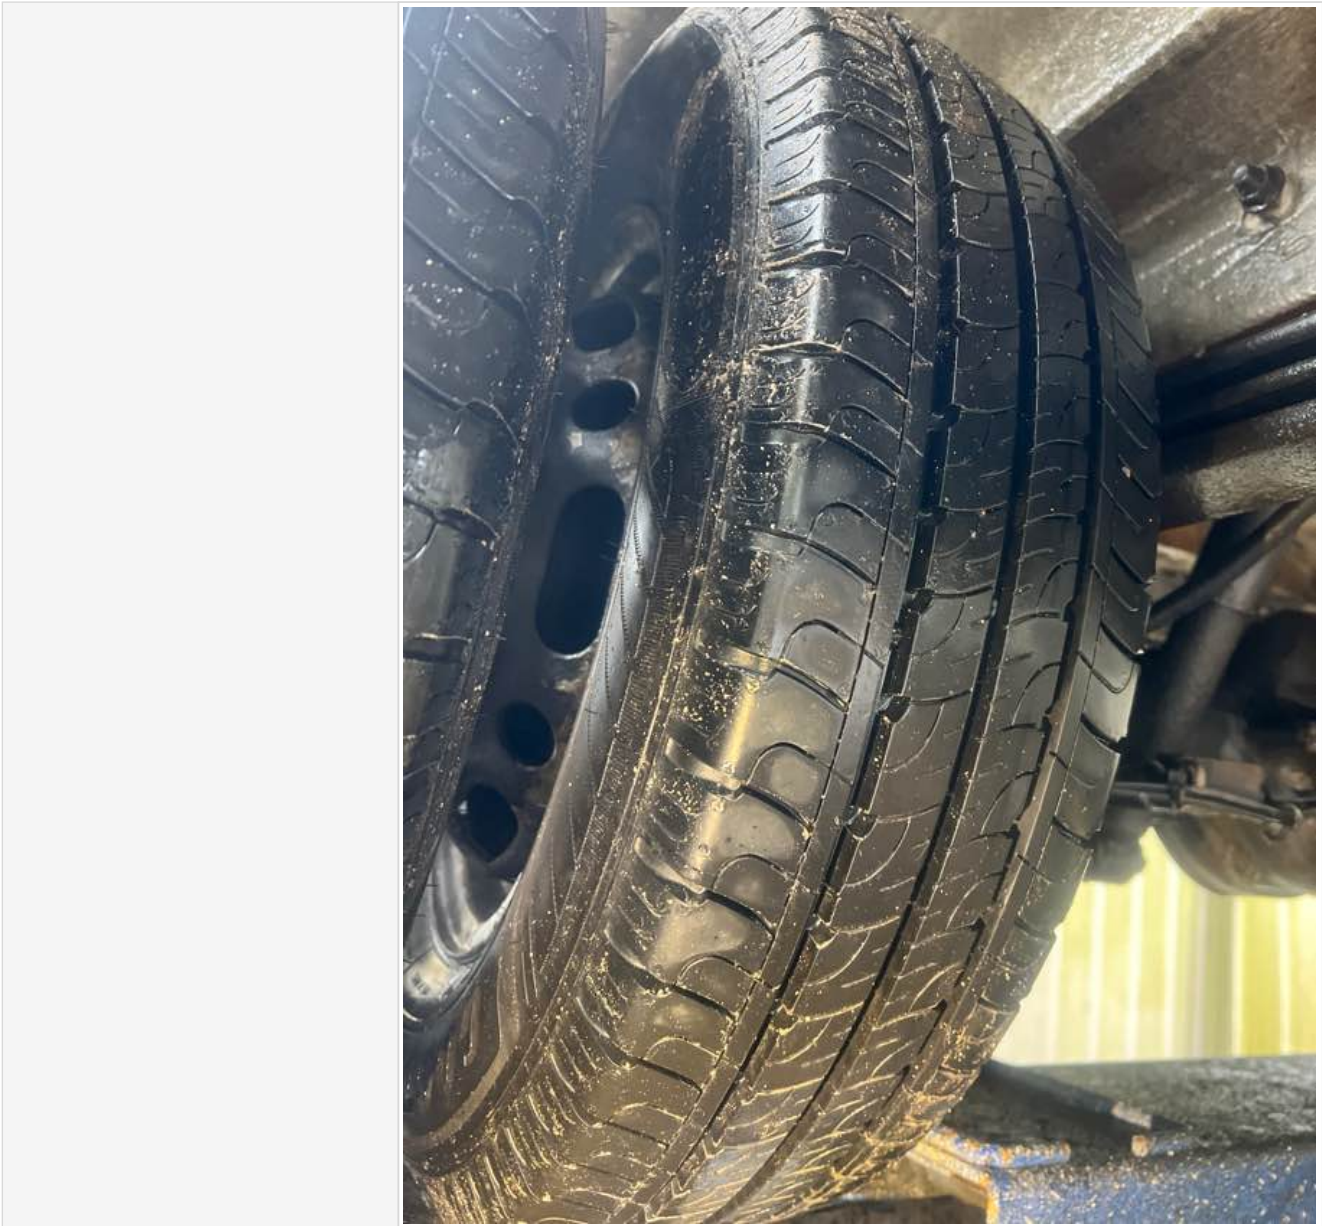
### off side Inner (for twin wheel vans)

Is the vehicle a twin wheel axle? (if no don't fill out)	
Age (month/year) Manufactured	
Make, brand.	Good Year
Tyre size	195/75/R16
Pressure 1	
Pressure 2	
Wearing / Perishing (inner)	none
Wearing / Perishing (outer)	None

tread depth (mm)	8
General comments	
Images of tyre

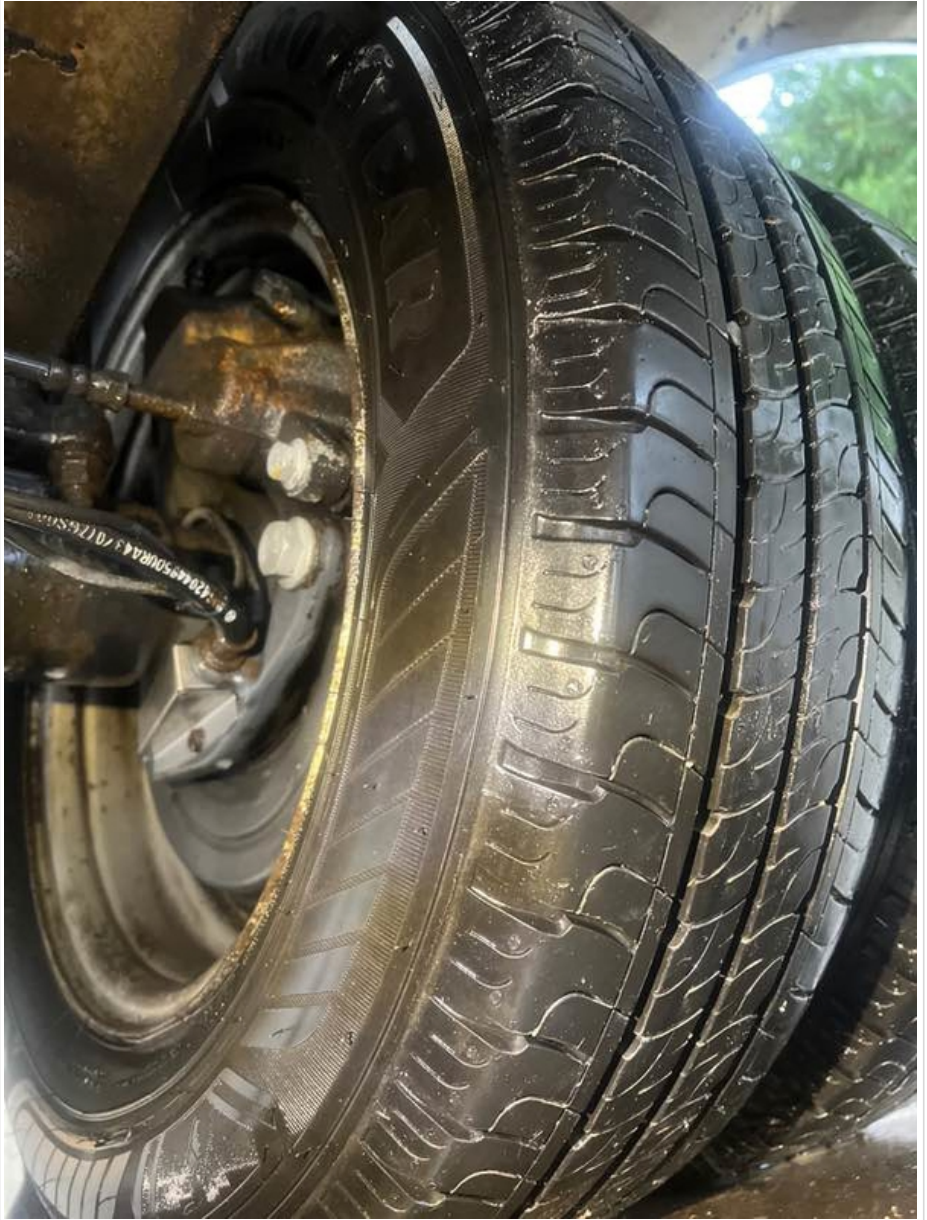
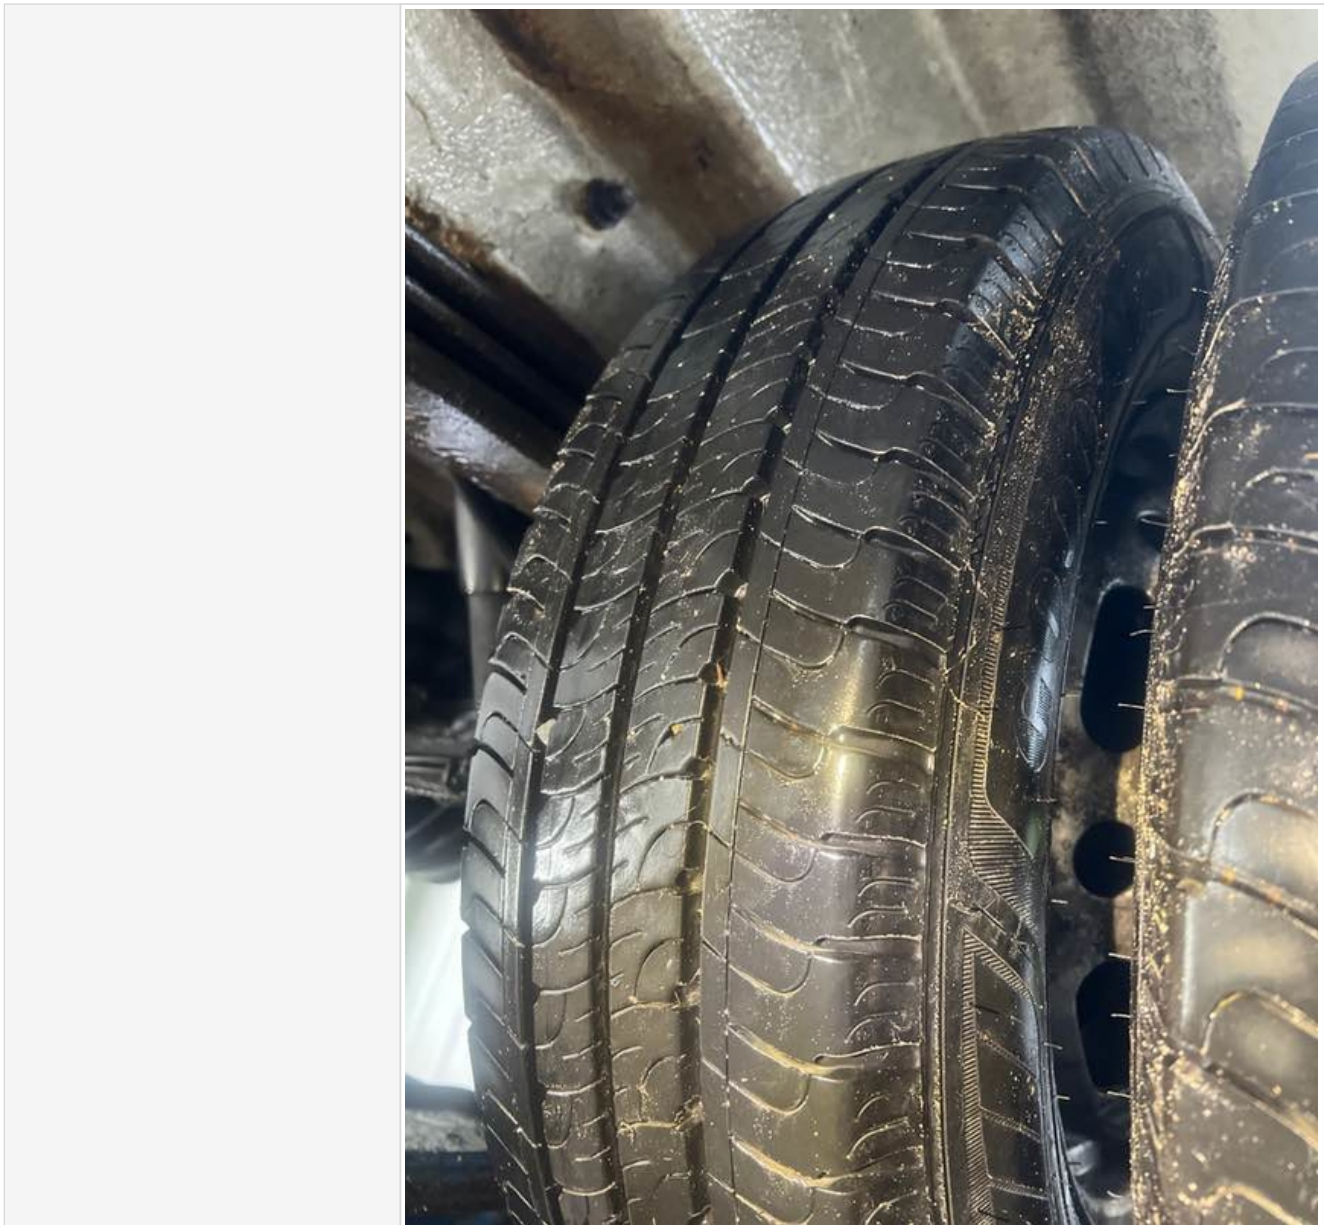
### near side Inner (for twin wheel vans)

Is the vehicle a twin wheel axle? (if no don't fill out)	Yes
Age (month/year) Manufactured	11/24
Make, brand.	Good Year
Tyre size	195/75/R16
Pressure 1	
Pressure 2	
Wearing / Perishing (inner)	none
Wearing / Perishing (outer)	None

tread depth (mm)	8
General comments	
Images of tyre

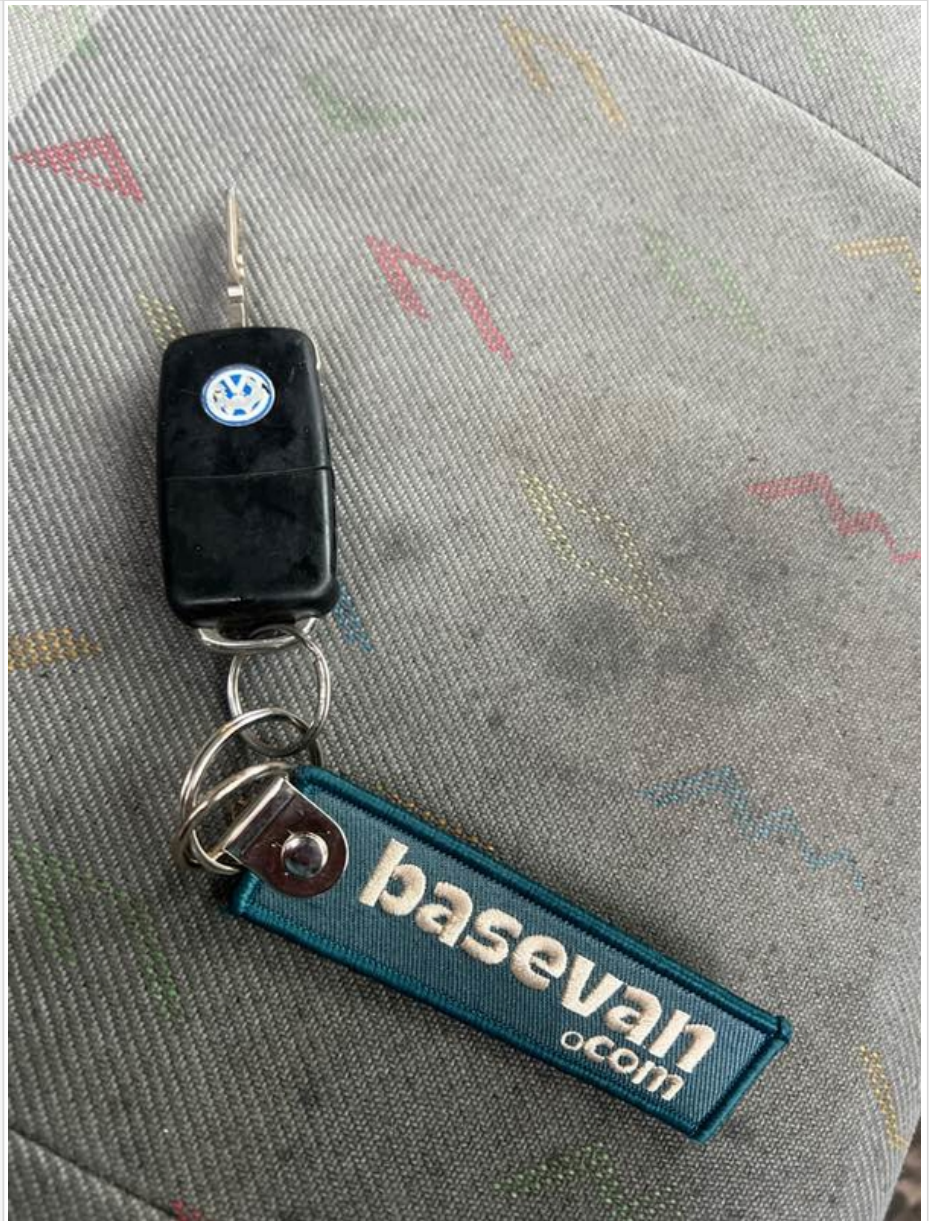
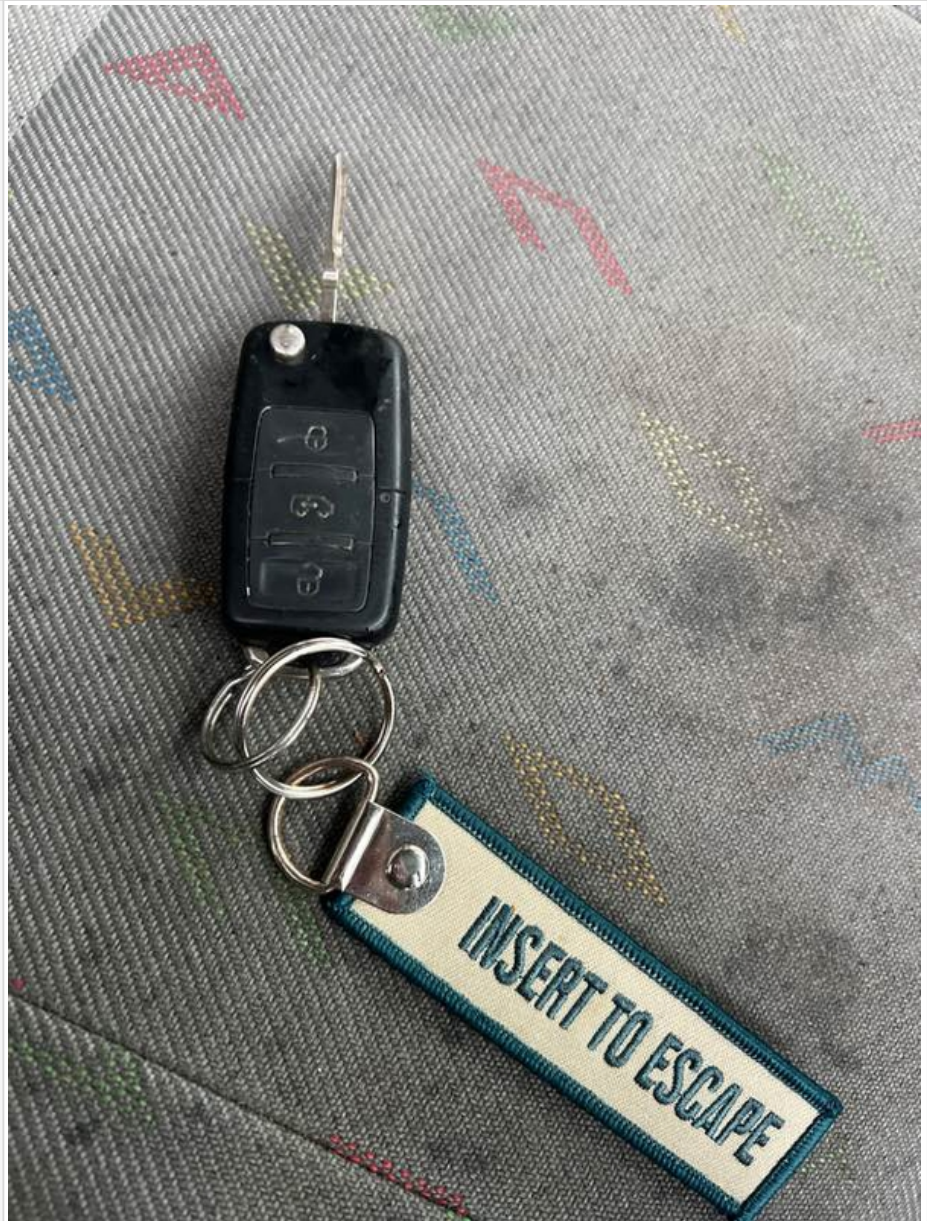
How many keys present at time of inspection?

Comment	1 key good condition
---------	----------------------

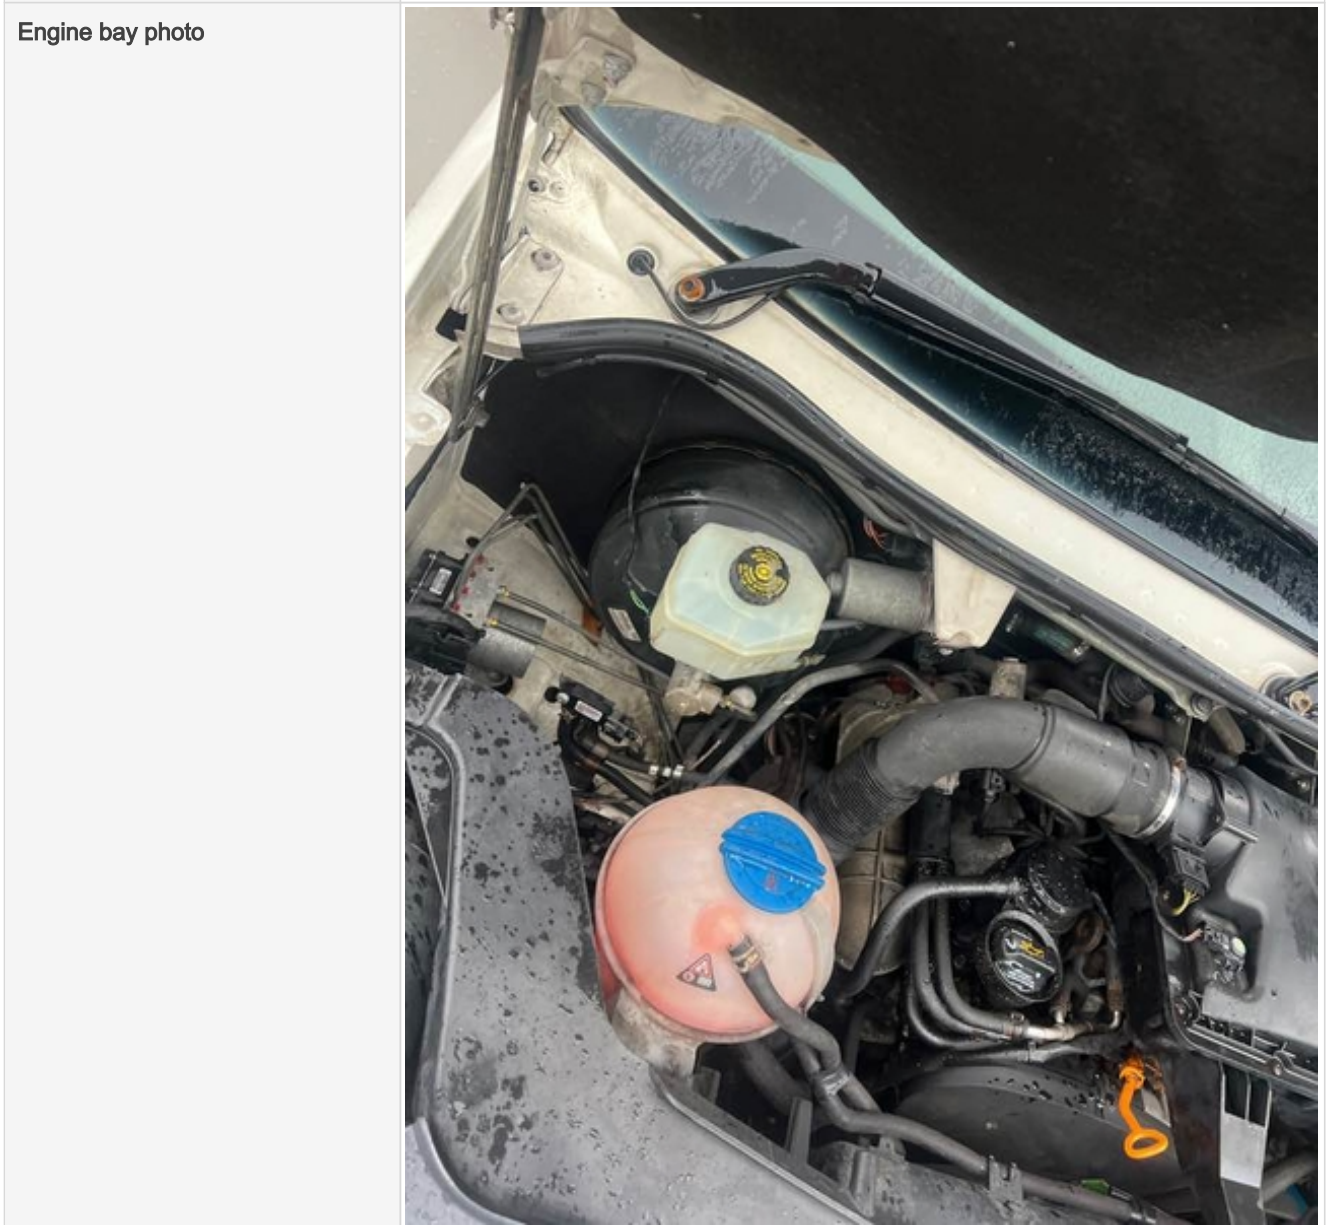
Coolant condition	Clean
Coolant level	Full
Anti-freeze temperature check	-23
Washer fluid	Full
Brake fluid	Full
Power steering fluid	Miniumum
Dashboard warning light	No warning lights
OBD Scan results
