BaseVan Initial Inspection

Vehicle registration	WX05XXB
Vehicle chassis no.	WDB9046122R741637
Miles (if in km, multiply by 0.62)	122,140
Make	Mercedes
Model	Sprinter
Transmission	Manual, 5 speed
Factory immobiliser installed	Yes
Speed limiter installed	Yes
Drive configuration	
Gross vehicle weight	4600kg
Towing capacity	2000
Tow bar installed	No

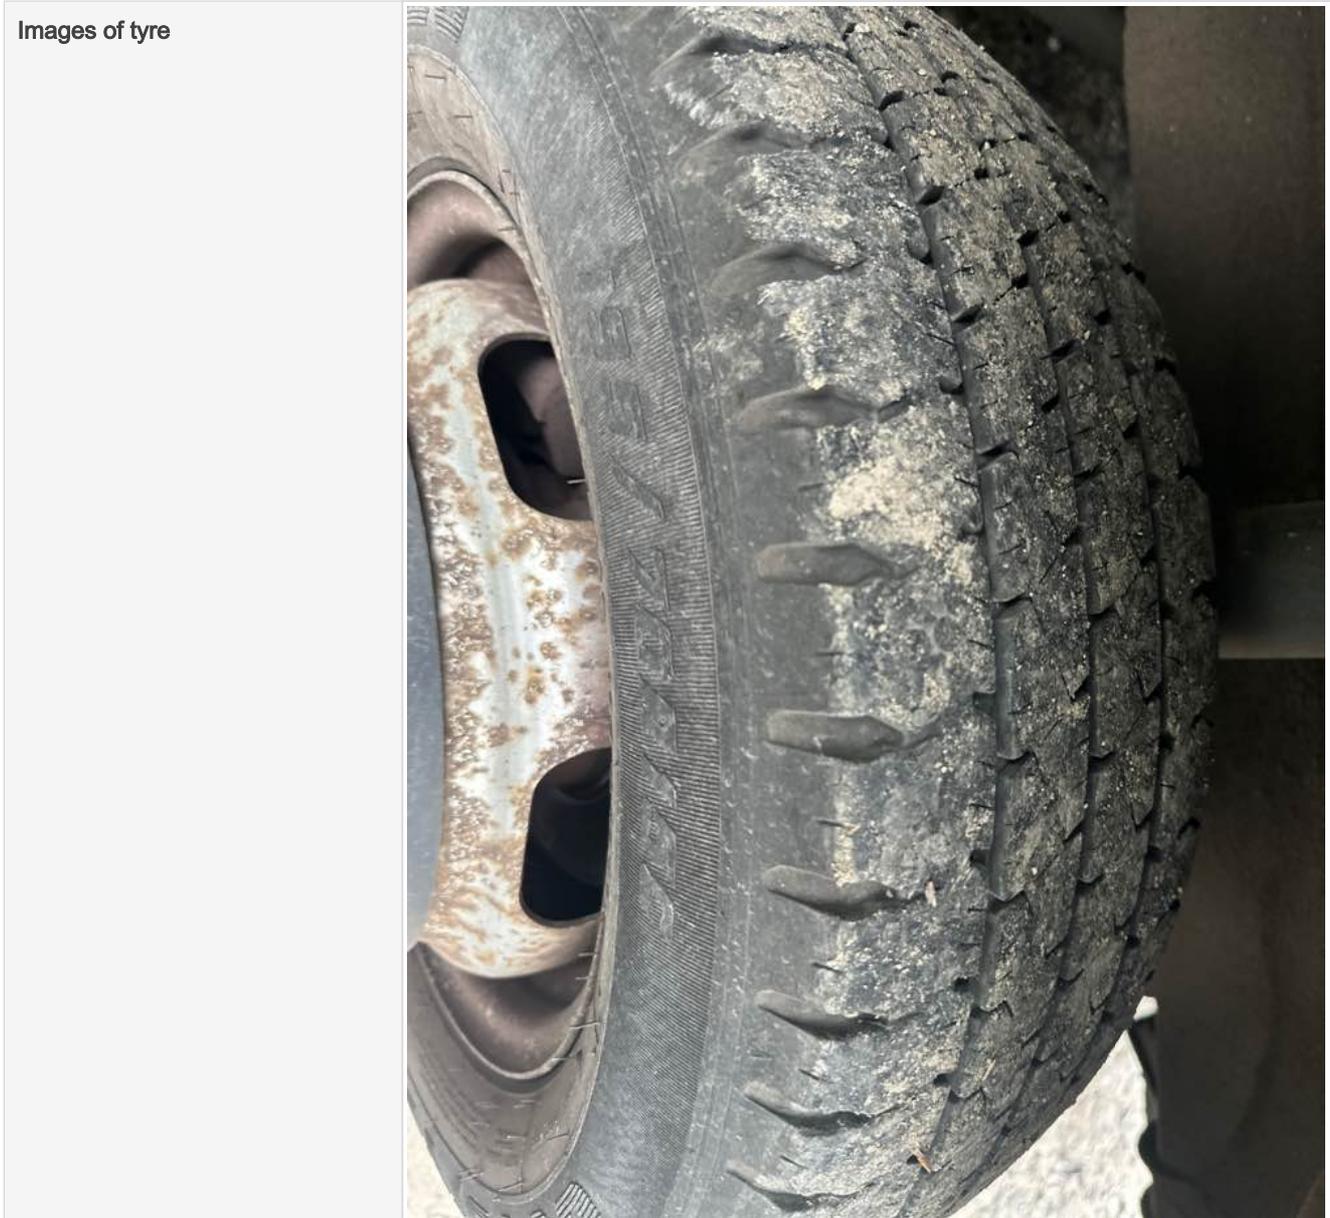
Off side front

Age (month/year) Manufactured	15/14
Make, brand.	Good Year
Tyre size	Not here (see comment)
Pressure 1	
Pressure 2	
Wearing / Perishing (inner)	Slight
Wearing / Perishing (outer)	Slight
tread depth (mm)	6
General comments	195/70R15c

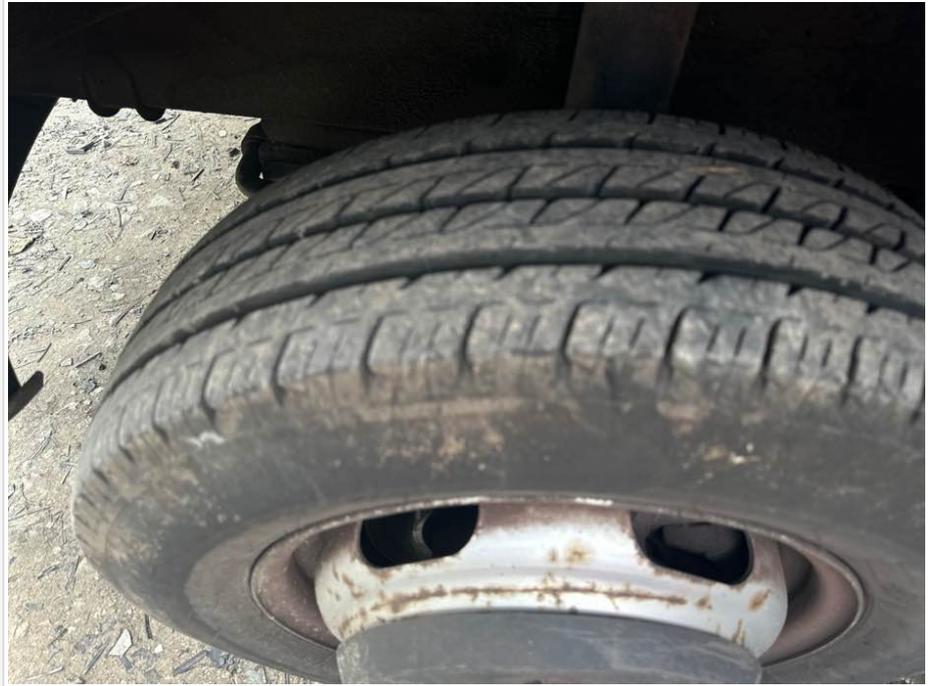
Near side front

Age (month/year) Manufactured	34/20
Make, brand.	Budget
Tyre size	Not here (see comment)
Pressure 1	
Pressure 2	
Wearing / Perishing (inner)	none
Wearing / Perishing (outer)	None
tread depth (mm)	9
General comments	185/65R15

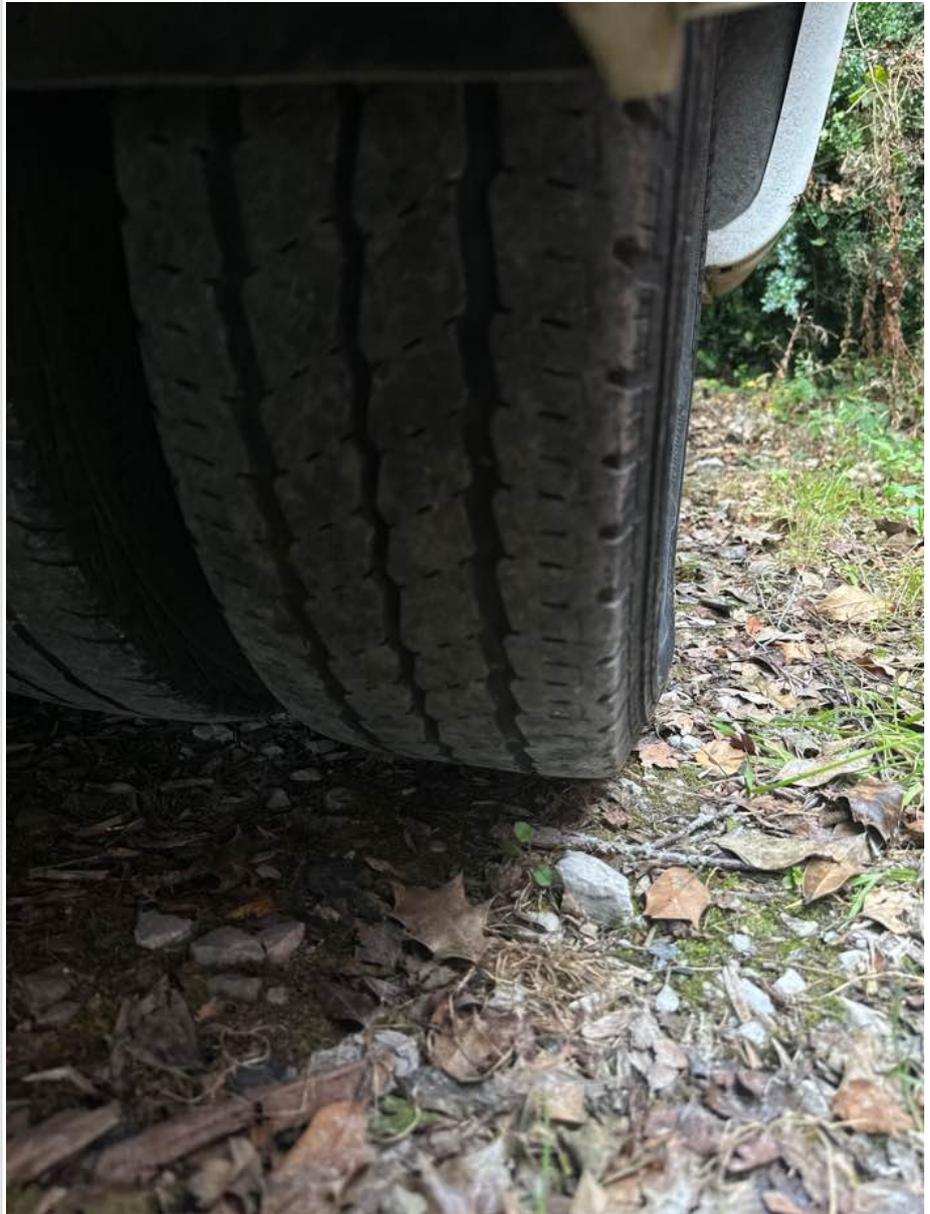
near side rear

Age (month/year) Manufactured	22/15
Make, brand.	Continental
Tyre size	Not here (see comment)
Pressure 1	
Pressure 2	
Wearing / Perishing (inner)	Slight
Wearing / Perishing (outer)	Slight
tread depth (mm)	6
General comments	185/65R15

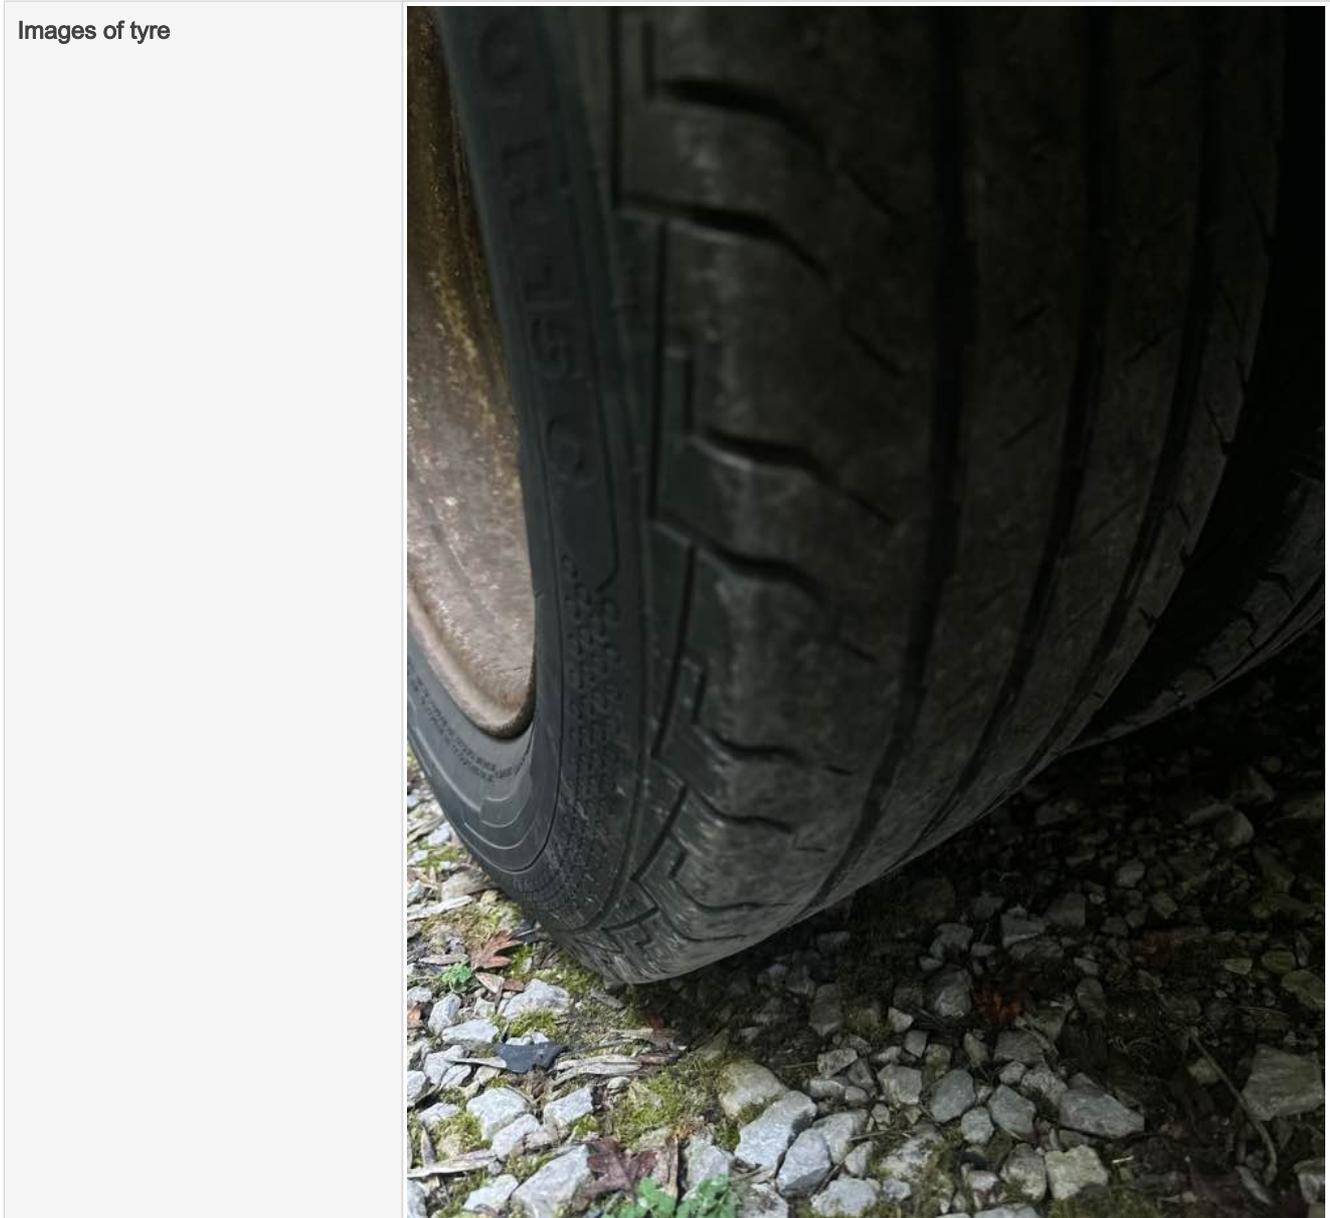
Off side rear

Age (month/year) Manufactured	22/15
Make, brand.	Continental
Tyre size	Not here (see comment)
Pressure 1	
Pressure 2	
Wearing / Perishing (inner)	Slight
Wearing / Perishing (outer)	Slight
tread depth (mm)	6
General comments	185/65R15

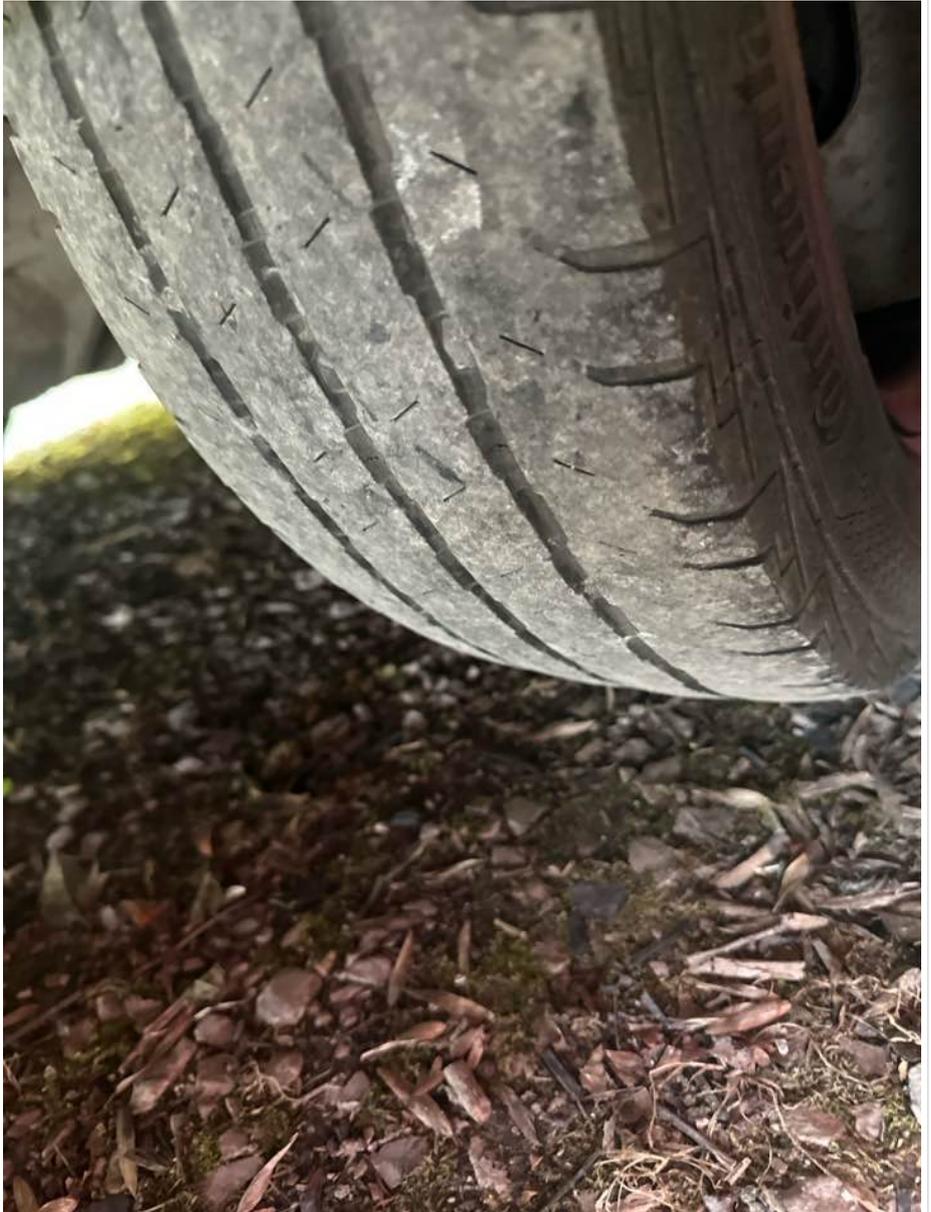
near side Inner (for twin wheel vans)

Is the vehicle a twin wheel axle? (if no don't fill out)	Yes
Age (month/year) Manufactured	13/19
Make, brand.	Continental
Tyre size	Not here (see comment)
Pressure 1	
Pressure 2

Wearing / Perishing (inner)	Medium
Wearing / Perishing (outer)	Medium
tread depth (mm)	5
General comments	185/65R15
Images of tyre

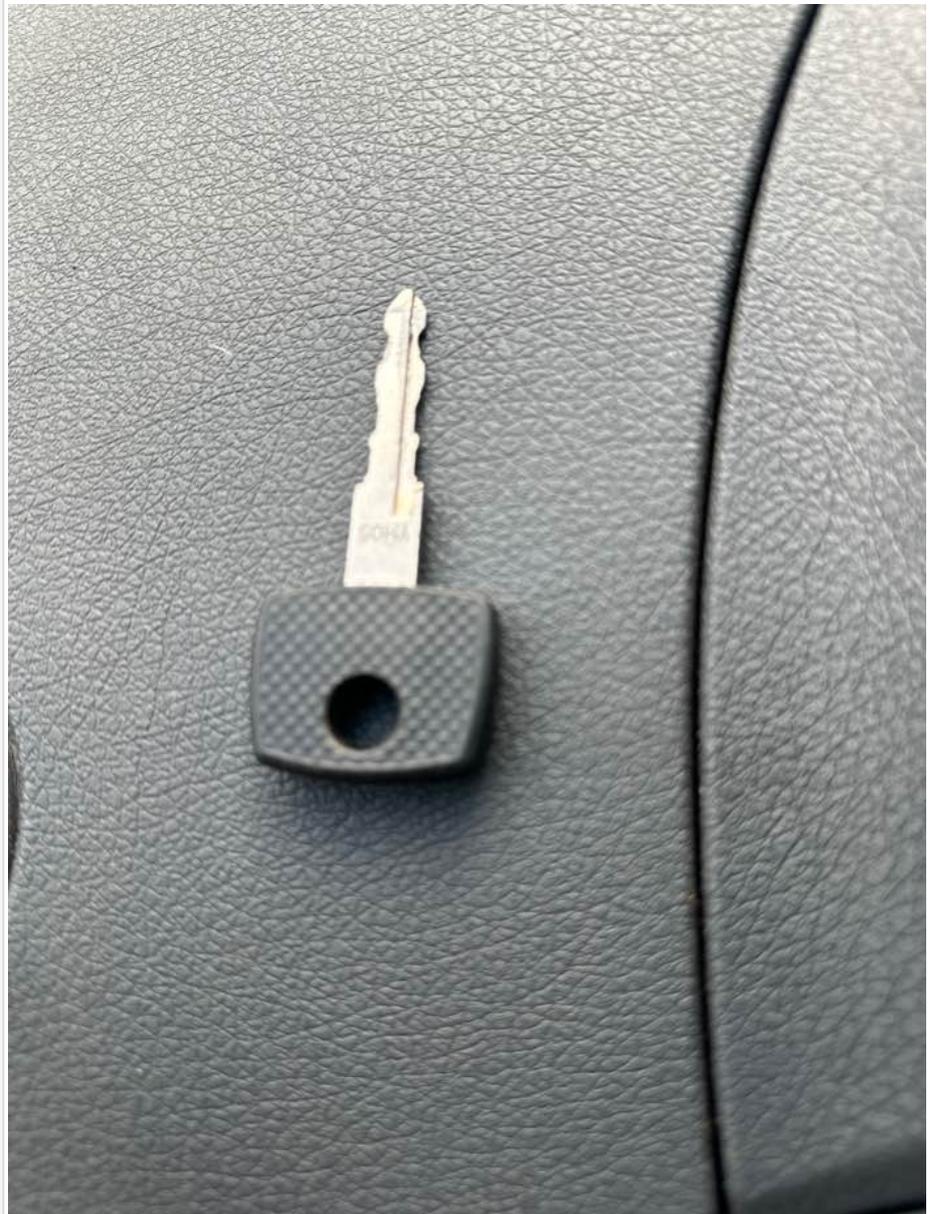
Factory central locking fitted?	No
Response from key fob?	N/A
Response from in-cab locking button?	N/A
Do all the doors lock from central locking function?	None
Select the following doors that lock.	N/S Front
Method of locking	Key
In conclusion can all the doors be locked in some way and thus the vehicle can be left unattended at night safely?	No

Comment Only has n/s front and rear doors
