Basevan.com General Inspection

Vehicle registration	LK08CPY
Vehicle chassis no.	WDB6683222N126652
Miles (if in km, multiply by 0.62)	122,238mi (197159km)
Make	Mercedes-Benz
Model	Vario
Transmission	Automatic
Factory immobiliser installed	Yes
Speed limiter installed	Yes
Drive configuration	RWD
Gross Vehicle Weight (kg)	5990
Towing capacity	3000kg
Tow bar installed	No

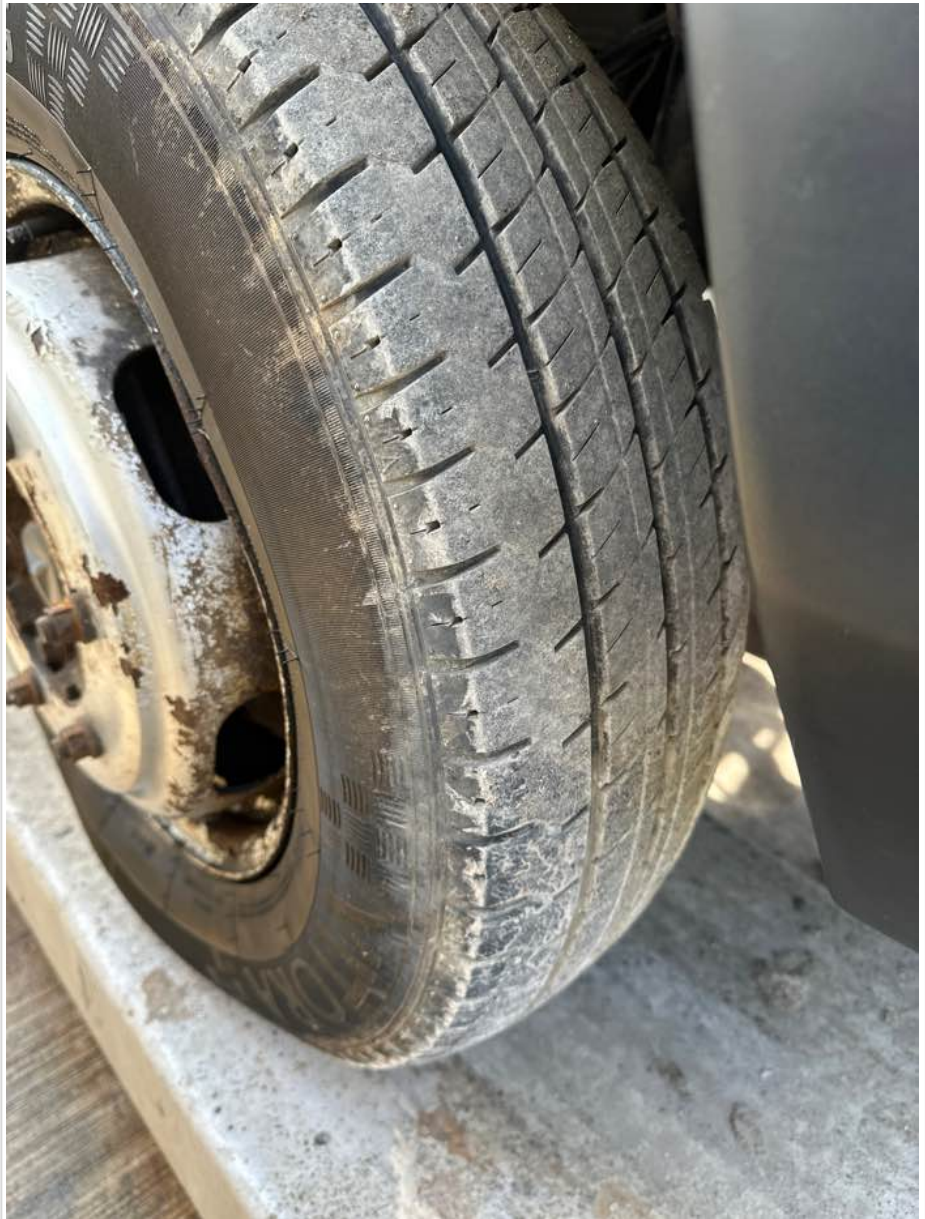
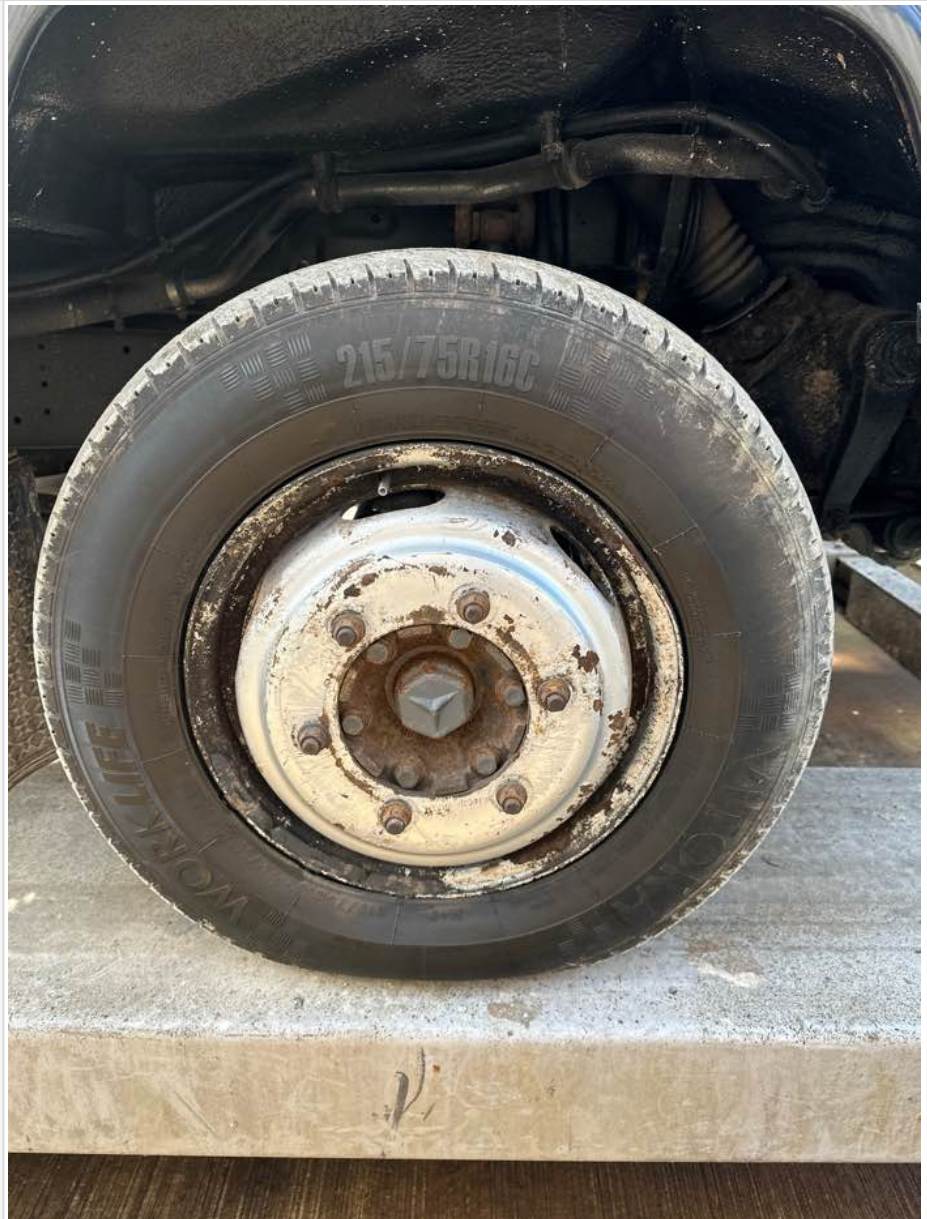
Off side front

Age (month/year) Manufactured	19/20
Make, brand.	Budget
Tyre size	215/75/R16
Pressure 1	
Pressure 2	
Wearing / Perishing (inner)	none
Wearing / Perishing (outer)	None
tread depth (mm)	8
General comments	Nice tyre

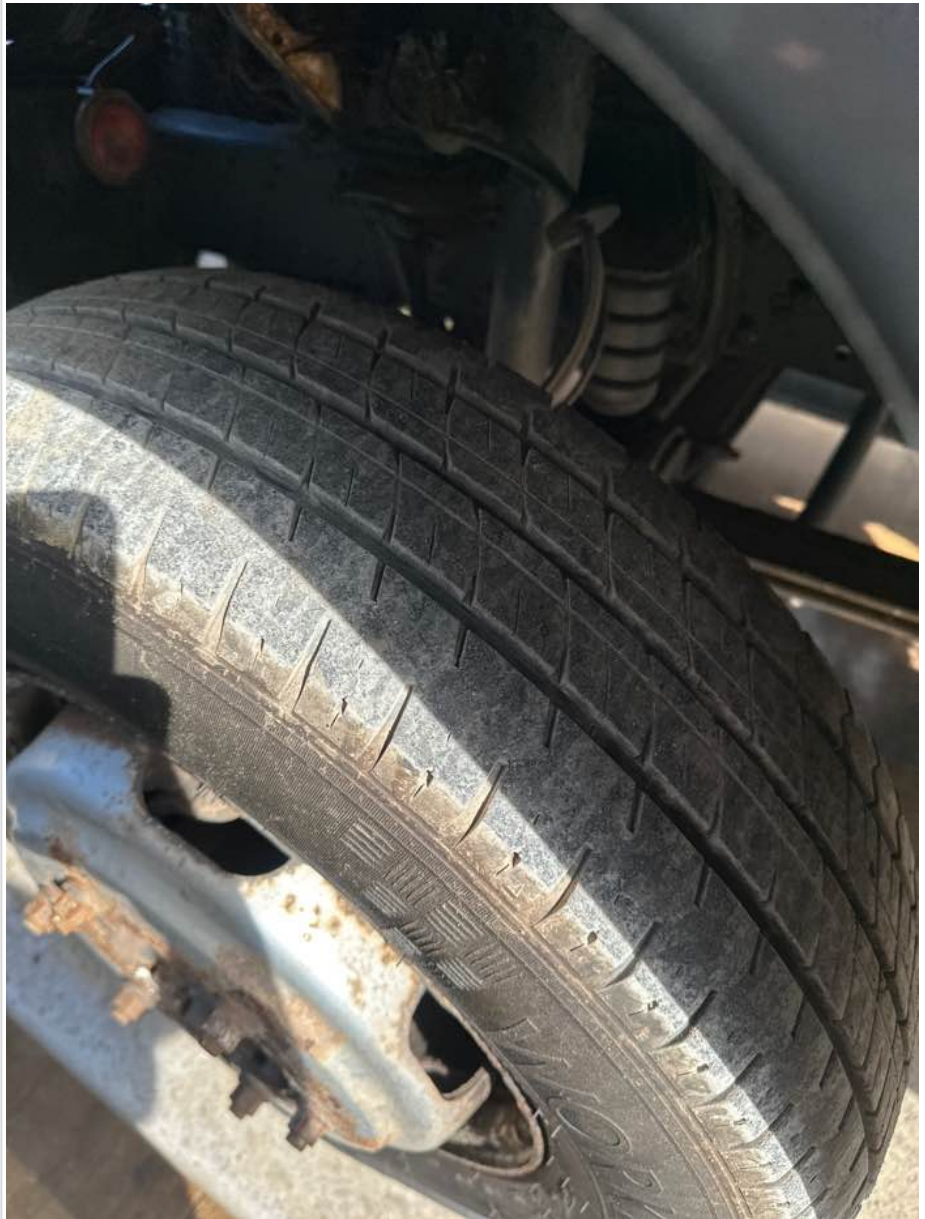
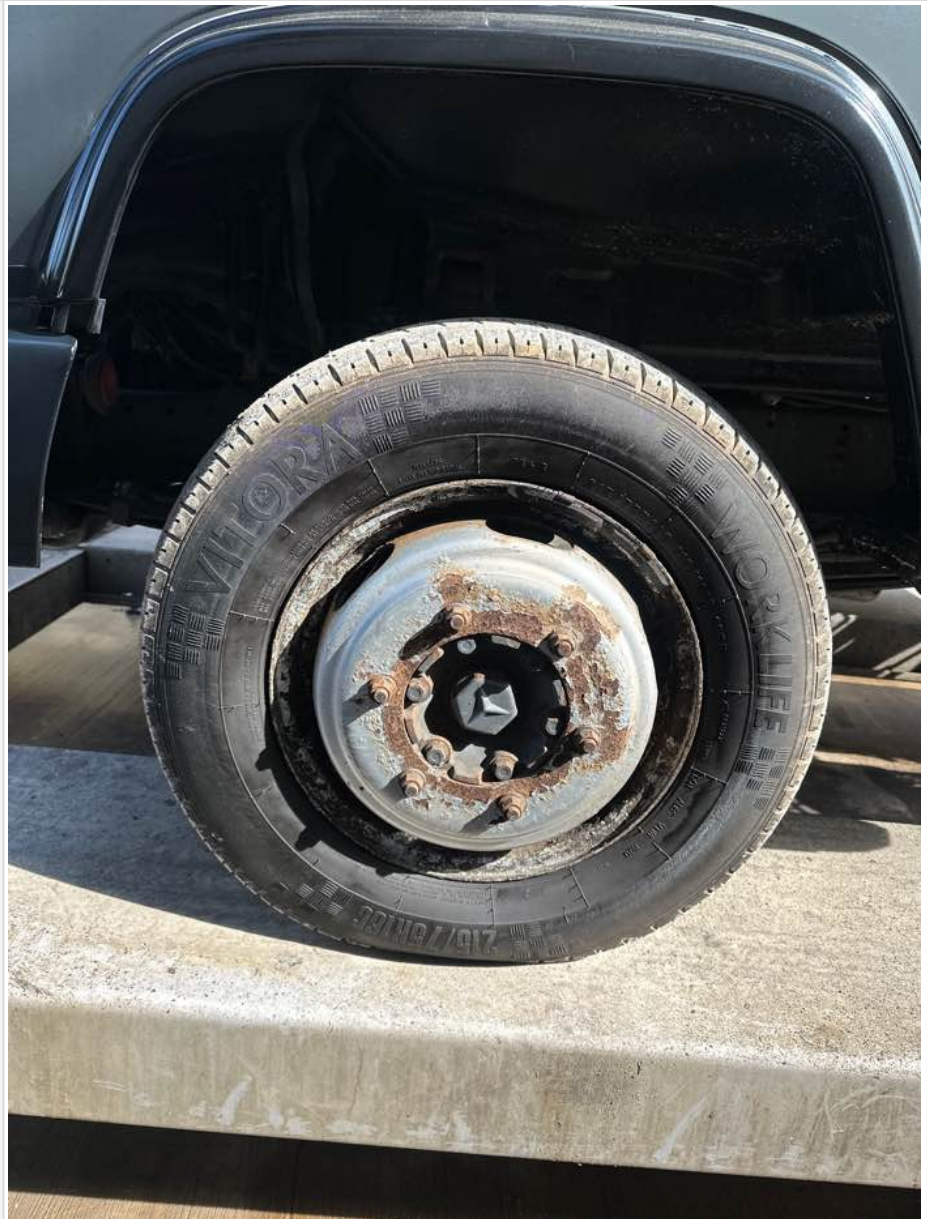
Near side front

Age (month/year) Manufactured	19/20
Make, brand.	Budget
Tyre size	215/75/R16
Pressure 1	
Pressure 2	
Wearing / Perishing (inner)	none
Wearing / Perishing (outer)	None
tread depth (mm)	8
General comments	nice tyre

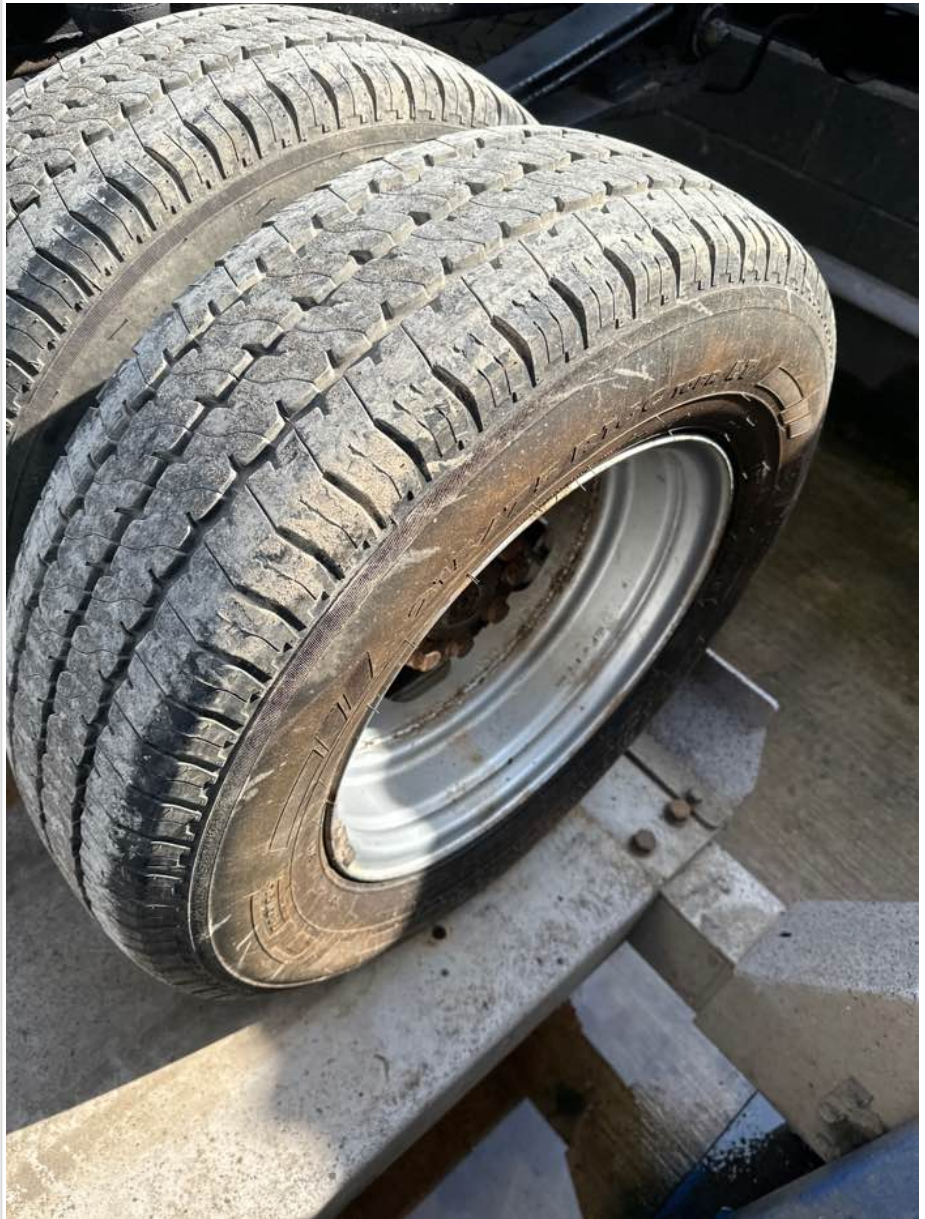
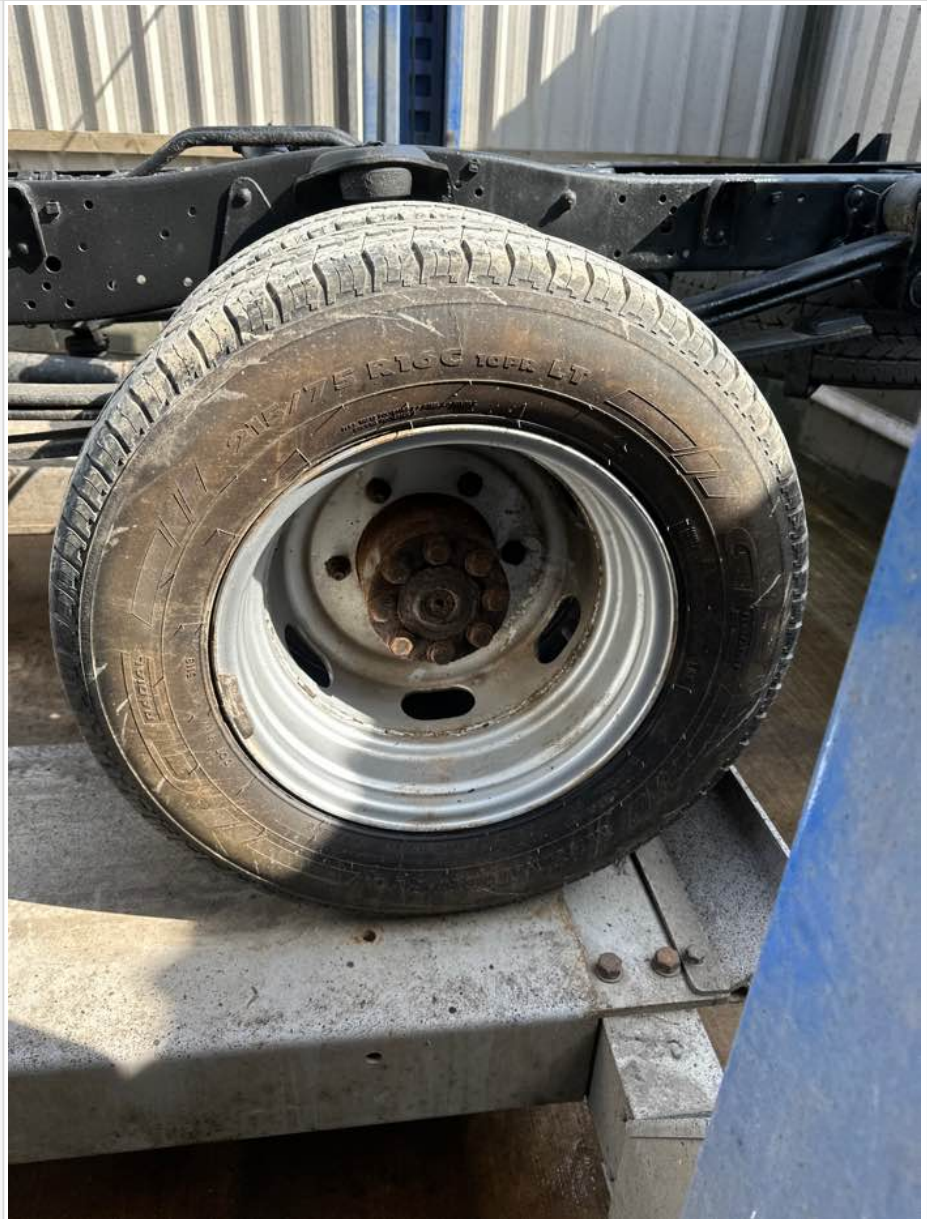
near side rear

Age (month/year) Manufactured	51/19
Make, brand.	GT Radial
Tyre size	215/75/R16
Pressure 1	
Pressure 2	
Wearing / Perishing (inner)	none
Wearing / Perishing (outer)	None
tread depth (mm)	8
General comments	very good tyre

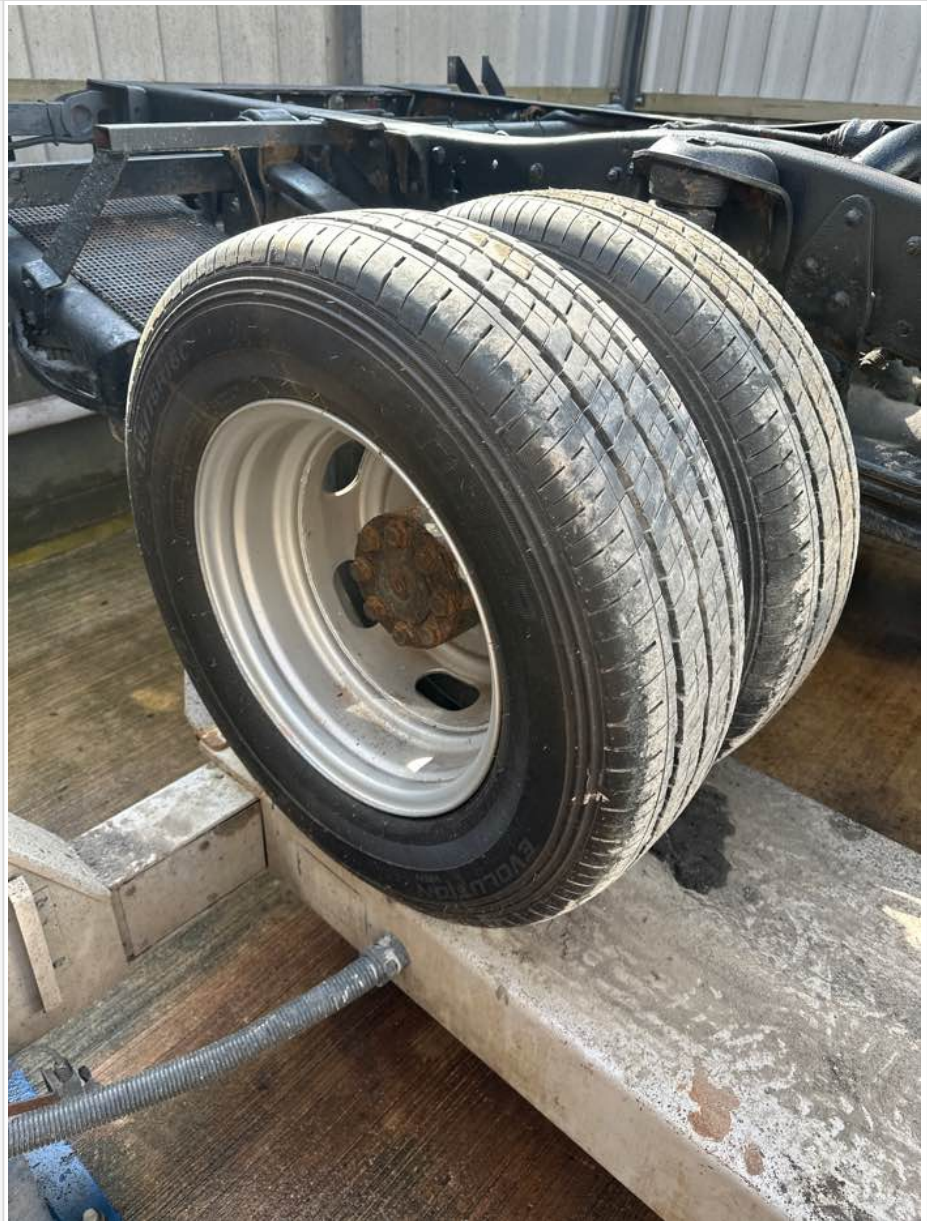
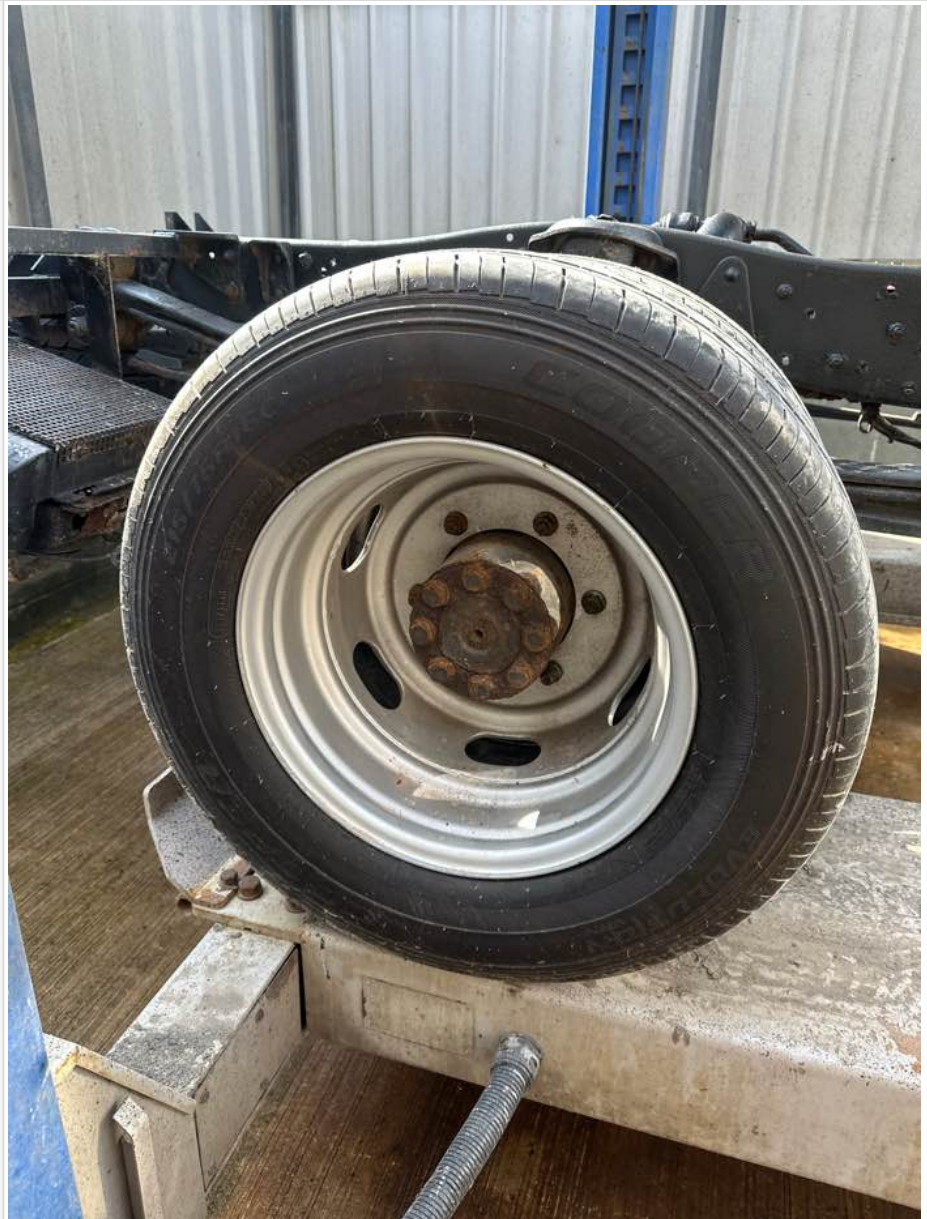
Off side rear

Age (month/year) Manufactured	11/21
Make, brand.	Cooper
Tyre size	215/75/R16
Pressure 1	
Pressure 2	
Wearing / Perishing (inner)	Slight
Wearing / Perishing (outer)	None
tread depth (mm)	9
General comments	slight perishing inner, good tread

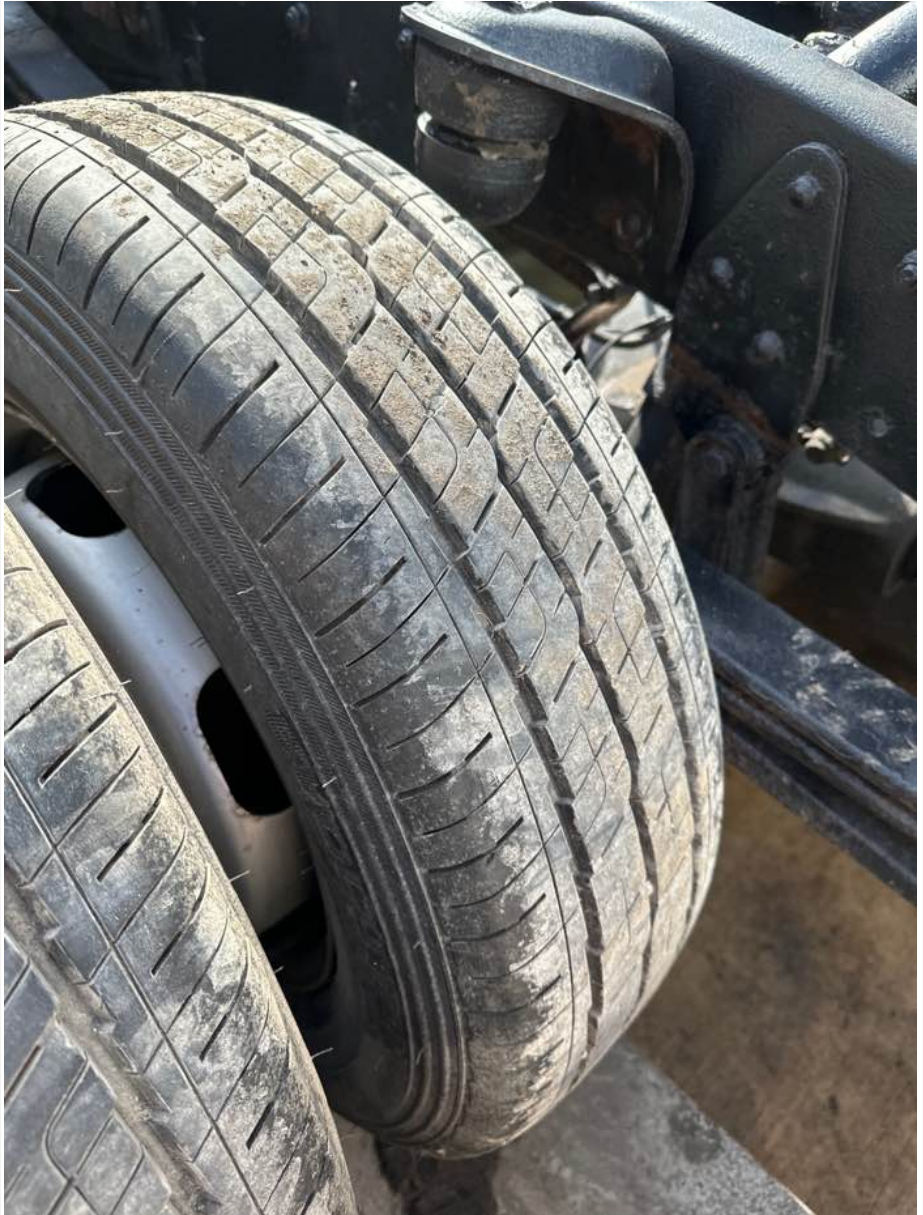
off side Inner (for twin wheel vans)

Is the vehicle a twin wheel axle? (if no don't fill out)	Yes
Age (month/year) Manufactured	11/21
Make, brand.	Cooper
Tyre size	215/75/R16
Pressure 1	
Pressure 2	
Wearing / Perishing (inner)	none
Wearing / Perishing (outer)	None

tread depth (mm)	8
General comments	good tyre
Images of tyre

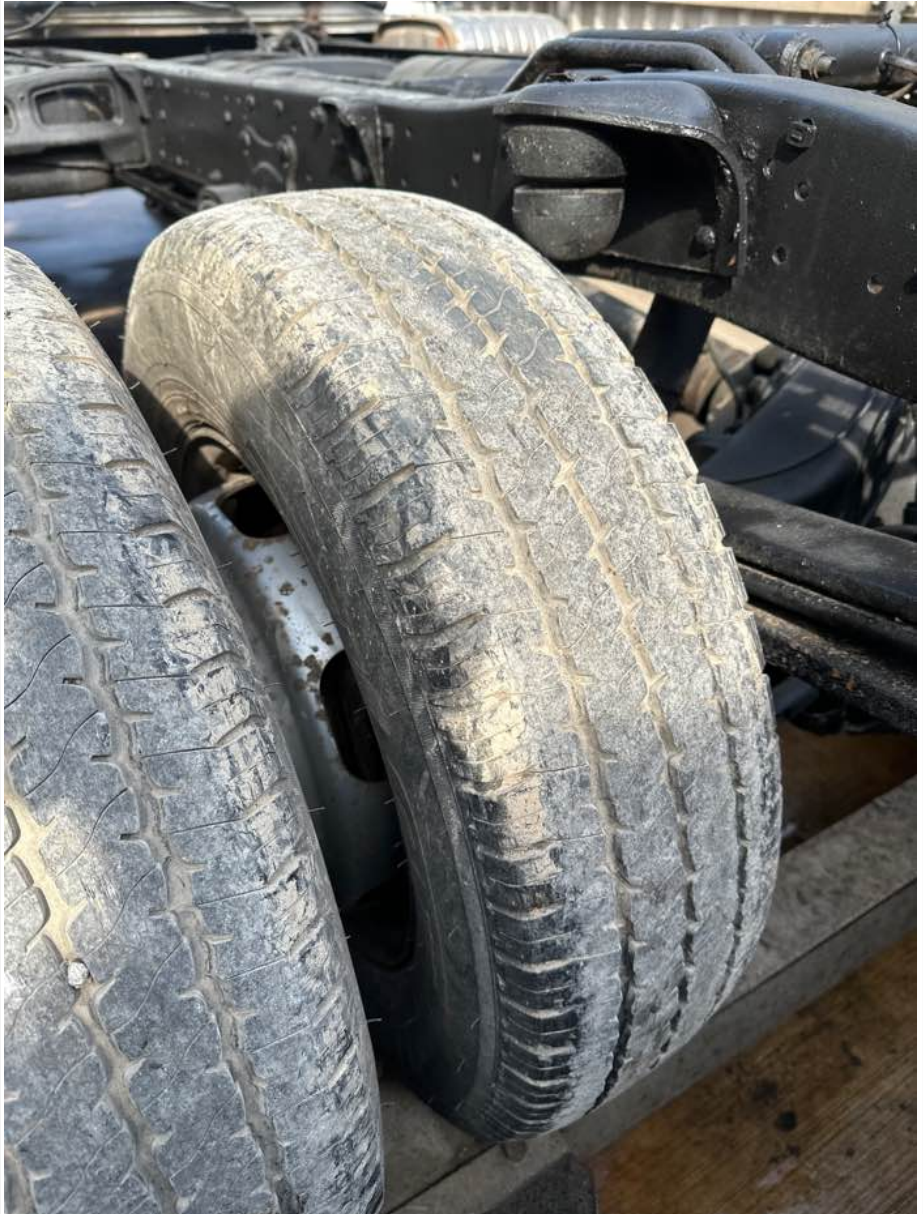
near side Inner (for twin wheel vans)

Is the vehicle a twin wheel axle? (if no don't fill out)	Yes
Age (month/year) Manufactured	51/19
Make, brand.	GT Radial
Tyre size	215/75/R16
Pressure 1	
Pressure 2

Wearing / Perishing (inner)	none
Wearing / Perishing (outer)	None
tread depth (mm)	8
General comments	good tyre, nice tread
Images of tyre

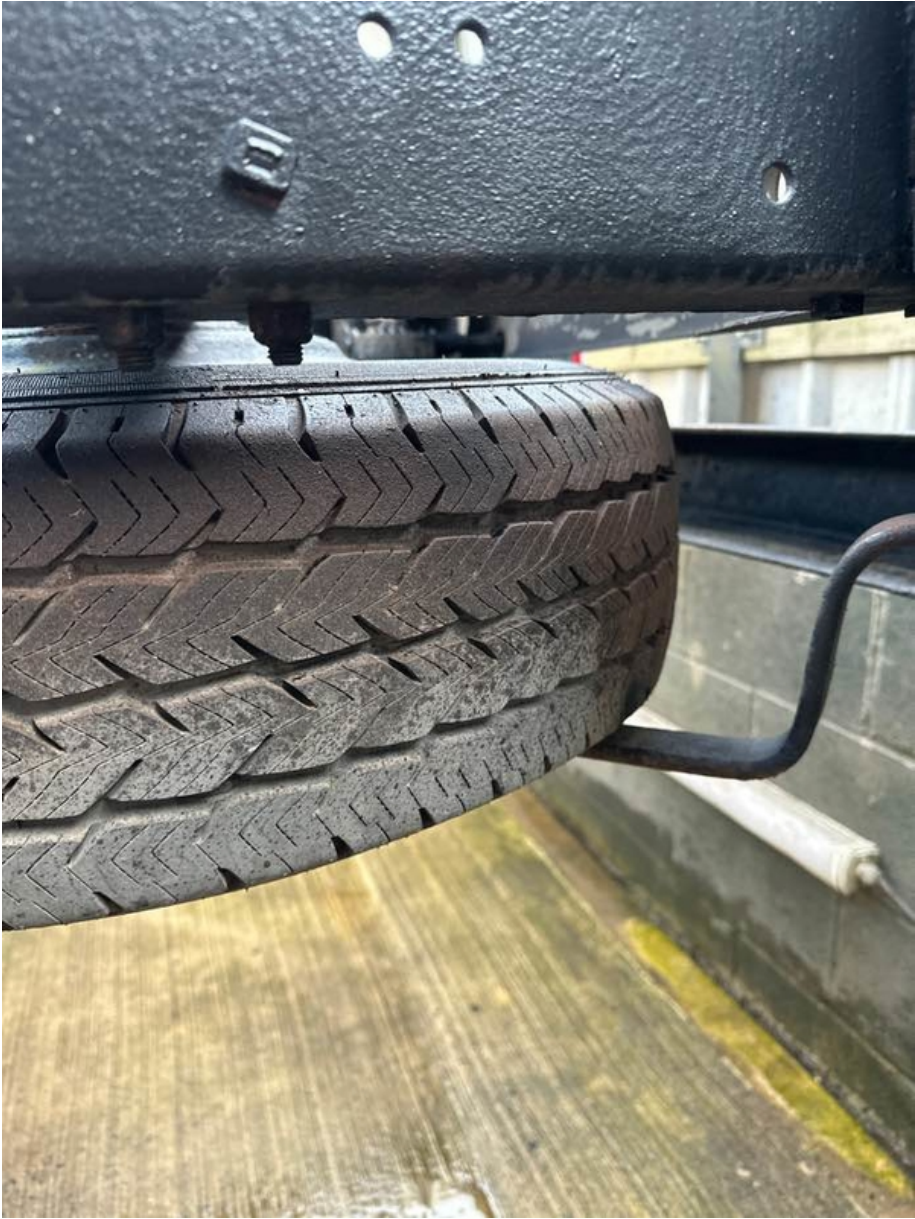
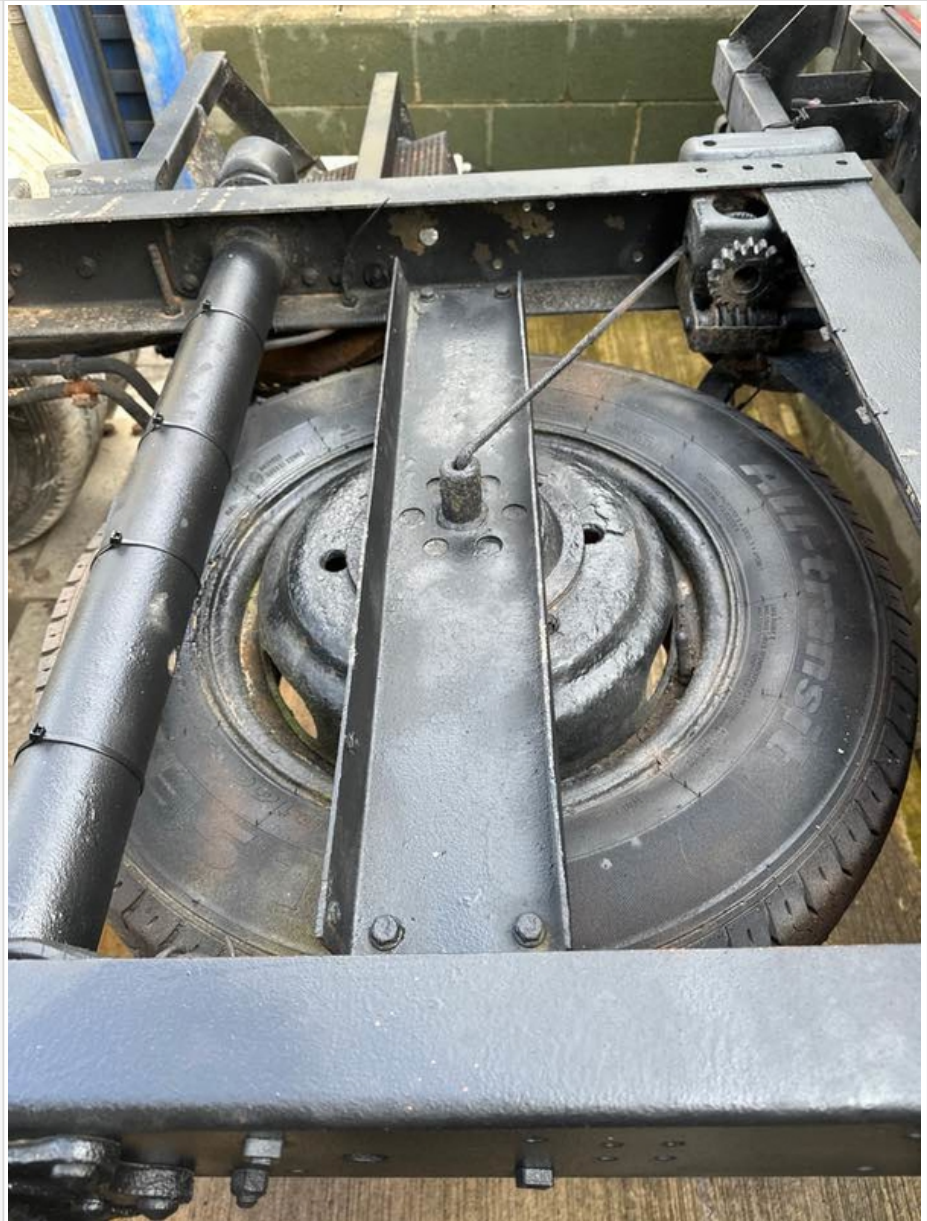
Spare wheel

Spare installed? (If no, don't fill out)	Yes
Age (month/year) Manufactured	21/17
Make, brand.	Budget
Tyre size	215/75/R16

Pressure 1	
Pressure 2	
Wearing / Perishing (inner)	none
Wearing / Perishing (outer)	None
tread depth (mm)	10
General comments	Never used
Images of tyre

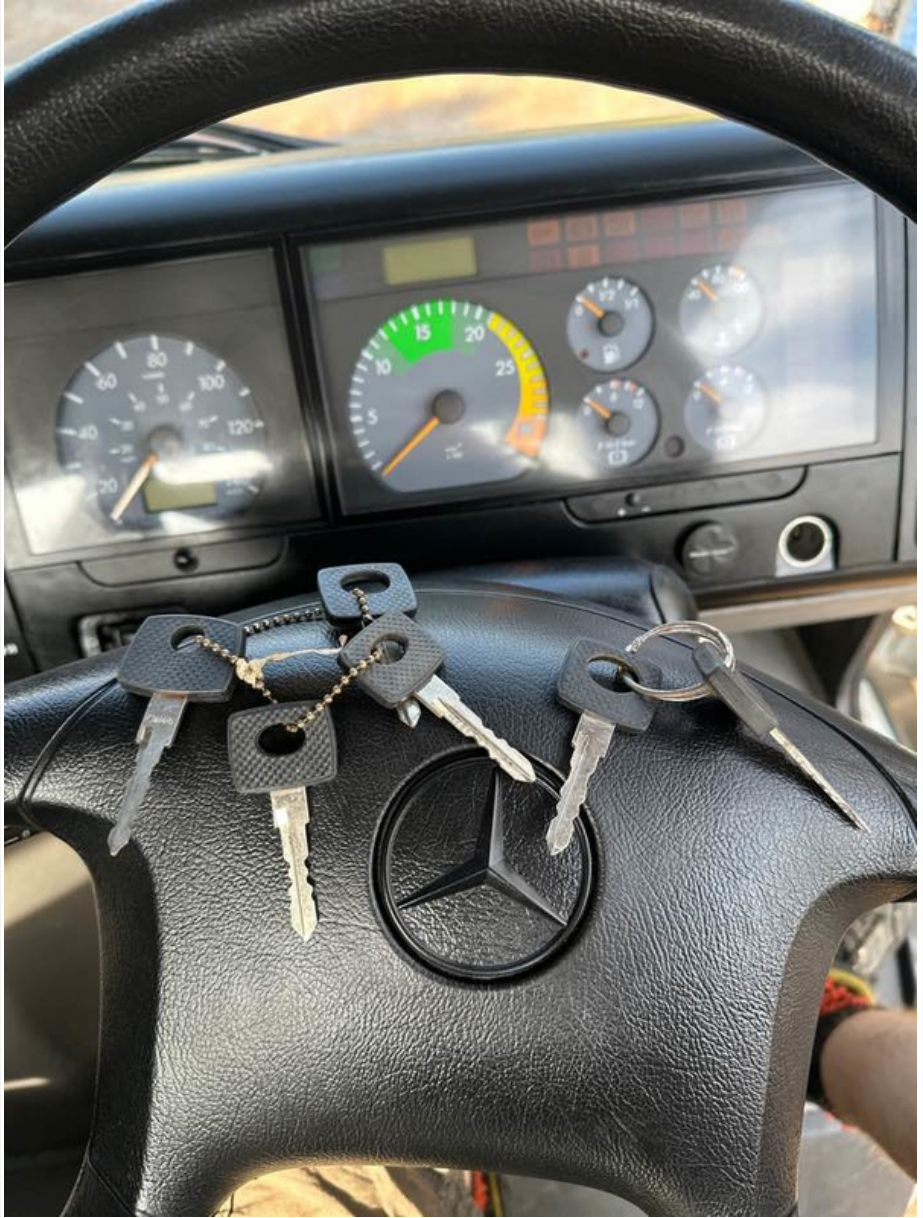
Comment	6 keys wow, all works good

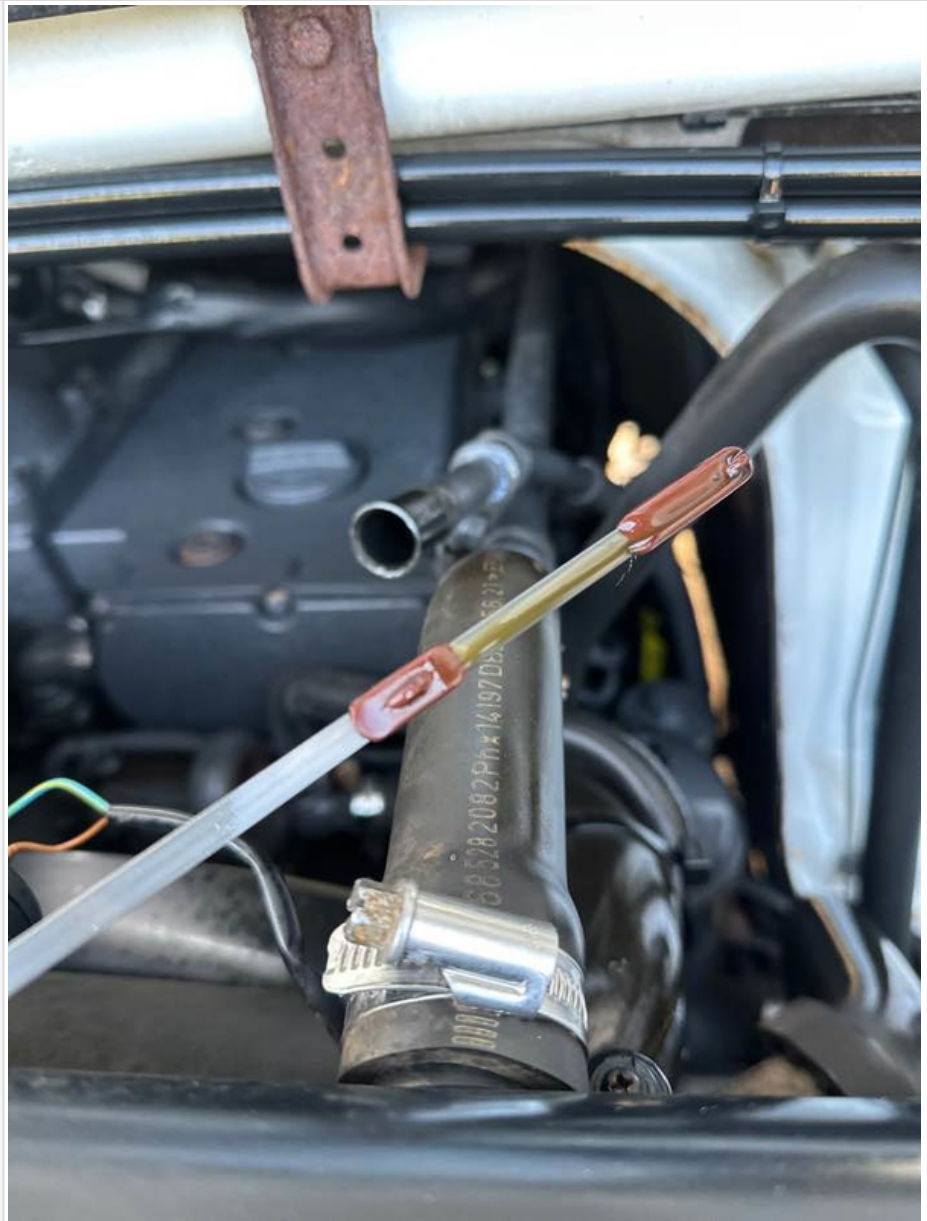
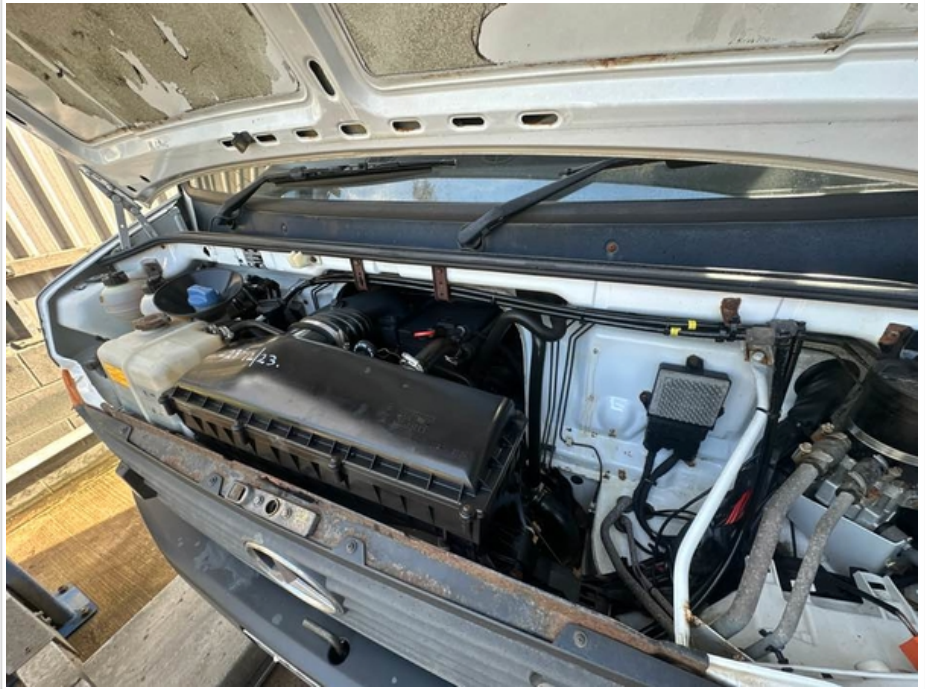
Engine bay photo

Fuel level	1/2 Full
Oil level	Full
Oil conditon	Clean
Start up, chassis battery check	Started, but required boost pack, Chassis battery requires charging
Start-up from cold	Instant
Exhaust smoke from cold	Normal
Output Voltage of Alternator test	
Chain or Belt driven engine?	Chain
If belt any proof of change?	n/a
Coolant condition	Clean
Coolant level	Full
Anti-freeze temperature check	-23
Washer fluid	Medium
Brake fluid	Full
Power steering fluid	Maximum
Dashboard warning light	No warning lights
OBD Scan results

incredible
