Basevan.com General Inspection

VOITIOIC GOTAIIS	
Vehicle registration	YX65DOJ
Vehicle chassis no.	ZFA25000002887928
Miles (if in km, multiply by 0.62)	289,907
Make	FIAT
Model	ducato
Transmission	Manual, 6 speed
Factory immobiliser installed	Yes
Speed limiter installed	No
Drive configuration	FWD
Gross Vehicle Weight (kg)	4250
Towing capacity	2000
Tow bar installed	No

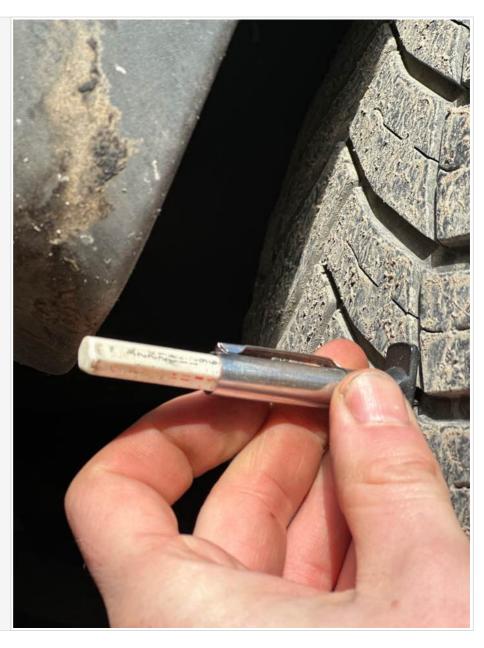
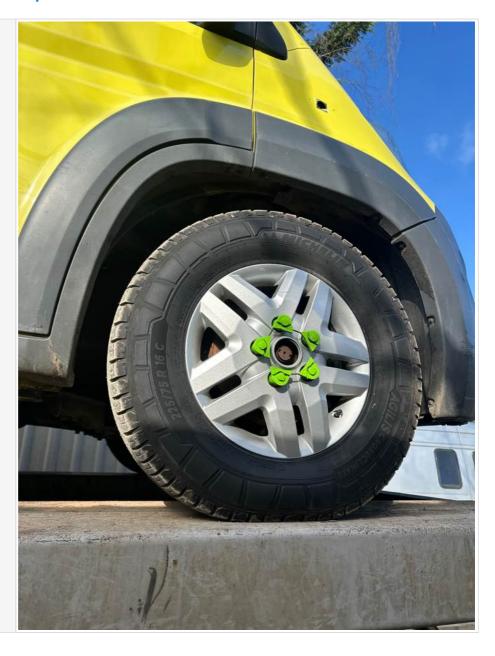
Off side front

Age (month/year) Manufactured	16/22
Make, brand.	Michelin
Tyre size	225/75/R16
Pressure 1	
Pressure 2	
Wearing / Perishing (inner)	none
Wearing / Perishing (outer)	None
tread depth (mm)	5
General comments	recent tyre, some wear

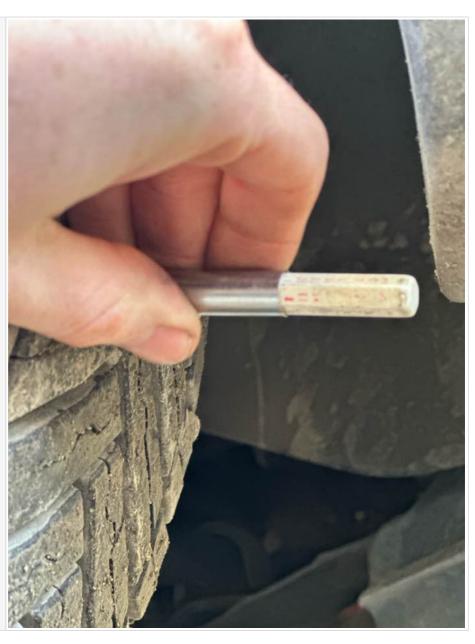
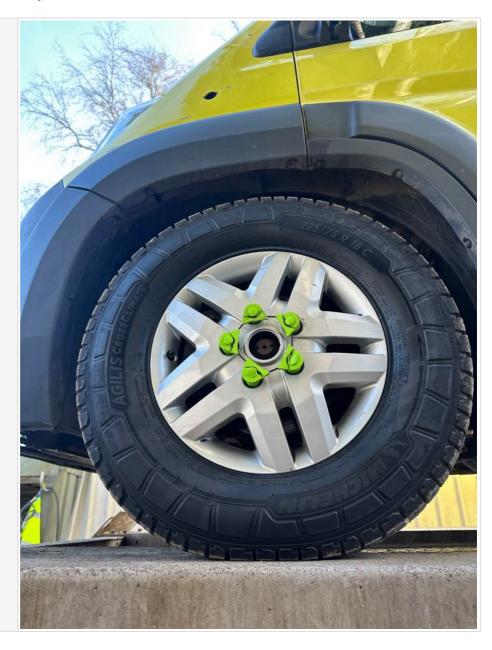
Near side front

Age (month/year) Manufactured	25/24
Make, brand.	Michelin
Tyre size	225/75/R16
Pressure 1	
Pressure 2	
Wearing / Perishing (inner)	none
Wearing / Perishing (outer)	None
tread depth (mm)	8
General comments	brand spanking new

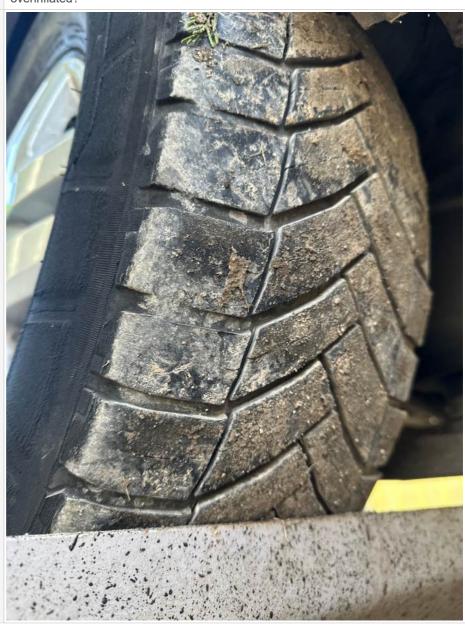
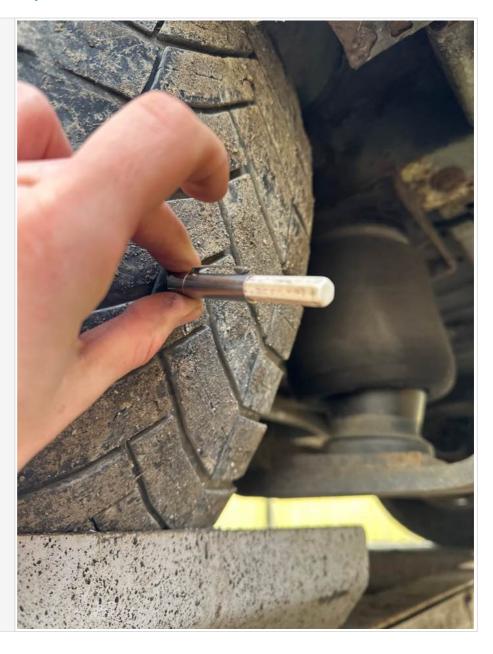
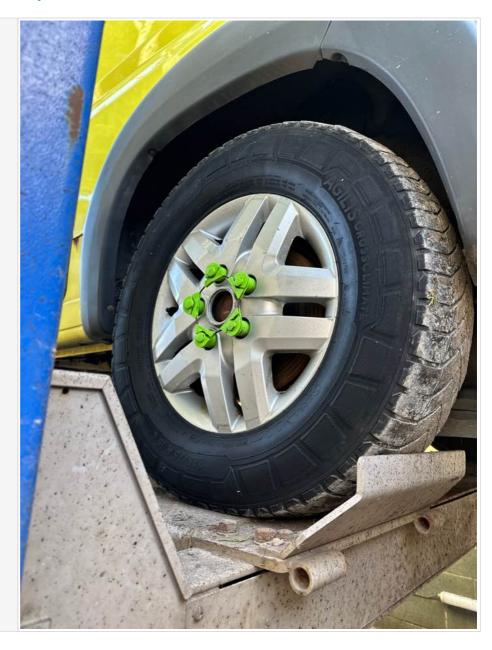
near side rear

Age (month/year) Manufactured	08/22
Make, brand.	Michelin
Tyre size	225/75/R16
Pressure 1	
Pressure 2	
Wearing / Perishing (inner)	Slight
Wearing / Perishing (outer)	Slight
tread depth (mm)	6

General commentsgood tyre lots of life to go- slight abnormal wear toward shoulders, possibly overinflated?

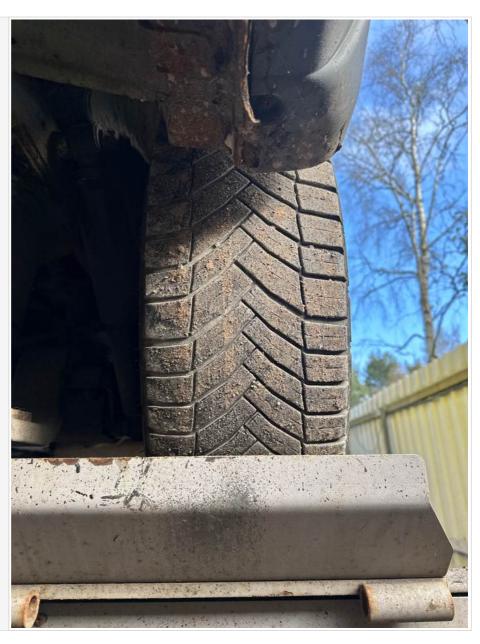
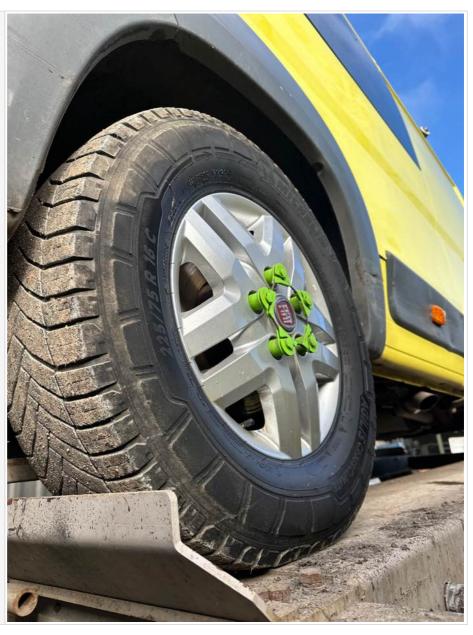
Off side rear

Age (month/year) Manufactured	04/22
Make, brand.	Michelin
Tyre size	225/75/R16
Pressure 1	
Pressure 2	
Wearing / Perishing (inner)	none
Wearing / Perishing (outer)	None
tread depth (mm)	4
General comments	worn more toward inner edge

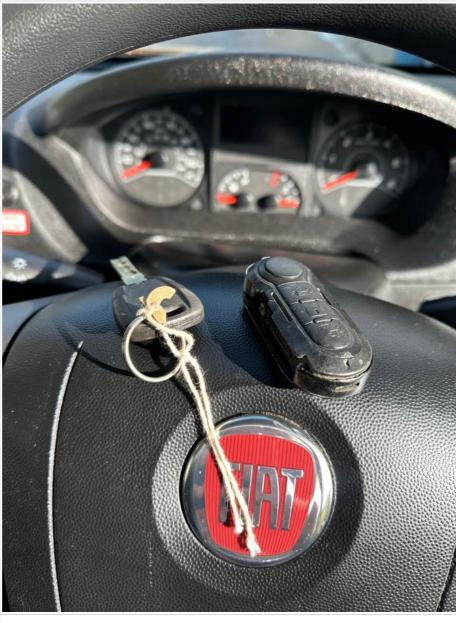
Comment	Rear doors do not lock

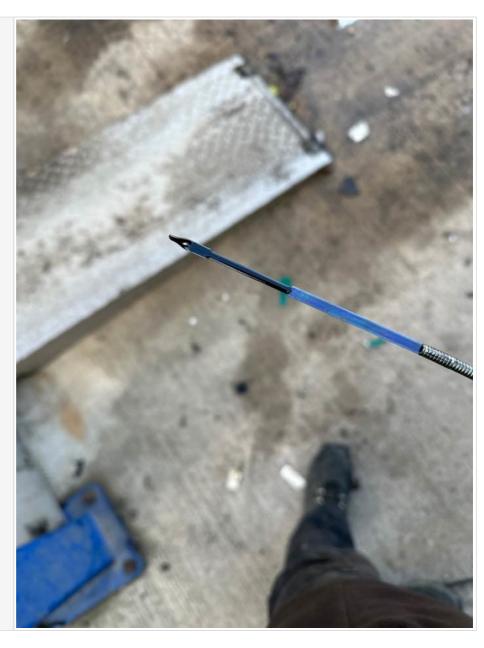
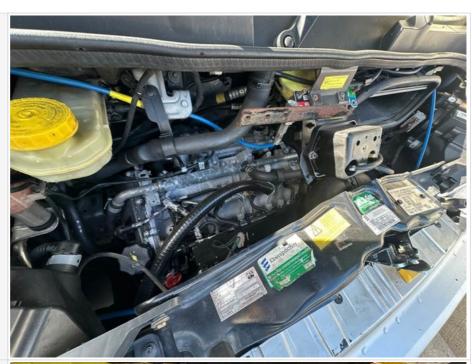
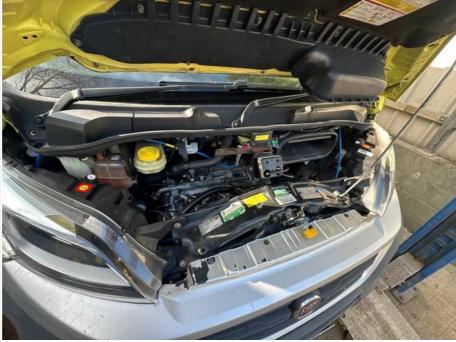
Engine bay photo

Fuel level	1/2 Full
Oil level	Full
Oil conditon	Clean
Start up, chassis battery check	Started without jump pack
Start-up from cold	Instant
Exhaust smoke from cold	Normal
Output Voltage of Alternator test	13.7
Chain or Belt driven engine?	Chain
If belt any proof of change?	N/a
Coolant condition	Clean, Oil present
Coolant level	Full
Anti-freeze temperature check	-16
Washer fluid	Full
Brake fluid	Full
Power steering fluid	Maximum
Dashboard warning light	No warning lights
OBD Scan results

new(ish) engine, oil present in bottle, possible oil cooler? workshop to inspect
