## BaseVan Initial Inspection

Vehicle registration	WA54KCY
Vehicle chassis no.	WV1ZZZ2DZ4H022653
Miles (if in km, multiply by 0.62)	42,817
Make	Volkswagen
Model	LT46
Transmission	Manual, 5 speed
Factory immobiliser installed	Yes
Speed limiter installed	No
Drive configuration	RWD
Gross vehicle weight	4600kg
Towing capacity	2000kg
Tow bar installed	Yes

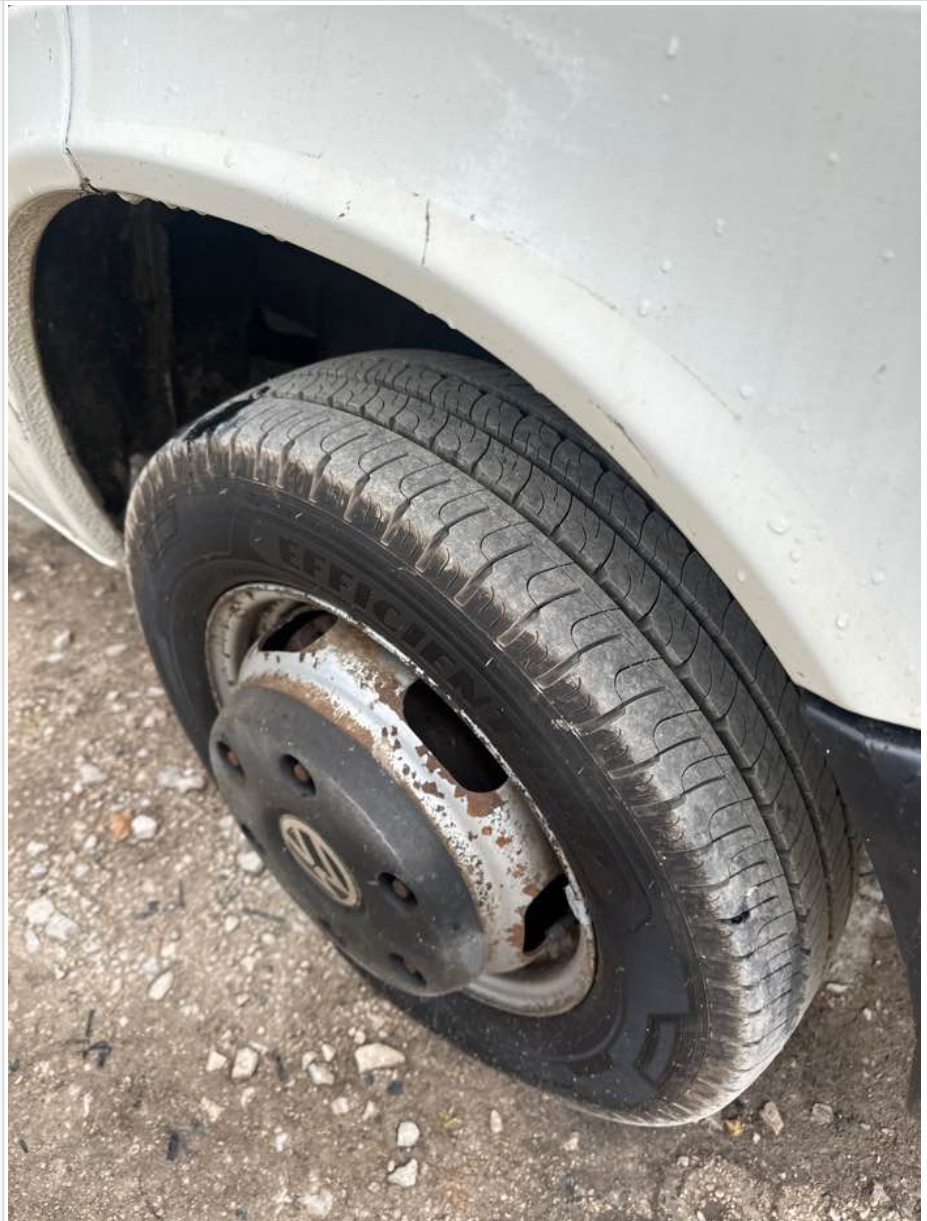
### Off side front

Age (month/year) Manufactured	Inside
Make, brand.	Good Year
Tyre size	195/75/R16
Pressure 1	
Pressure 2	
Wearing / Perishing (inner)	none
Wearing / Perishing (outer)	None
tread depth (mm)	8
General comments	basically brand new, very recent tyre

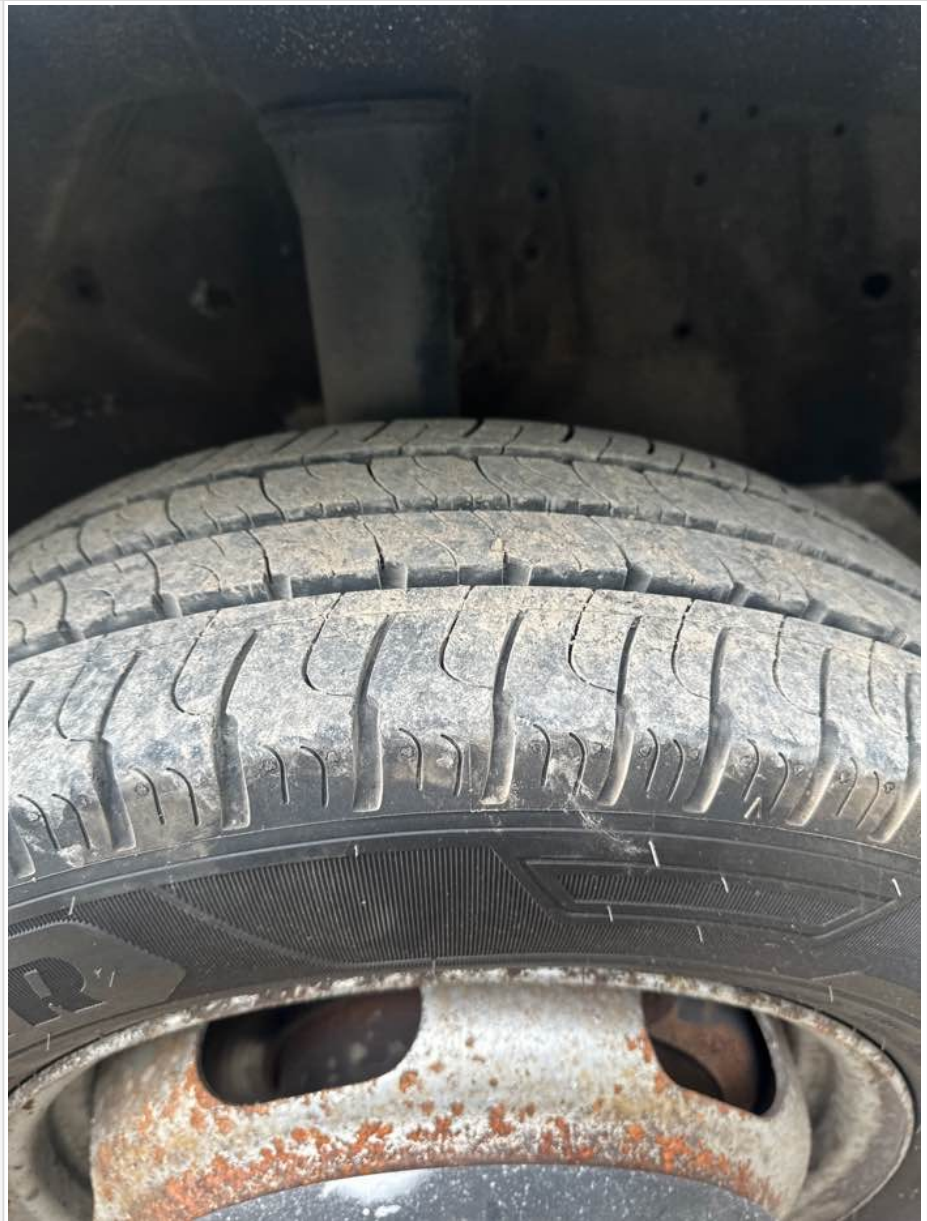
### Near side front

Age (month/year) Manufactured	Inside
Make, brand.	Good Year
Tyre size	195/75/R16
Pressure 1	
Pressure 2	
Wearing / Perishing (inner)	none
Wearing / Perishing (outer)	None
tread depth (mm)	8
General comments	basically brand new, very recent tyre

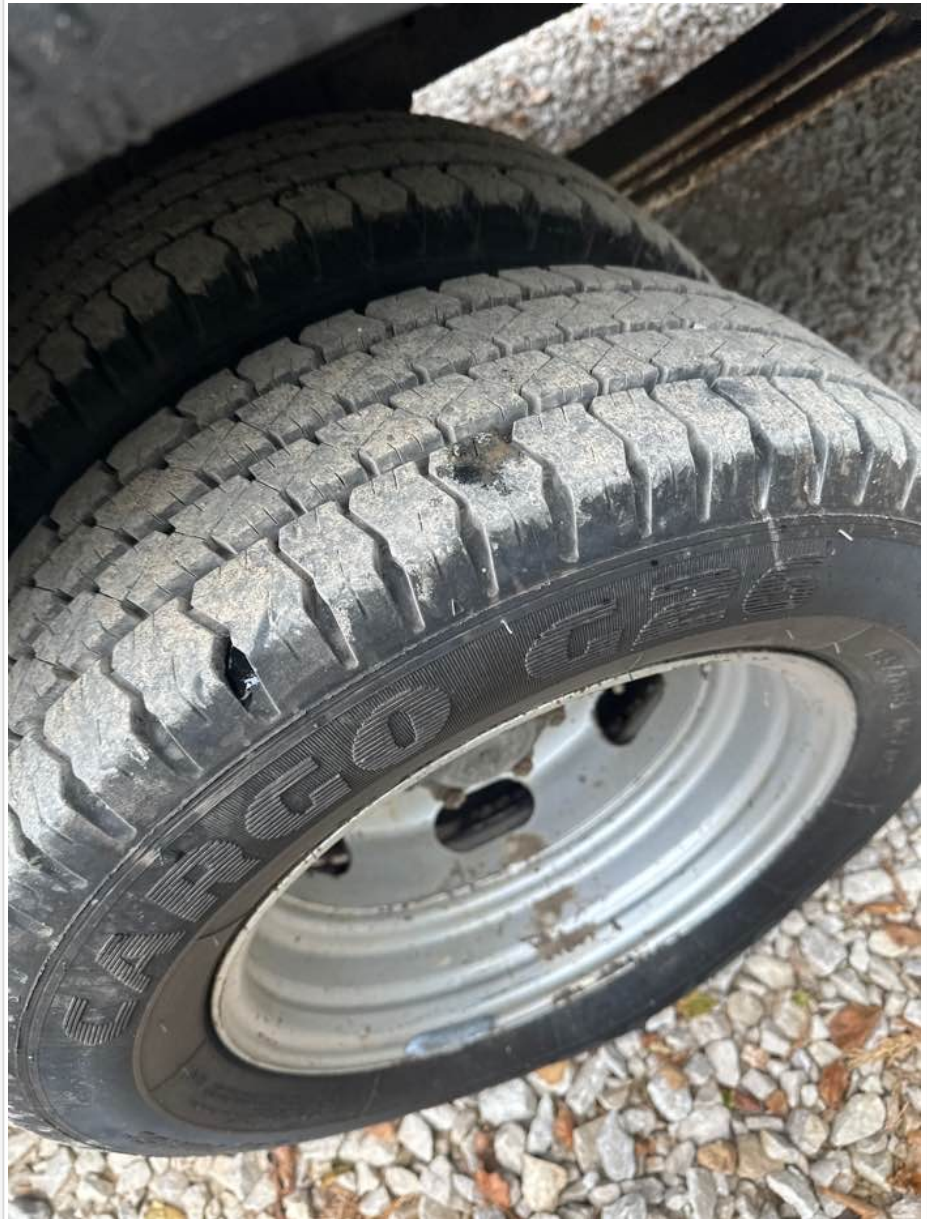
### near side rear

Age (month/year) Manufactured	inside
Make, brand.	Good Year
Tyre size	195/75/R16
Pressure 1	
Pressure 2	
Wearing / Perishing (inner)	none
Wearing / Perishing (outer)	None
tread depth (mm)	8
General comments	very good tread, recent tyre

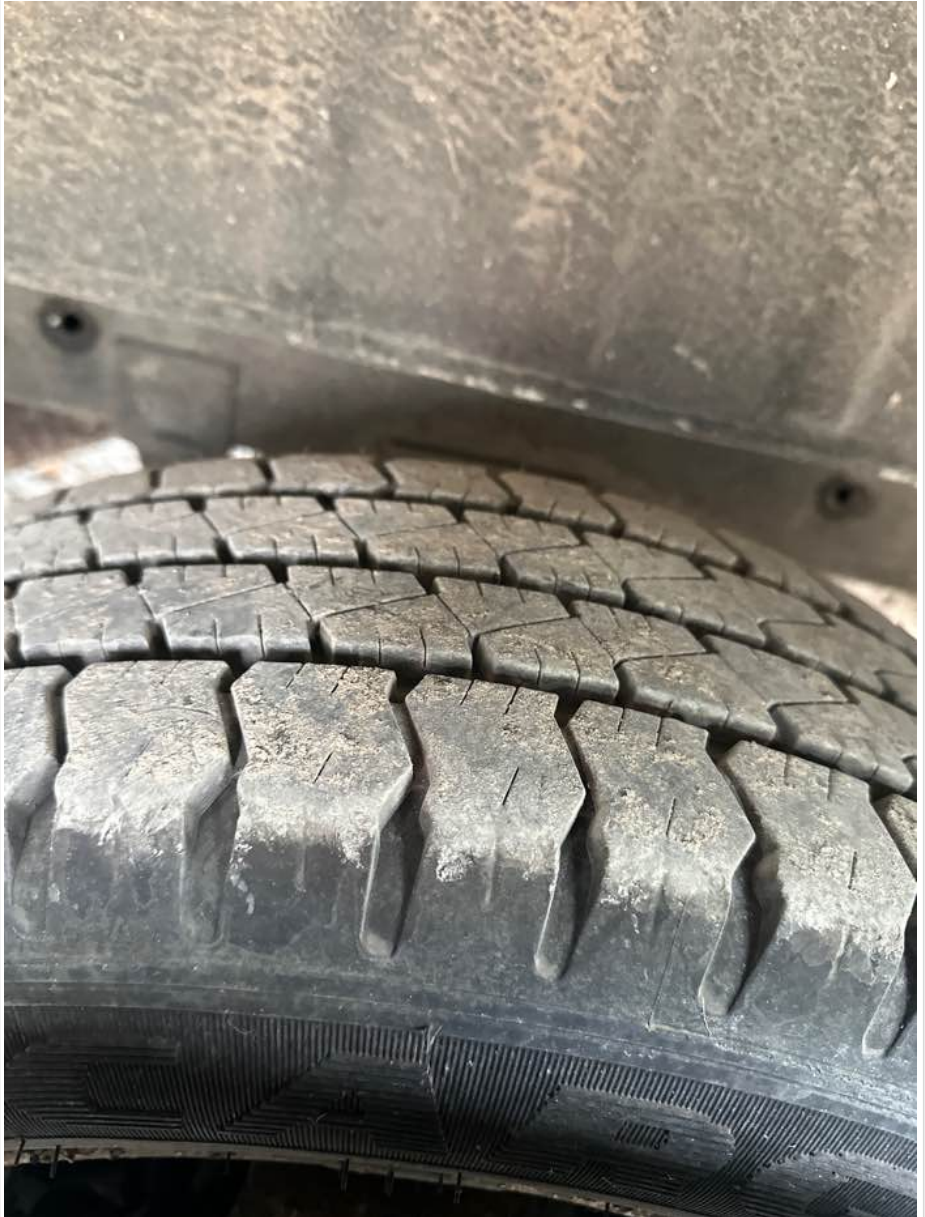
### off side Inner (for twin wheel vans)

Is the vehicle a twin wheel axle? (if no don't fill out)	Yes
Age (month/year) Manufactured	inside
Make, brand.	Good Year
Tyre size	195/75/R16
Pressure 1	
Pressure 2	
Wearing / Perishing (inner)	none
Wearing / Perishing (outer)	None

tread depth (mm)	7
General comments	good tyre very good tread
Images of tyre

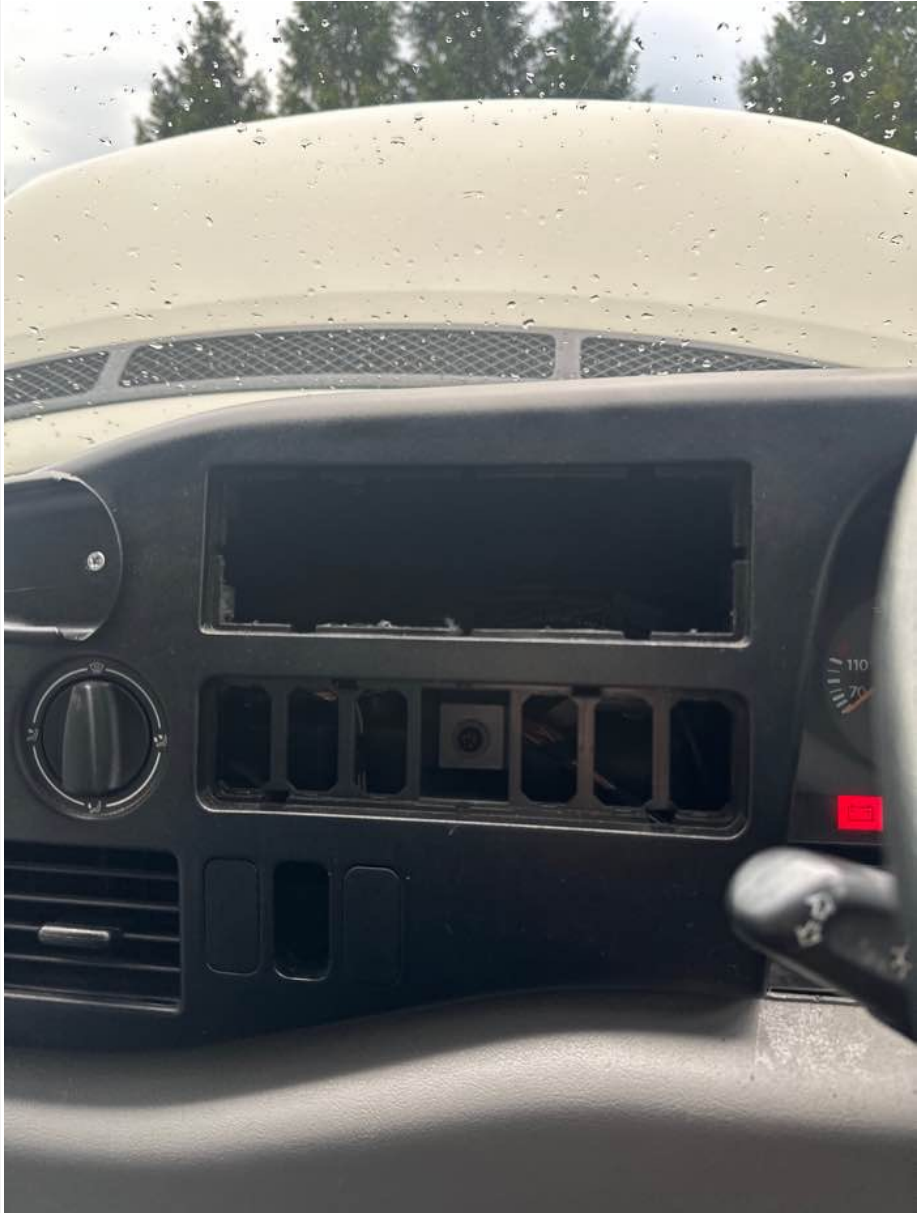
Number of seats (cab only)	Driver & 1 passenger
Cab heater check	Works on all settings
Comment on cab heater	1,2,3,4 all functional
Electric windows present	No
Cab windows function check	Driver side function, Passenger side function
Air conditioning present	No
Charging socket present (cigarette lighter)	Yes

Function working?	Yes
Radio / Media system fitted?	No
Radio / media system check	N/A not installed
Reverse camera present?	No
Reverse camera functioning?	N/A
Show any damage or missing items
