## Basevan.com General Inspection

Vehicle registration	SC10AKN
Vehicle chassis no.	VSKF4AHA6UV180579
Miles (if in km, multiply by 0.62)	175391
Make	Nissan
Model	Primastar
Transmission	Manual, 6 speed
Factory immobiliser installed	Yes
Speed limiter installed	N/A
Drive configuration	FWD
Gross Vehicle Weight (kg)	2770
Towing capacity	N/A
Tow bar installed	Yes

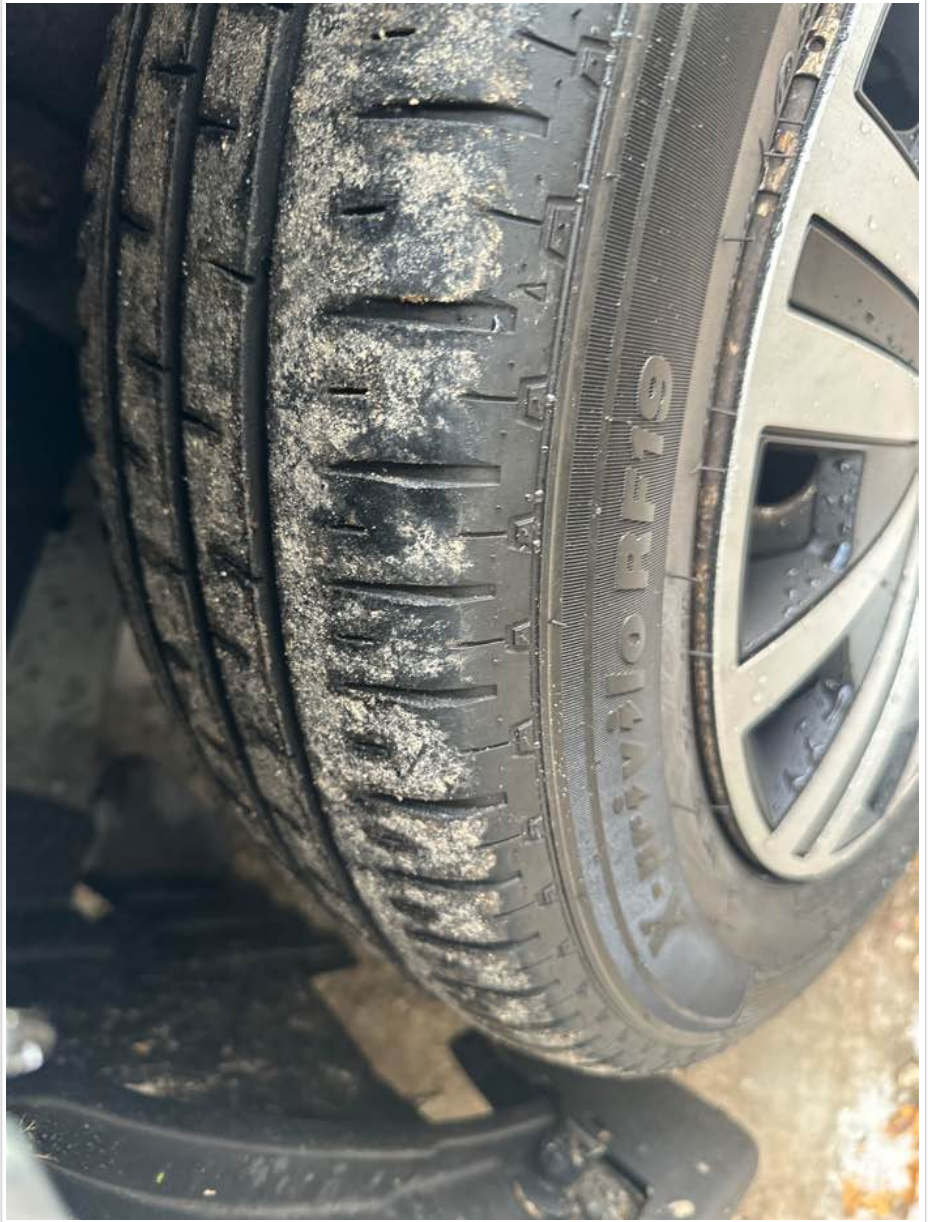
Images of tyre

Age (month/year) Manufactured	01/21
Make, brand.	Budget
Tyre size	Not here (see comment)
Pressure 1	34
Pressure 2	
Wearing / Perishing (inner)	Slight
Wearing / Perishing (outer)	Slight
tread depth (mm)	6
General comments	195/65R/16C

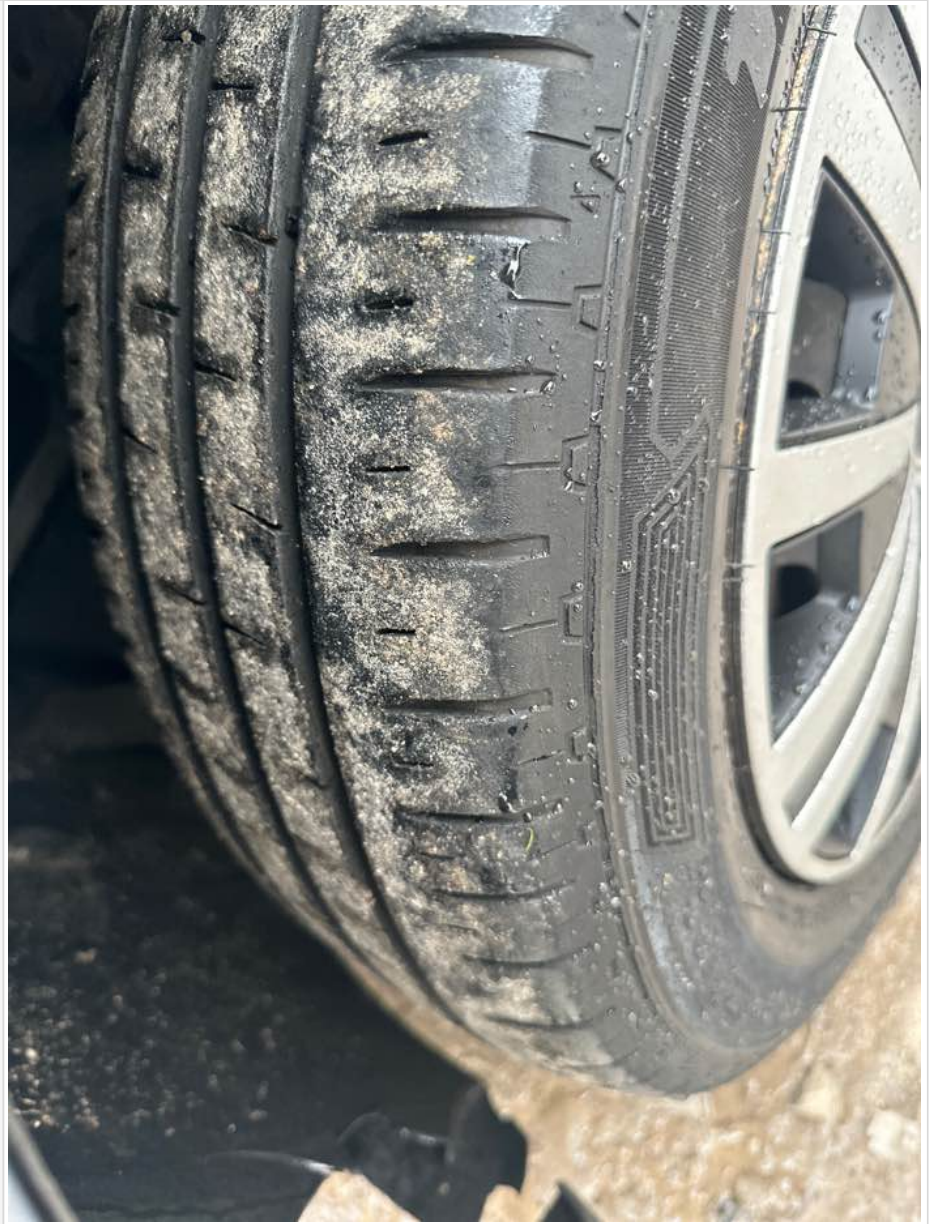
Images of tyre

Age (month/year) Manufactured	01/21
Make, brand.	Budget
Tyre size	Not here (see comment)
Pressure 1	34
Pressure 2	
Wearing / Perishing (inner)	Slight
Wearing / Perishing (outer)	Slight
tread depth (mm)	6
General comments	195/65R/16C

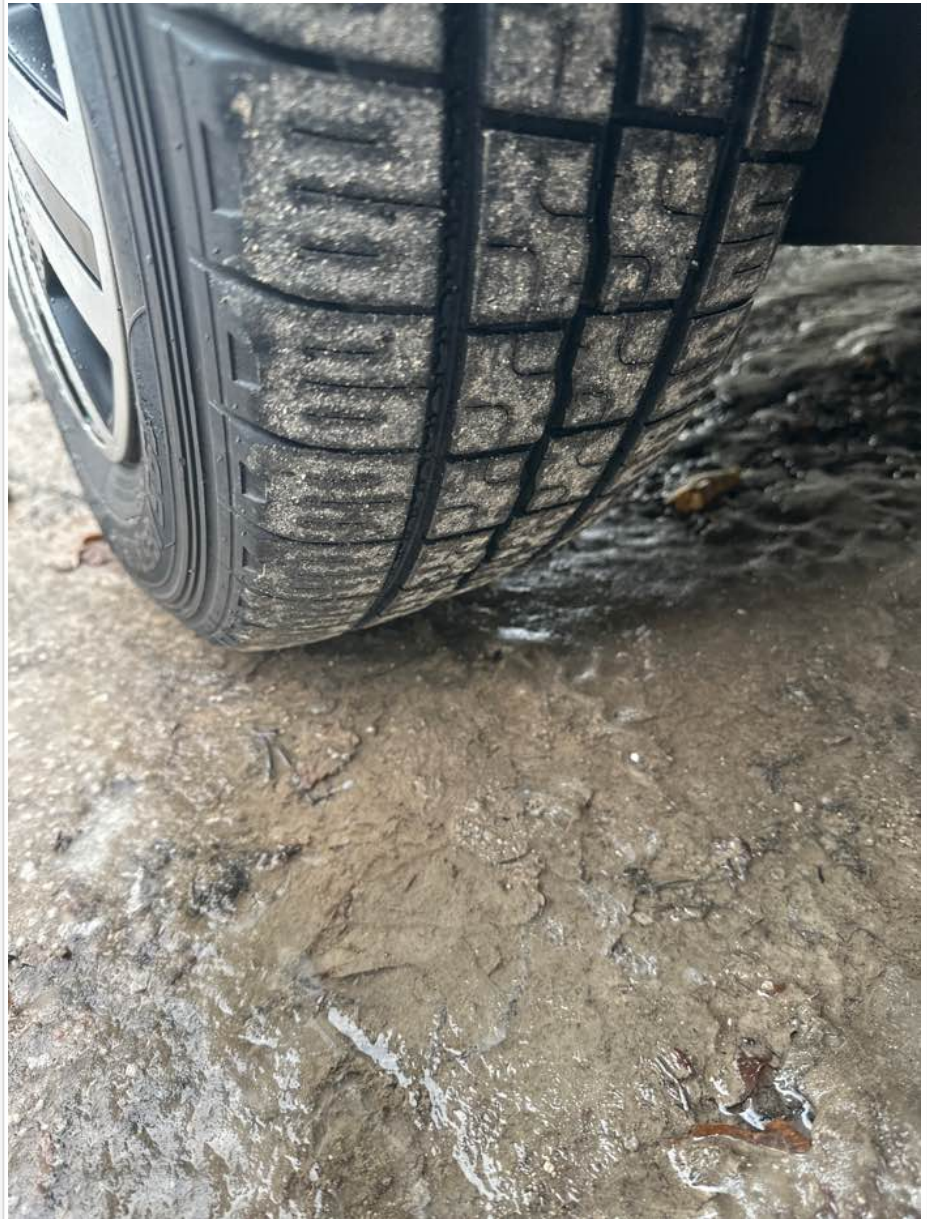
Images of tyre

Age (month/year) Manufactured	16/15
Make, brand.	Budget
Tyre size	Not here (see comment)
Pressure 1	34
Pressure 2	
Wearing / Perishing (inner)	Slight
Wearing / Perishing (outer)	Slight
tread depth (mm)	6
General comments	195/65R/16C

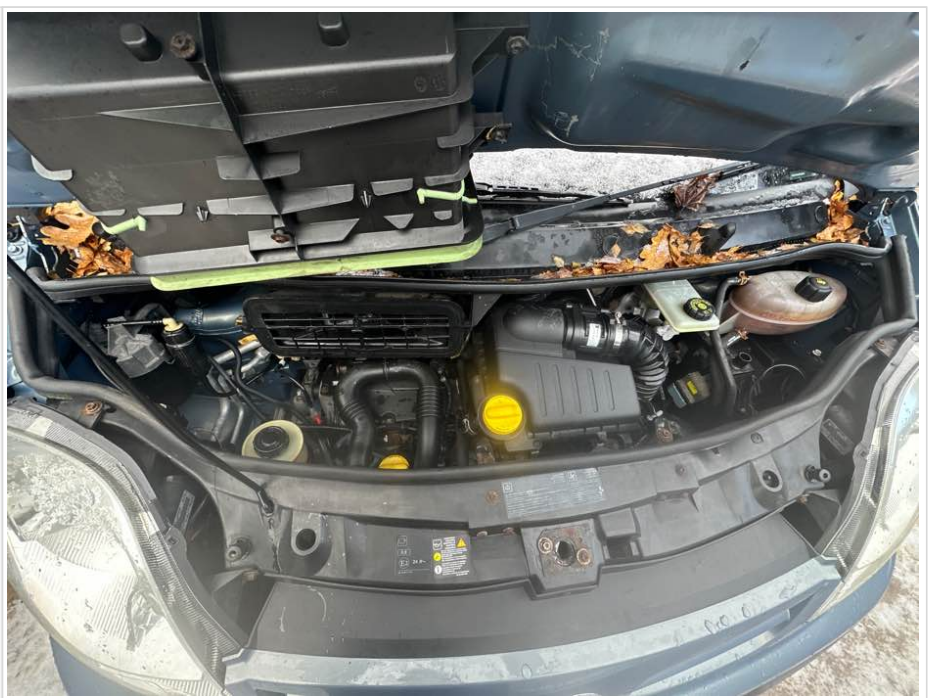
<p>Engine bay photo</p>

Fuel level	1/2 Full
Oil level	Medium
Oil condition	Requires replacing
Start up, chassis battery check	Started without jump pack
Start-up from cold	4 seconds
Exhaust smoke from cold	some white
Output Voltage of Alternator test	14
Chain or Belt driven engine?	Chain
If belt any proof of change?	N/A
Coolant condition	Clean
Coolant level	Medium
Anti-freeze temperature check	
Washer fluid	Medium
Brake fluid	Full
Power steering fluid	Maximum
Dashboard warning light	No warning lights
