## Basevan.com General Inspection

Vehicle registration	ASZ3755
Vehicle chassis no.	VF3YCTMFC12A85456
Miles (if in km, multiply by 0.62)	43638
Make	PEUGUEOT
Model	BOXER
Transmission	6 speed, Manual
Factory immobiliser installed	Yes
Speed limiter installed	No
Drive configuration	FWD
Gross Vehicle Weight (kg)	3500
Towing capacity	2500
Tow bar installed	No

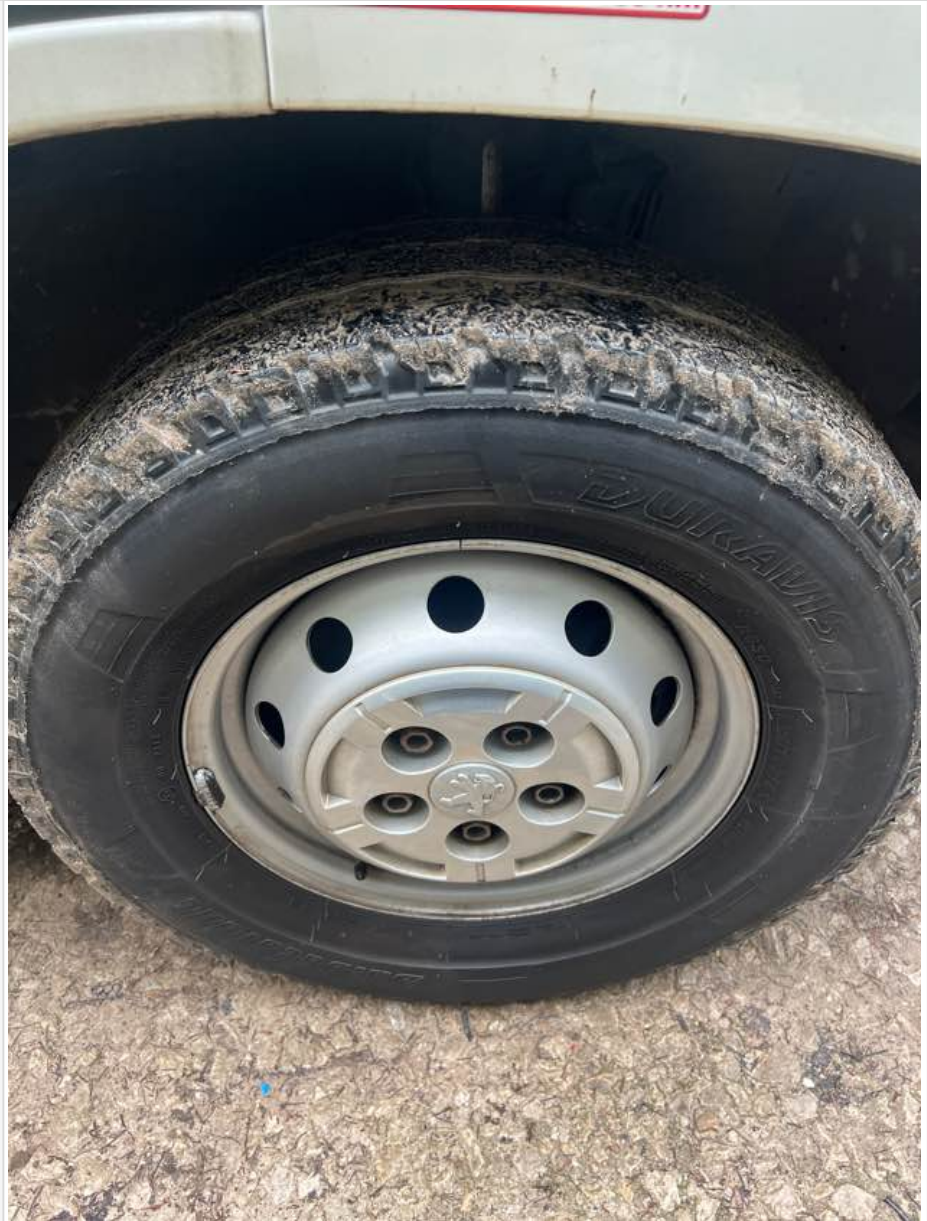
### Off side front

Age (month/year) Manufactured	21/12
Make, brand.	Other (comment)
Tyre size	Not here (see comment)
Pressure 1	
Pressure 2	
Wearing / Perishing (inner)	none
Wearing / Perishing (outer)	Slight
tread depth (mm)	2
General comments	Bridgestone tyre, 225/70/R15, i would replace before next MOT.

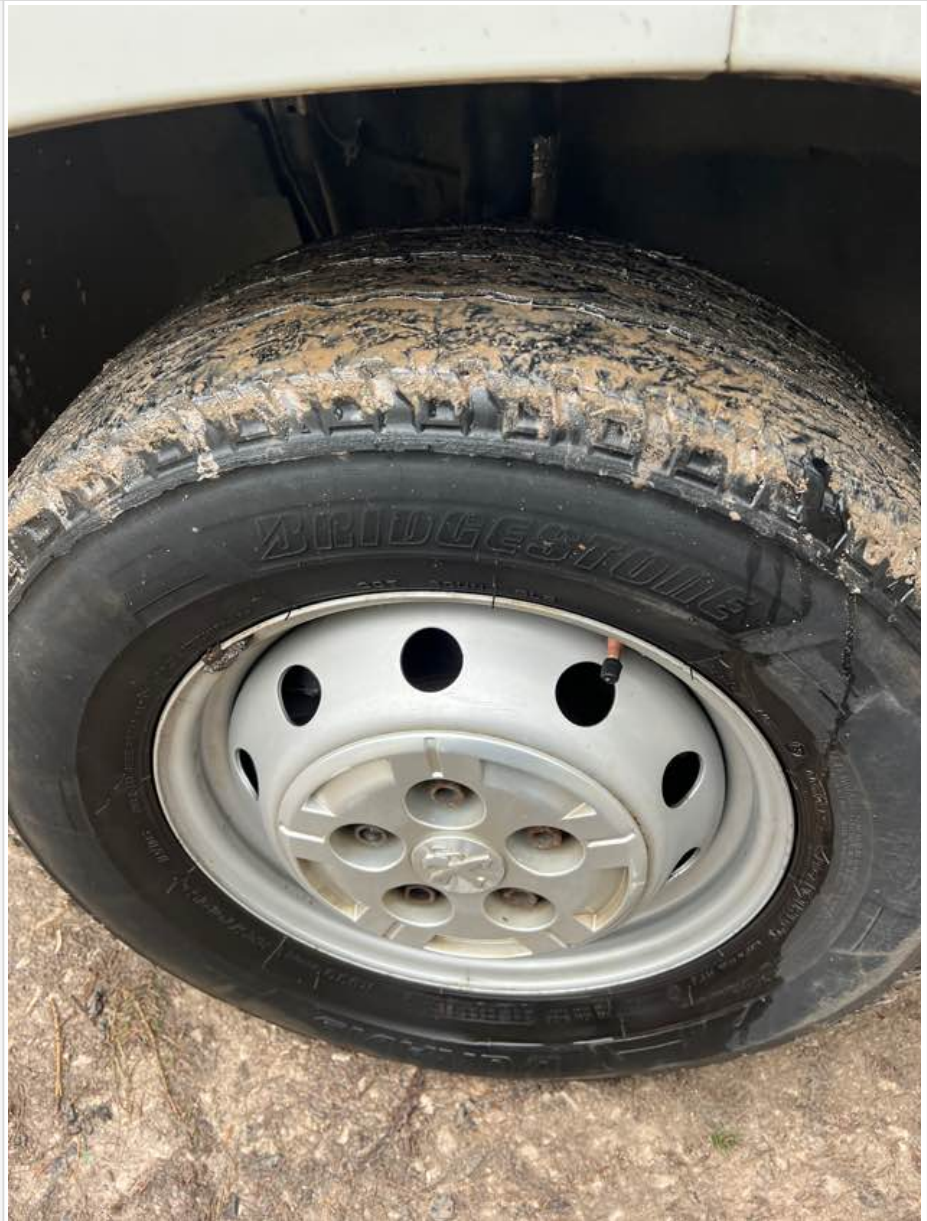
### Near side front

Age (month/year) Manufactured	21/12
Make, brand.	
Tyre size	Not here (see comment)
Pressure 1	
Pressure 2	
Wearing / Perishing (inner)	none
Wearing / Perishing (outer)	Slight
tread depth (mm)	2
General comments	Bridgestone, I'd also replace at next MOT

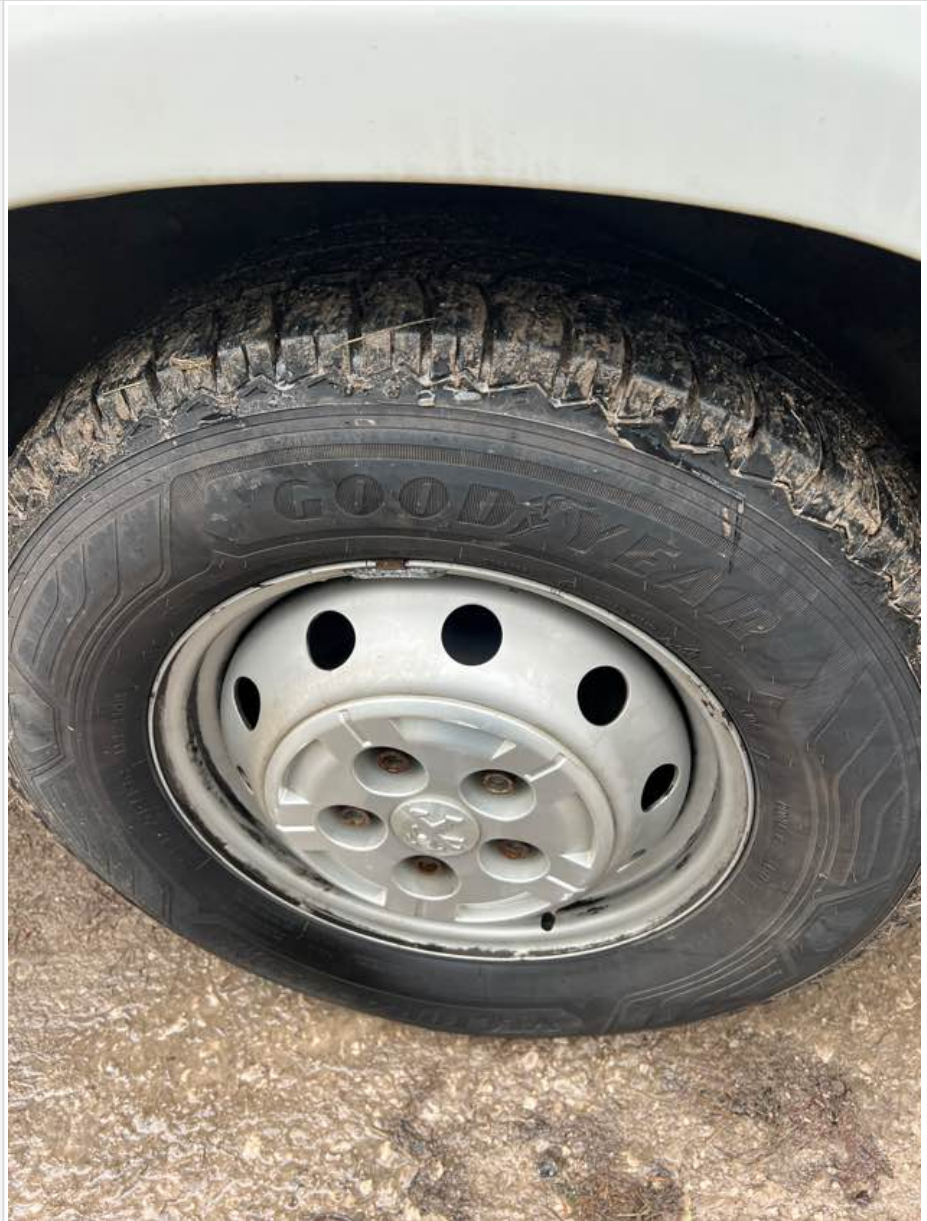
### near side rear

Age (month/year) Manufactured	43/22
Make, brand.	Good Year
Tyre size	
Pressure 1	
Pressure 2	
Wearing / Perishing (inner)	none
Wearing / Perishing (outer)	None
tread depth (mm)	8
General comments	Tyre is like new.

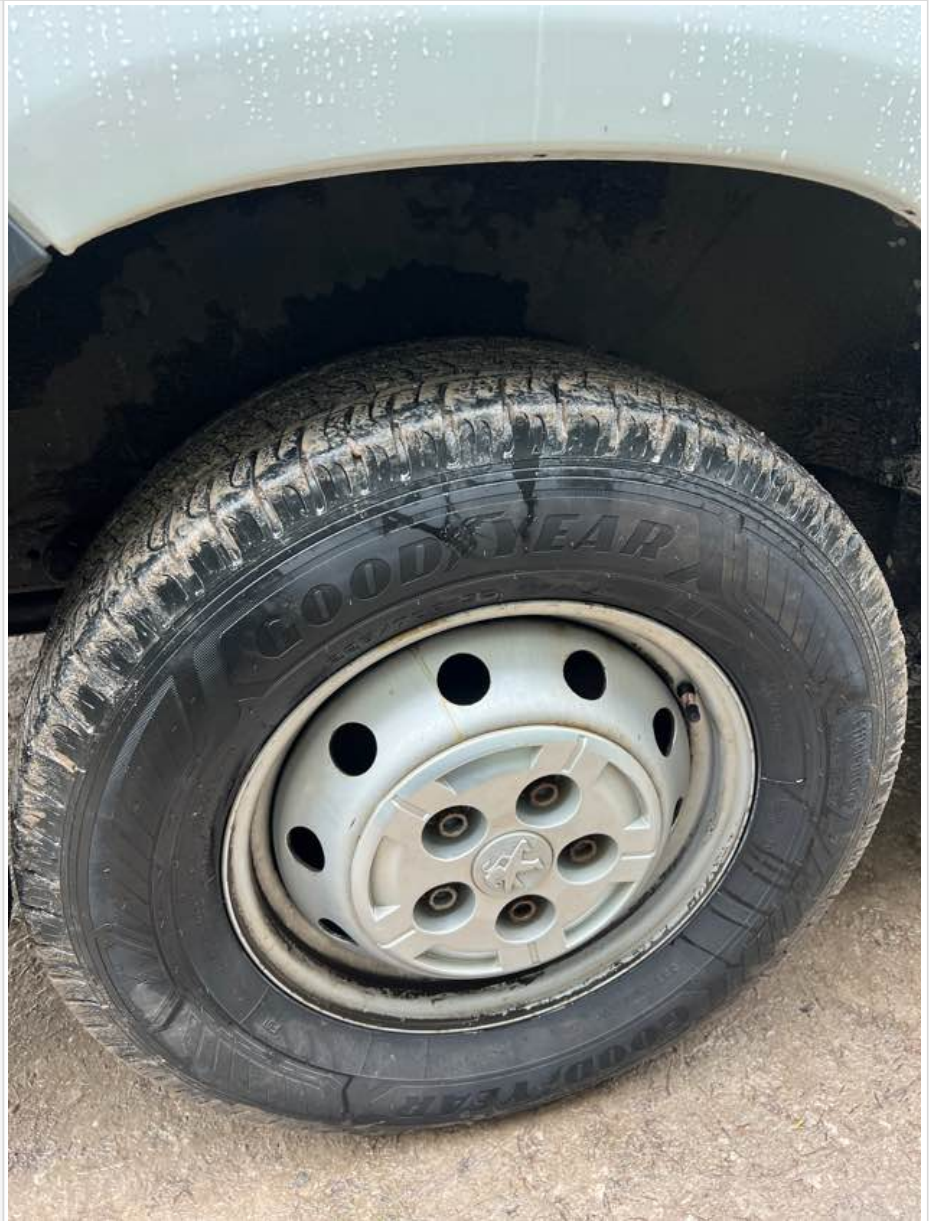
### Off side rear

Age (month/year) Manufactured	15/22
Make, brand.	Good Year
Tyre size	Not here (see comment)
Pressure 1	
Pressure 2	
Wearing / Perishing (inner)	none
Wearing / Perishing (outer)	None
tread depth (mm)	8
General comments	Like new!

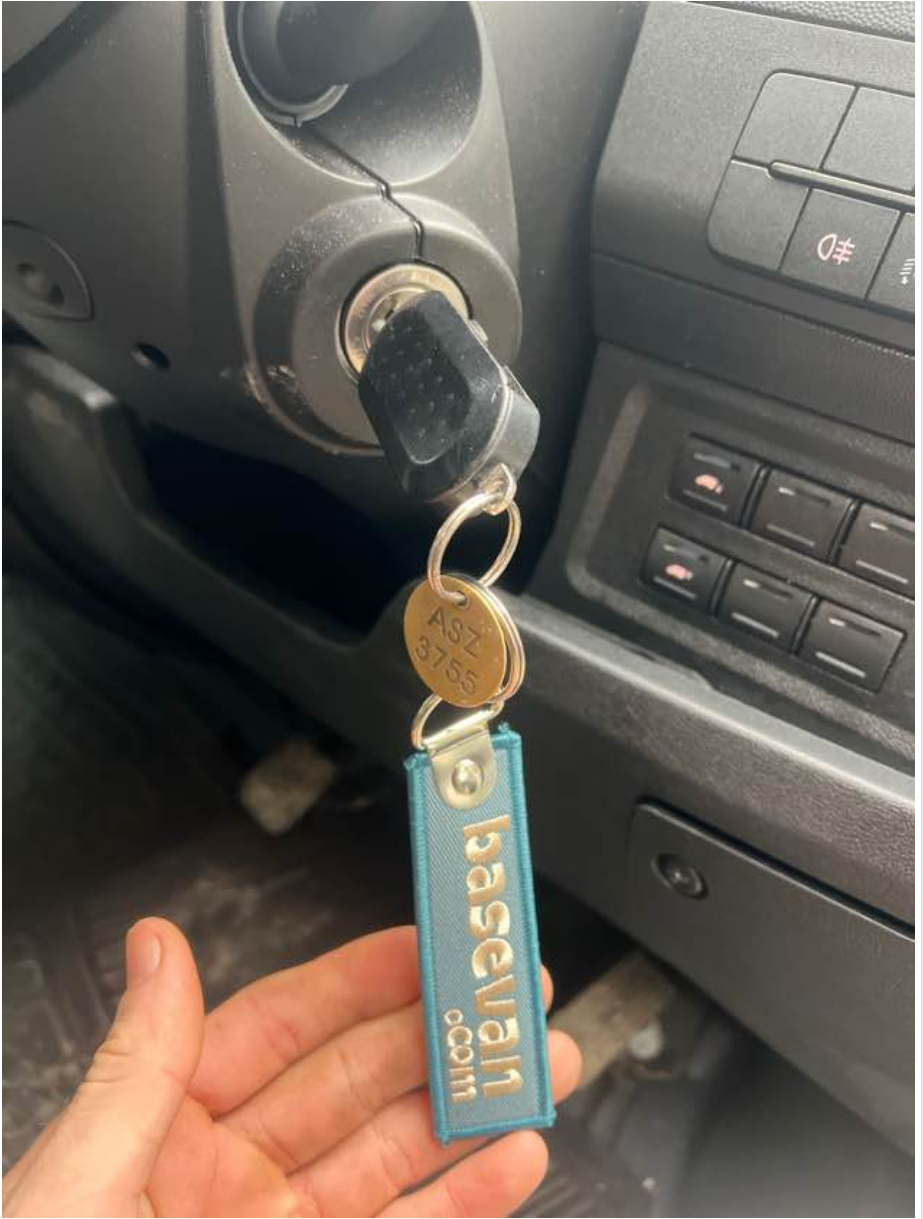
Comment	Only 1 key present

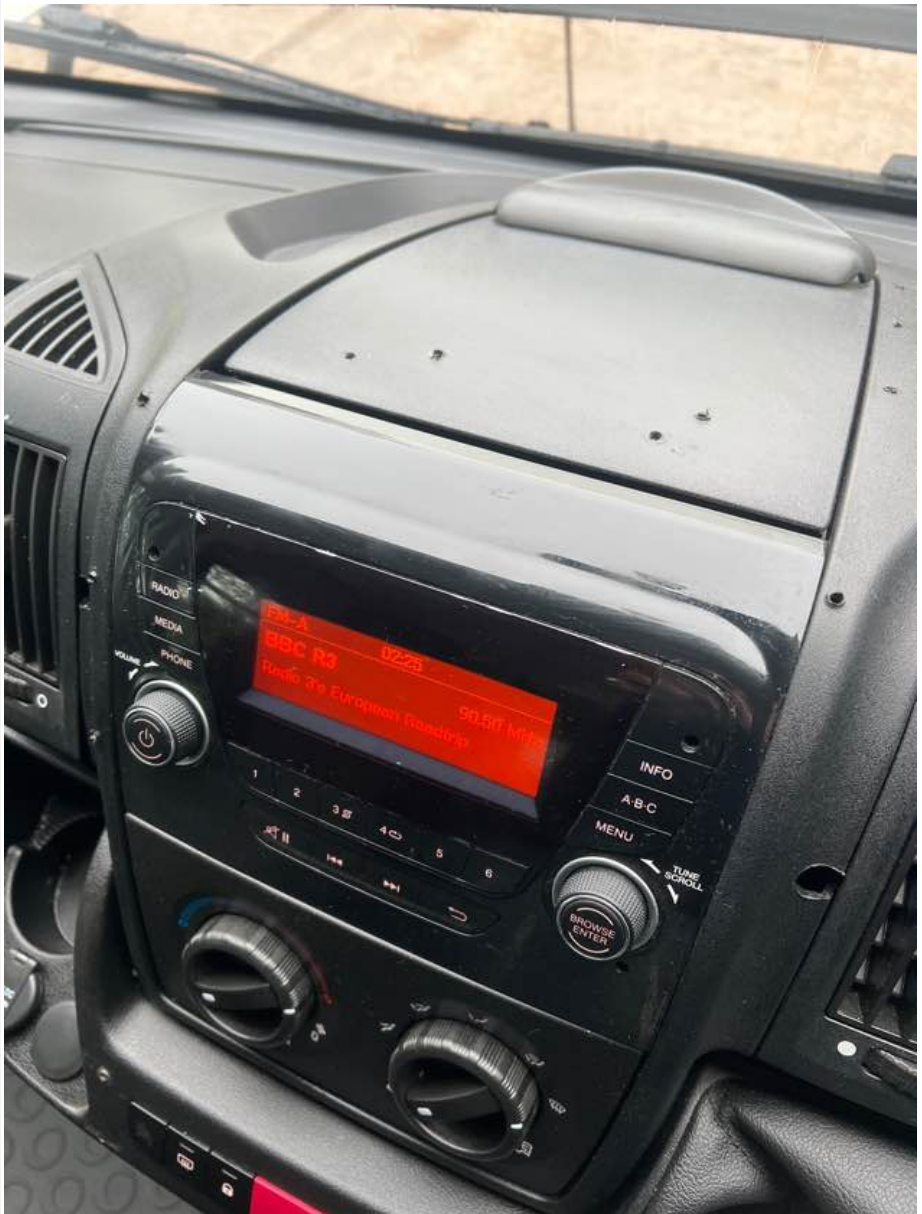
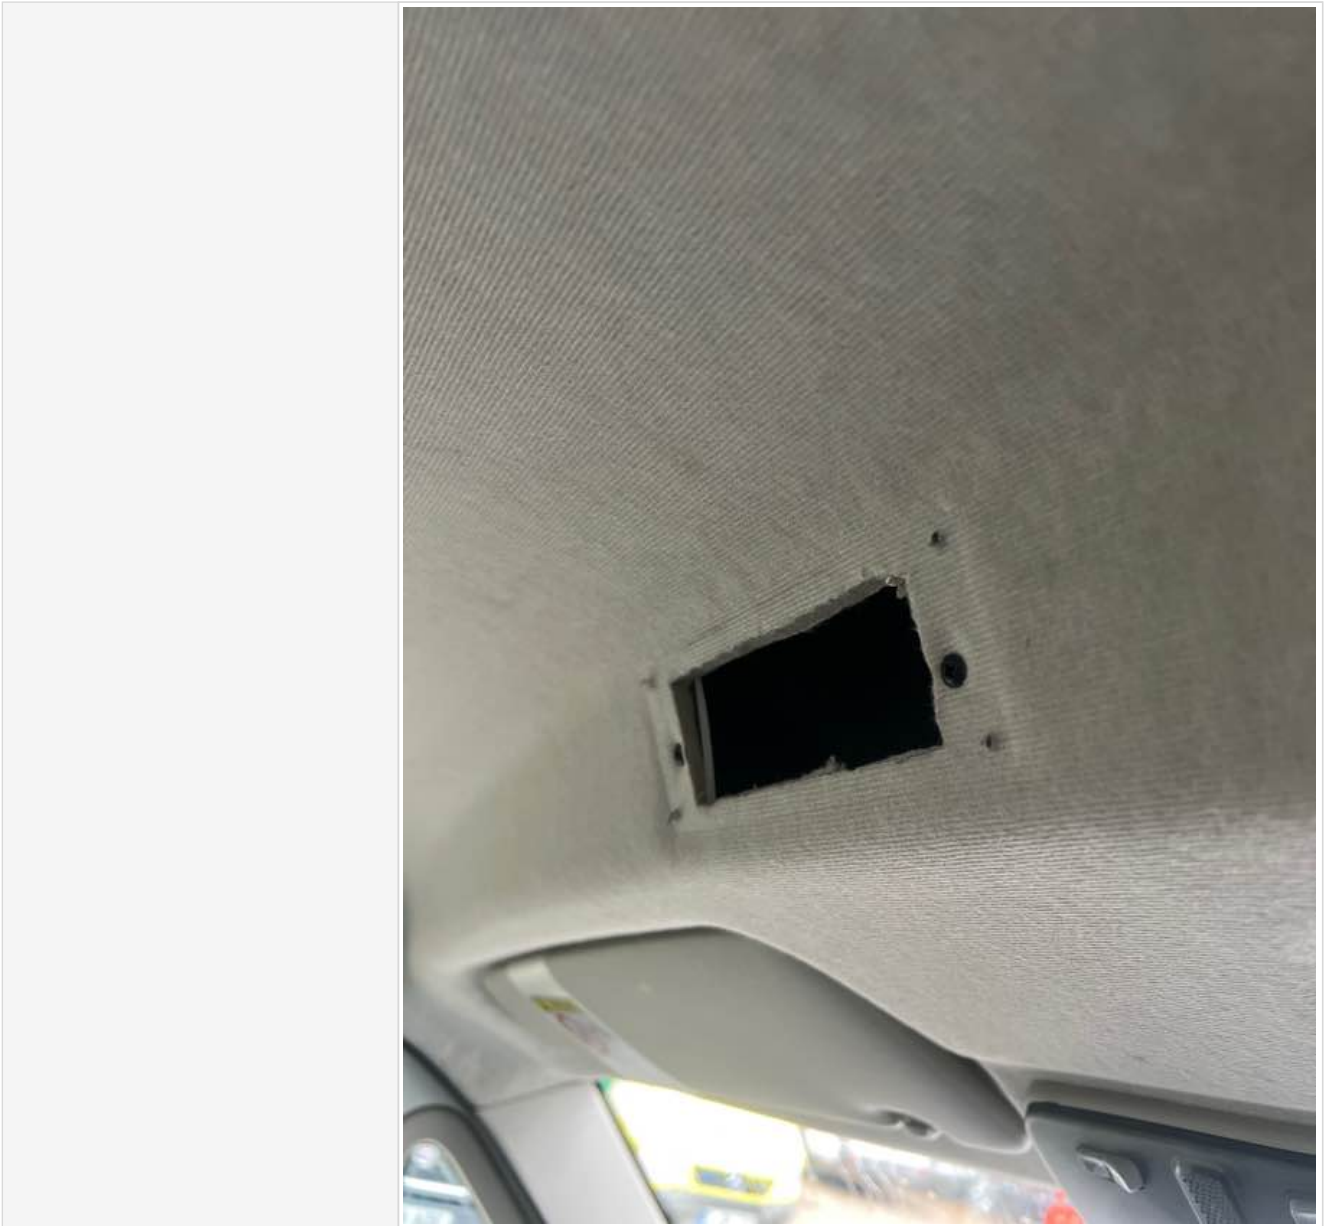
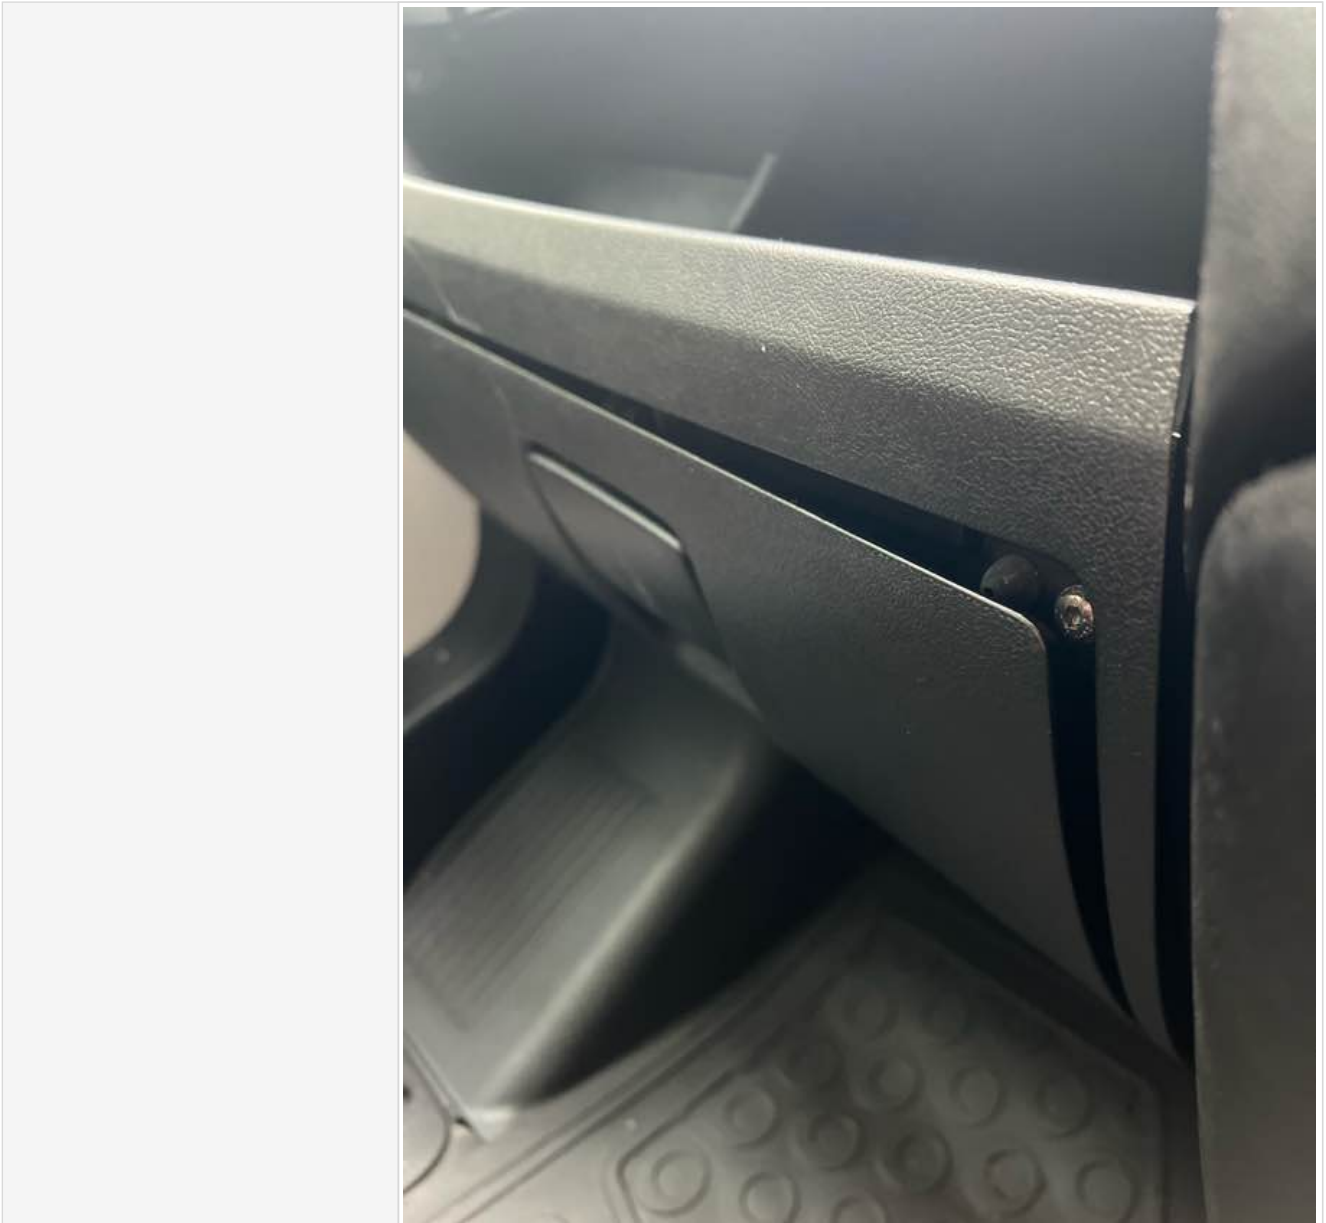
Electric windows present	Yes
Cab windows function check	Passenger side function, Driver side function
Air conditioning present	No
Charging socket present (cigarette lighter)	Yes
Function working?	Yes
Radio / Media system fitted?	Yes
Radio / media system check	Functions
Reverse camera present?	No
Reverse camera functioning?	N/A
Show any damage or missing items

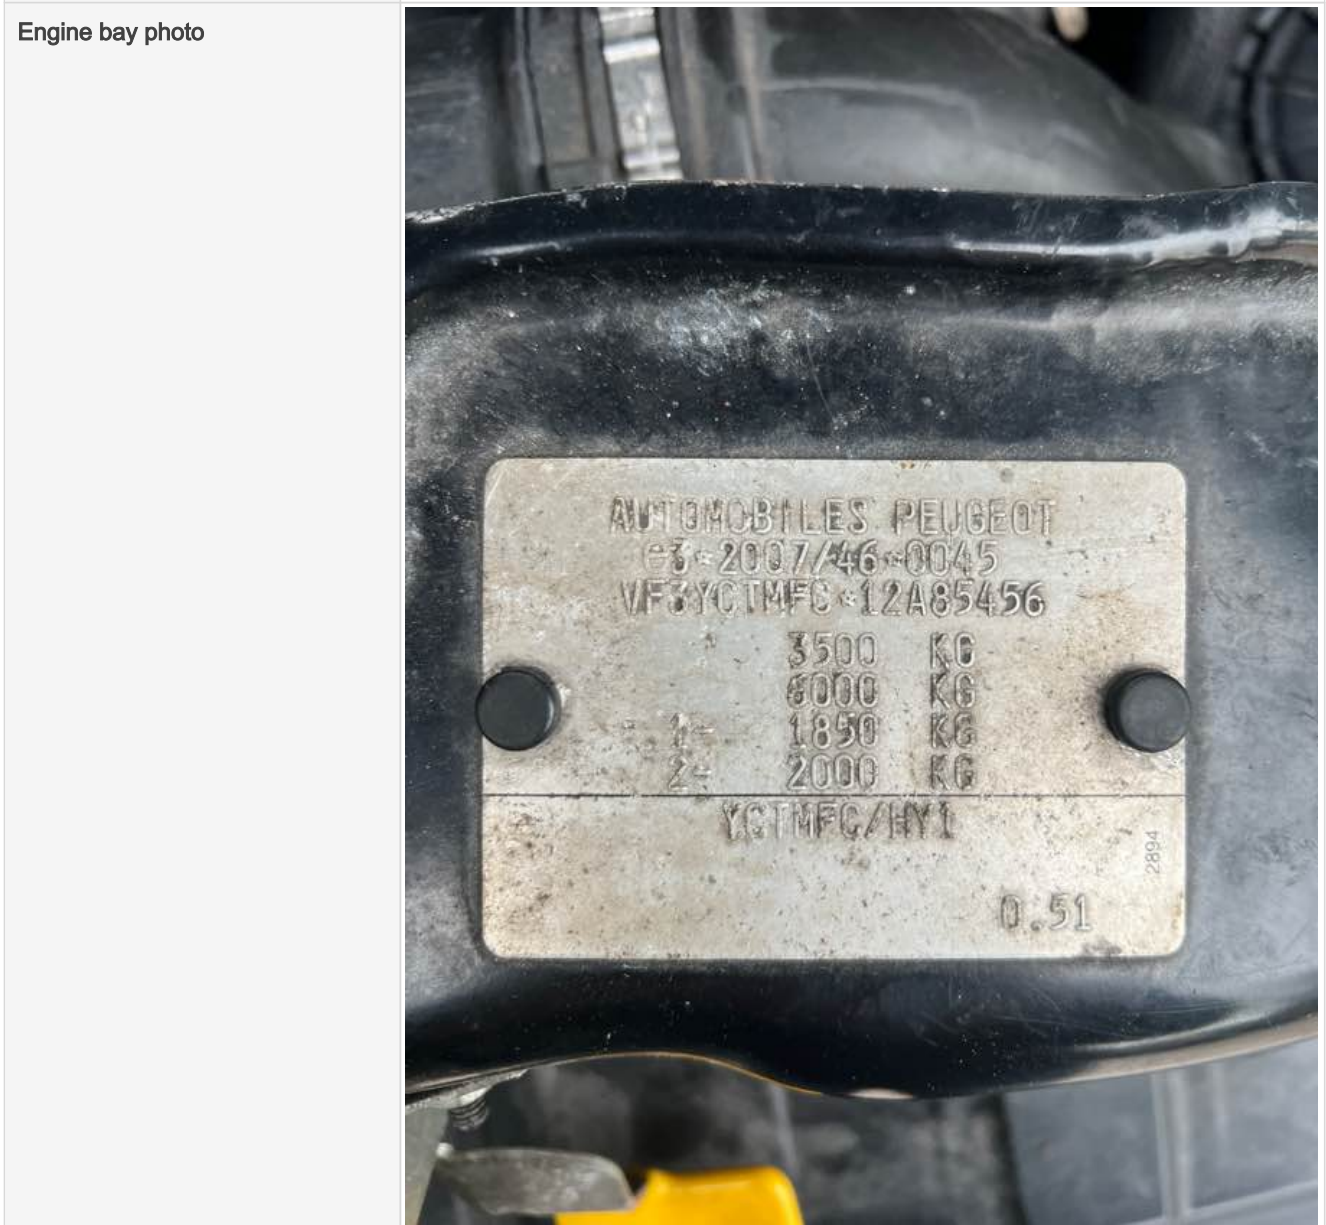
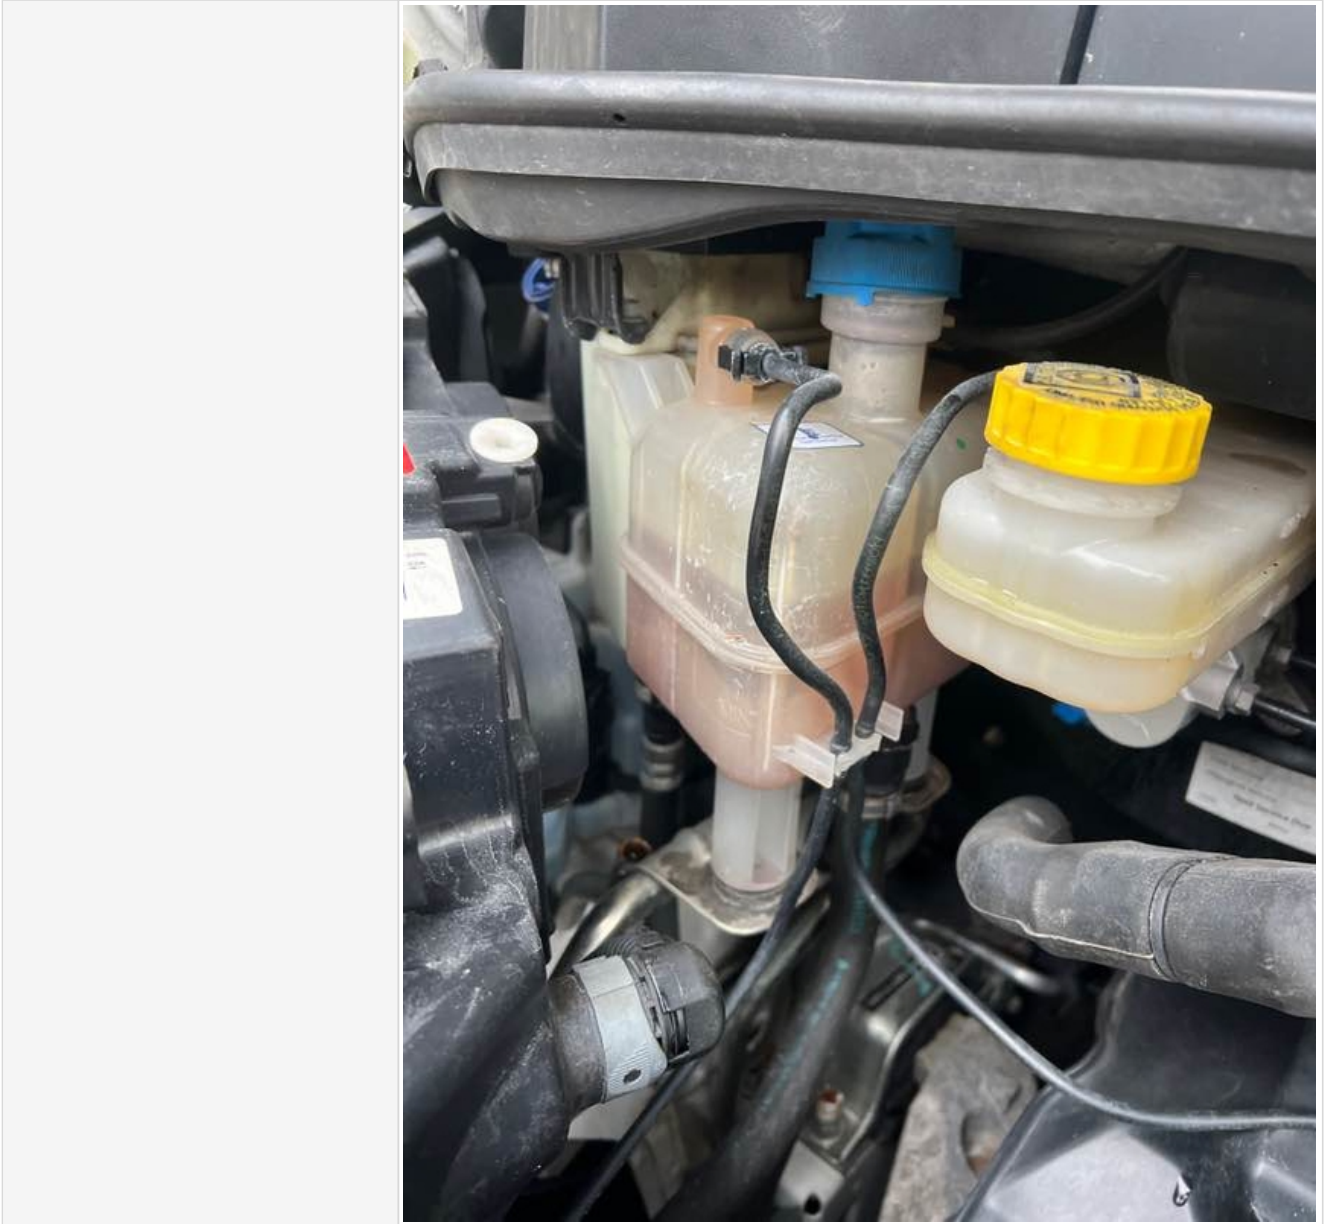
Coolant condition	Clean
Coolant level	Full
Anti-freeze temperature check	-15
Washer fluid	Medium, And now topped up to correct level
Brake fluid	Medium
Power steering fluid	Maximum
Dashboard warning light	
OBD Scan results

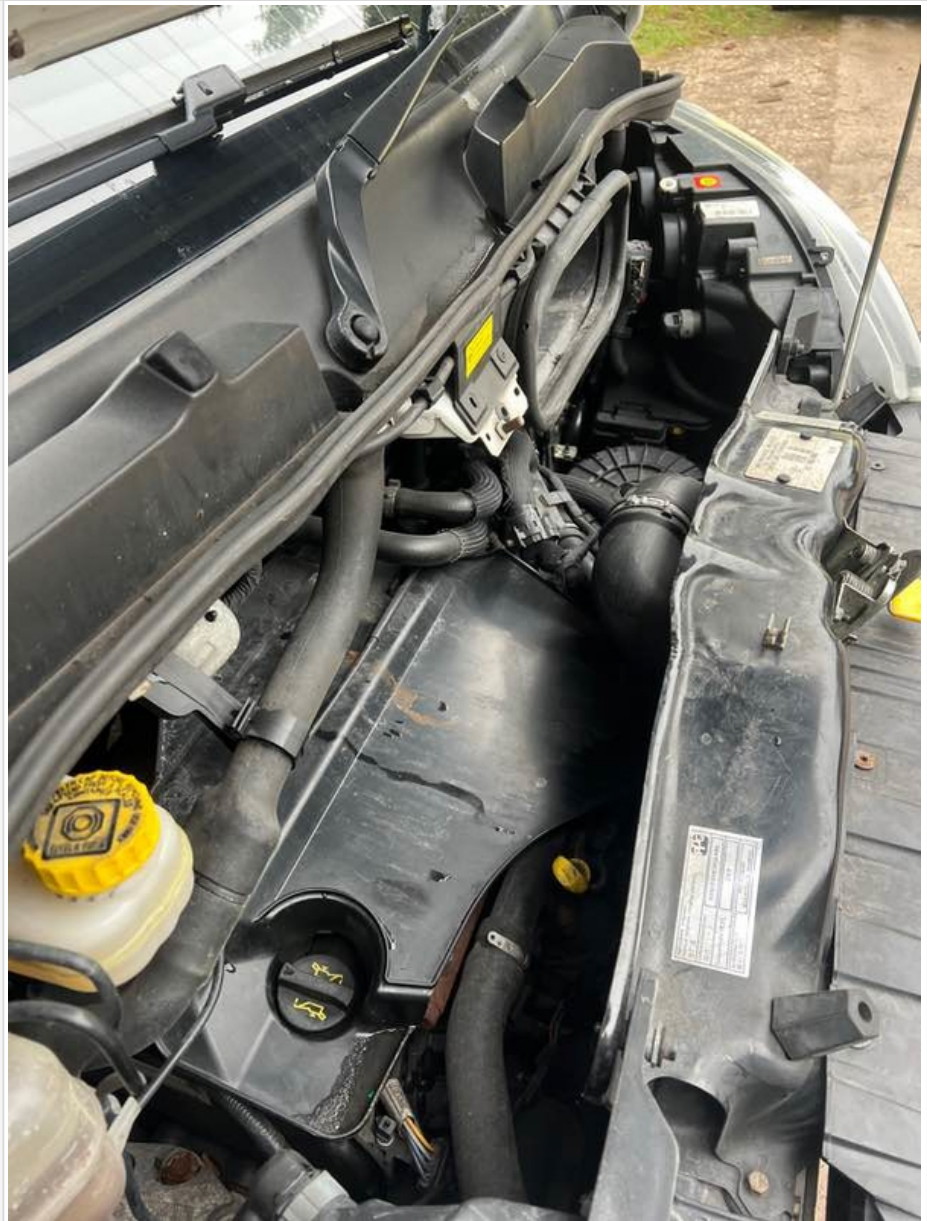
No Adblue present on vehicle
