Basevan.com General Inspection

Vehicle registration	VE51KKU
Vehicle chassis no.	VN1F9CCJ523002429
Miles (if in km, multiply by 0.62)	115325
Make	Vauxhall
Model	Movano
Transmission	5 speed
Factory immobiliser installed	Yes
Speed limiter installed	No
Drive configuration	FWD
Gross Vehicle Weight (kg)	3500
Towing capacity	2060
Tow bar installed	No

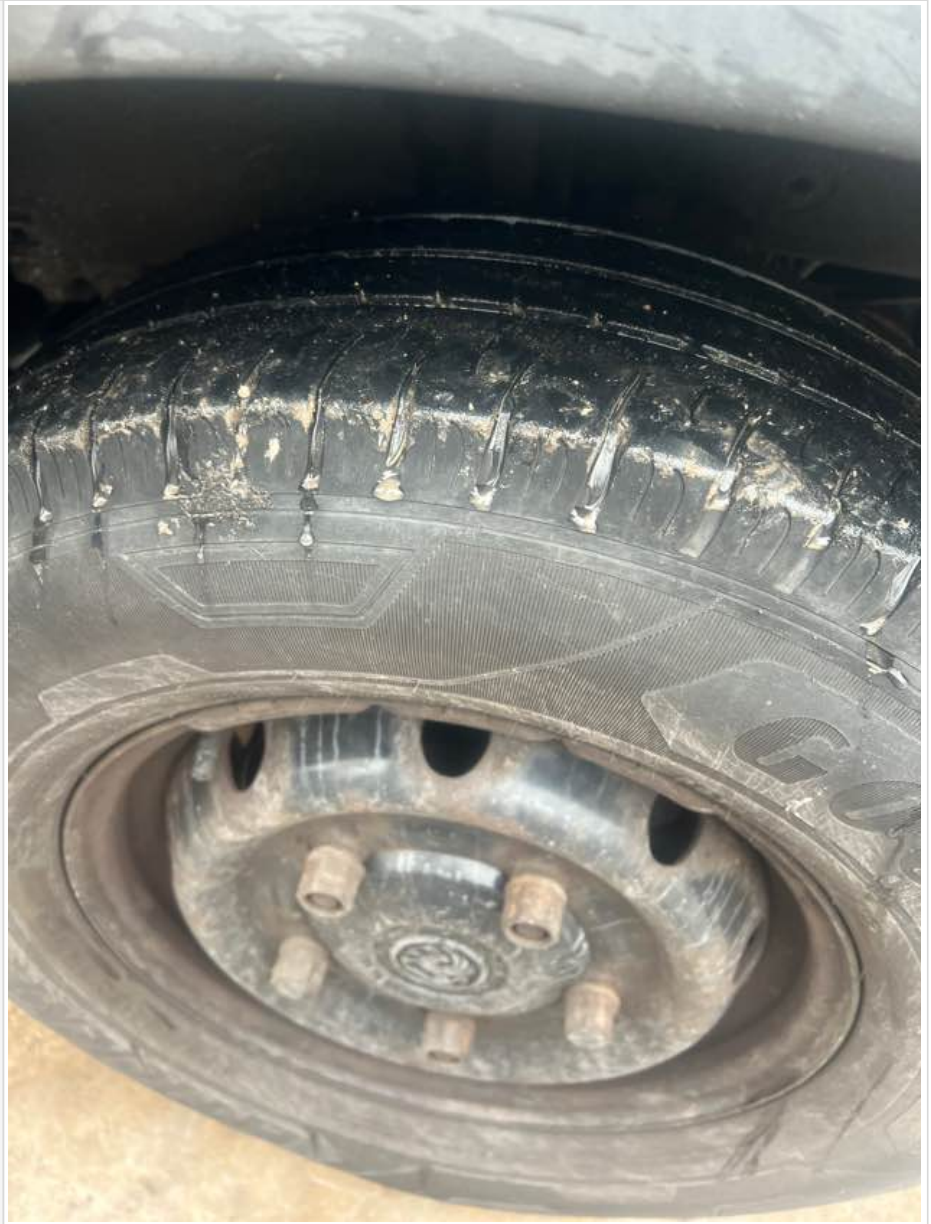
Off side front

Age (month/year) Manufactured	0617
Make, brand.	Good Year
Tyre size	Not here (see comment)
Pressure 1	
Pressure 2	
Wearing / Perishing (inner)	Slight
Wearing / Perishing (outer)	Slight
tread depth (mm)	
General comments	225/70R15C

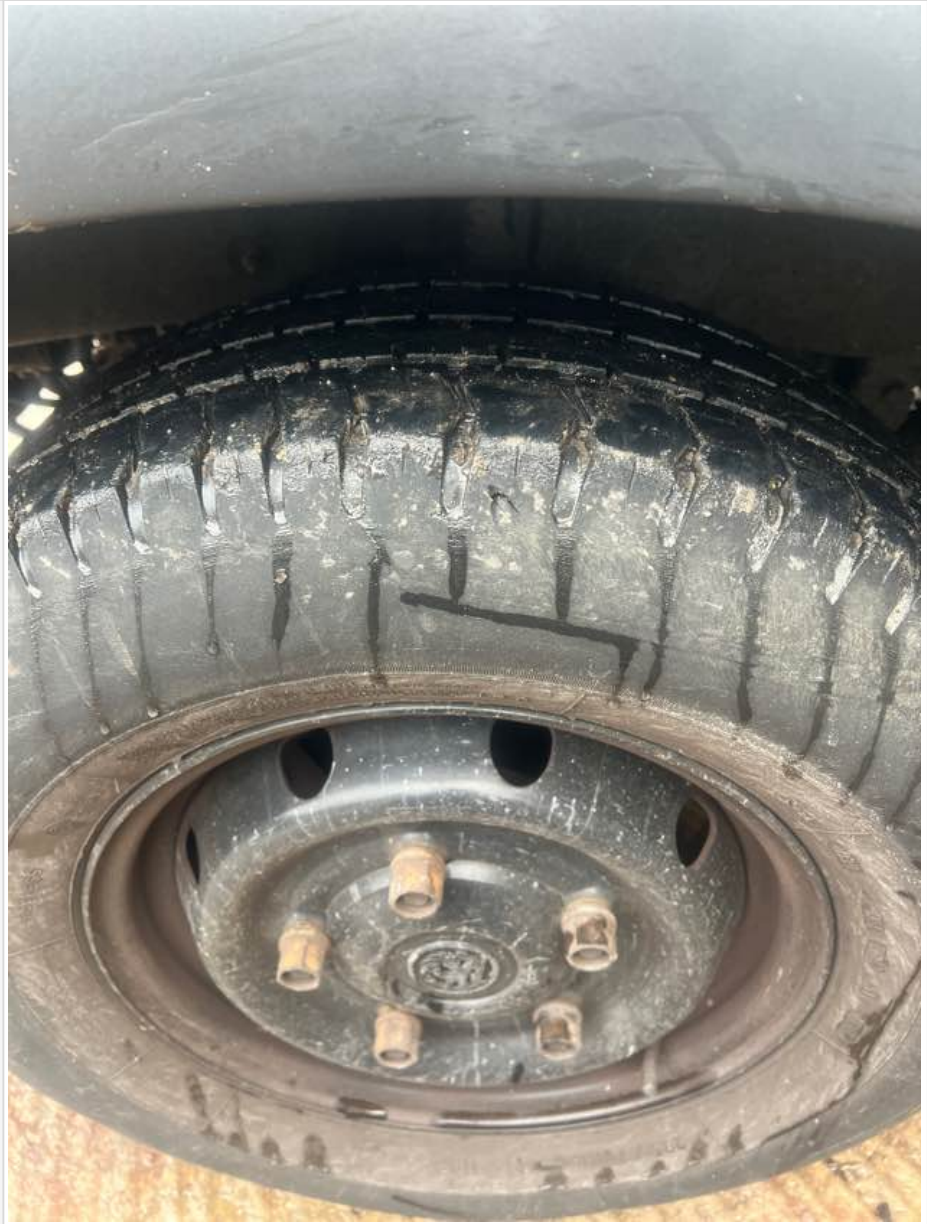
Near side front

Age (month/year) Manufactured	36/10
Make, brand.	Budget
Tyre size	Not here (see comment)
Pressure 1	
Pressure 2	
Wearing / Perishing (inner)	Slight
Wearing / Perishing (outer)	Slight
tread depth (mm)	
General comments	225/70R15C

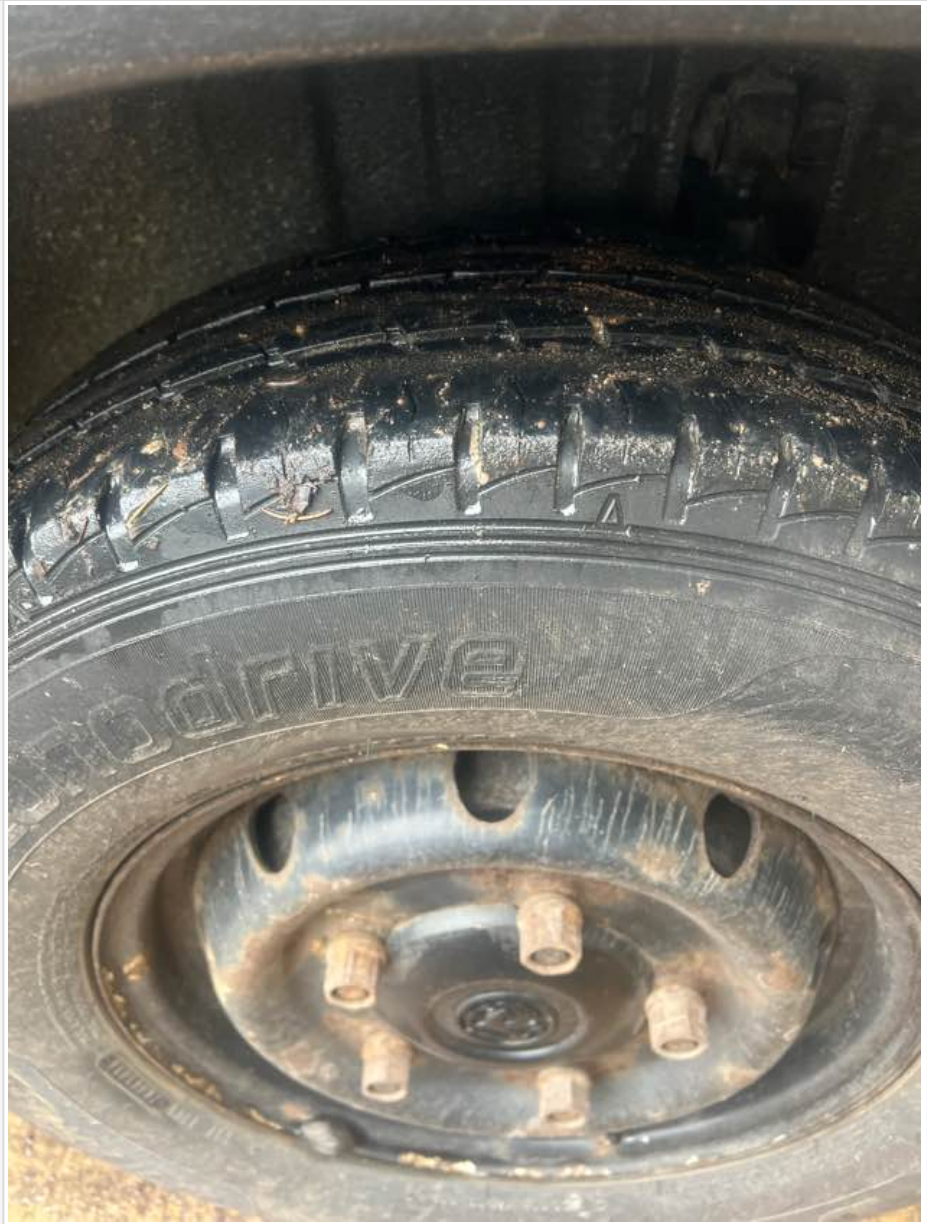
near side rear

Age (month/year) Manufactured	10/16
Make, brand.	Dunlop
Tyre size	Not here (see comment)
Pressure 1	
Pressure 2	
Wearing / Perishing (inner)	Slight
Wearing / Perishing (outer)	Slight
tread depth (mm)	
General comments	225/70R15C

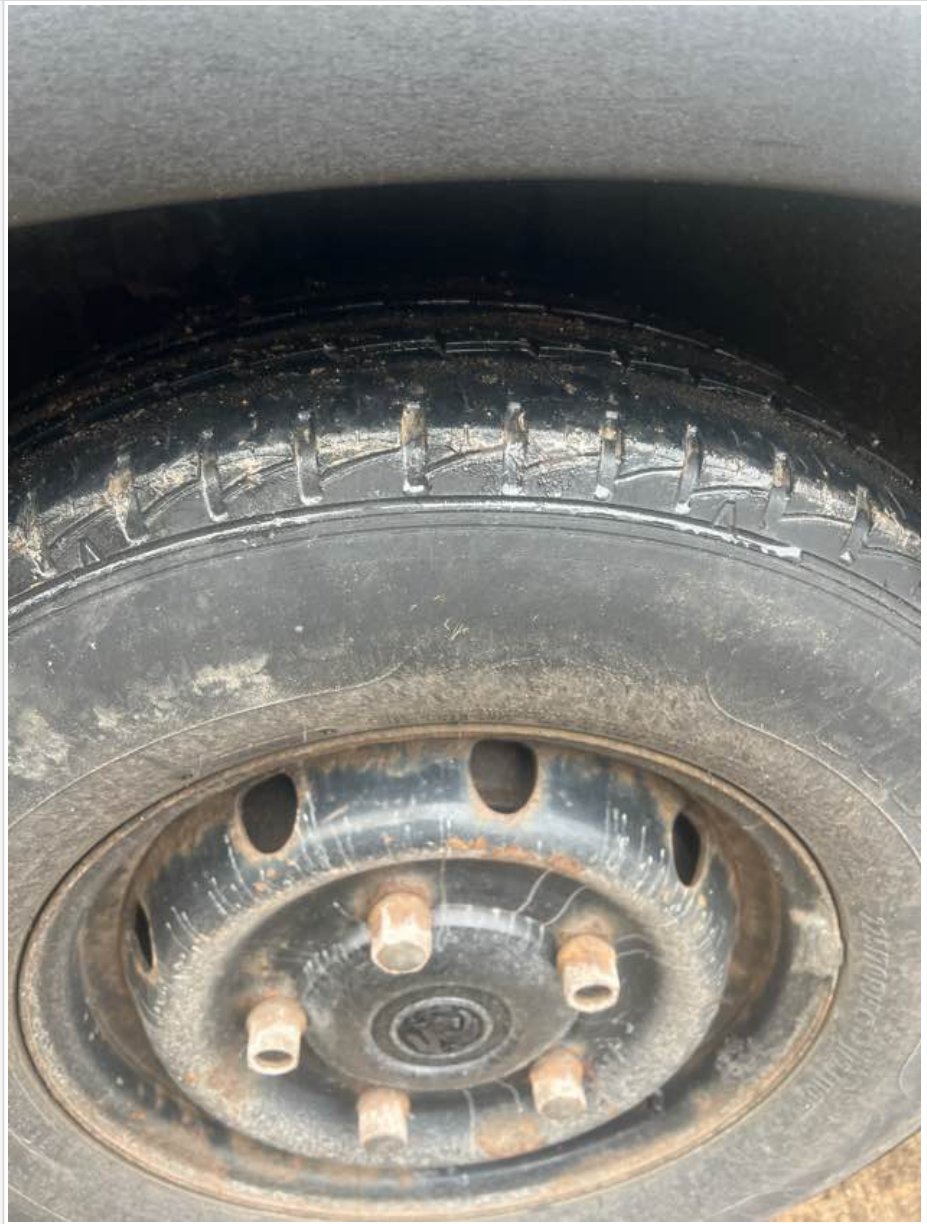
Off side rear

Age (month/year) Manufactured	35/15
Make, brand.	Dunlop
Tyre size	Not here (see comment)
Pressure 1	
Pressure 2	
Wearing / Perishing (inner)	Slight
Wearing / Perishing (outer)	Slight
tread depth (mm)	
General comments	225/70R15C

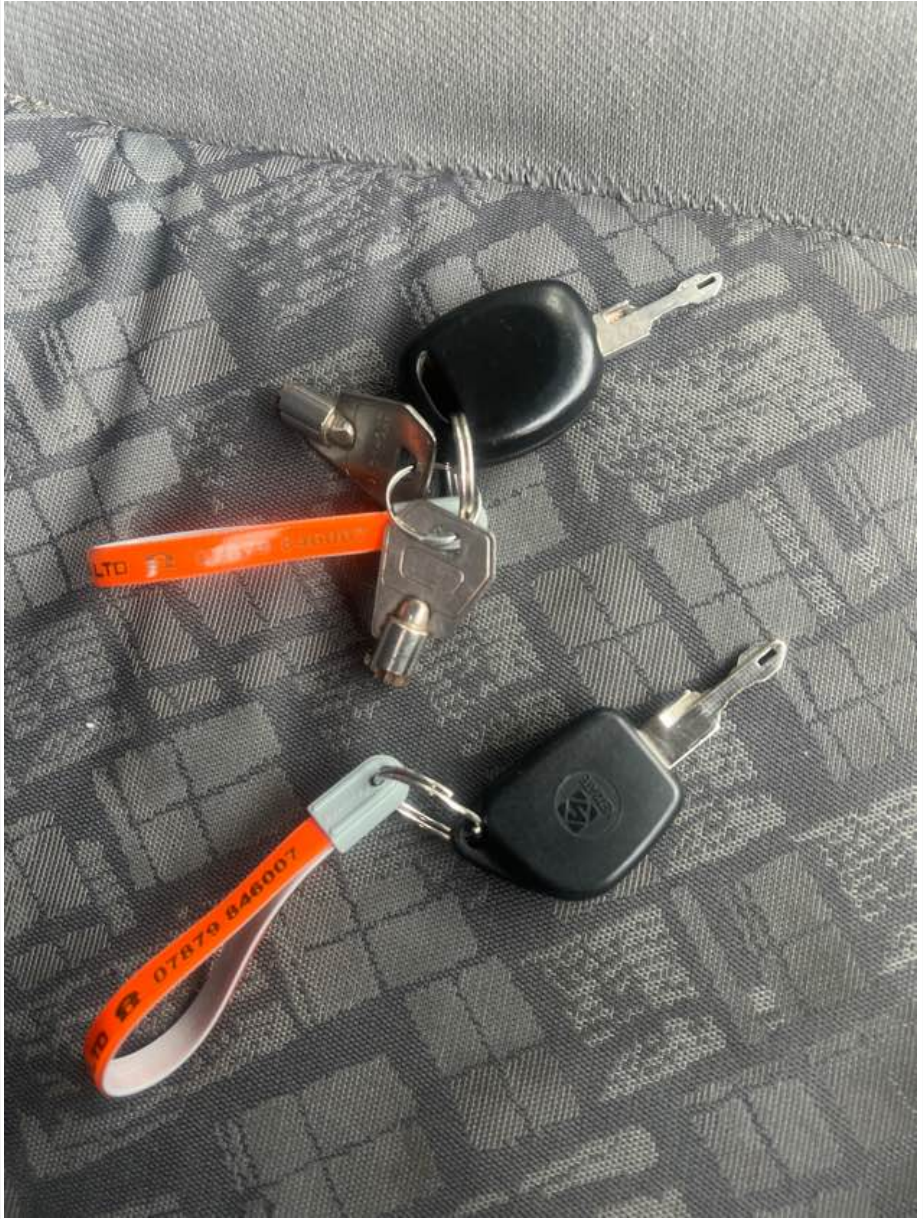
Comment	Two keys. Drivers side door cannot be unlocked with the key from the outside.

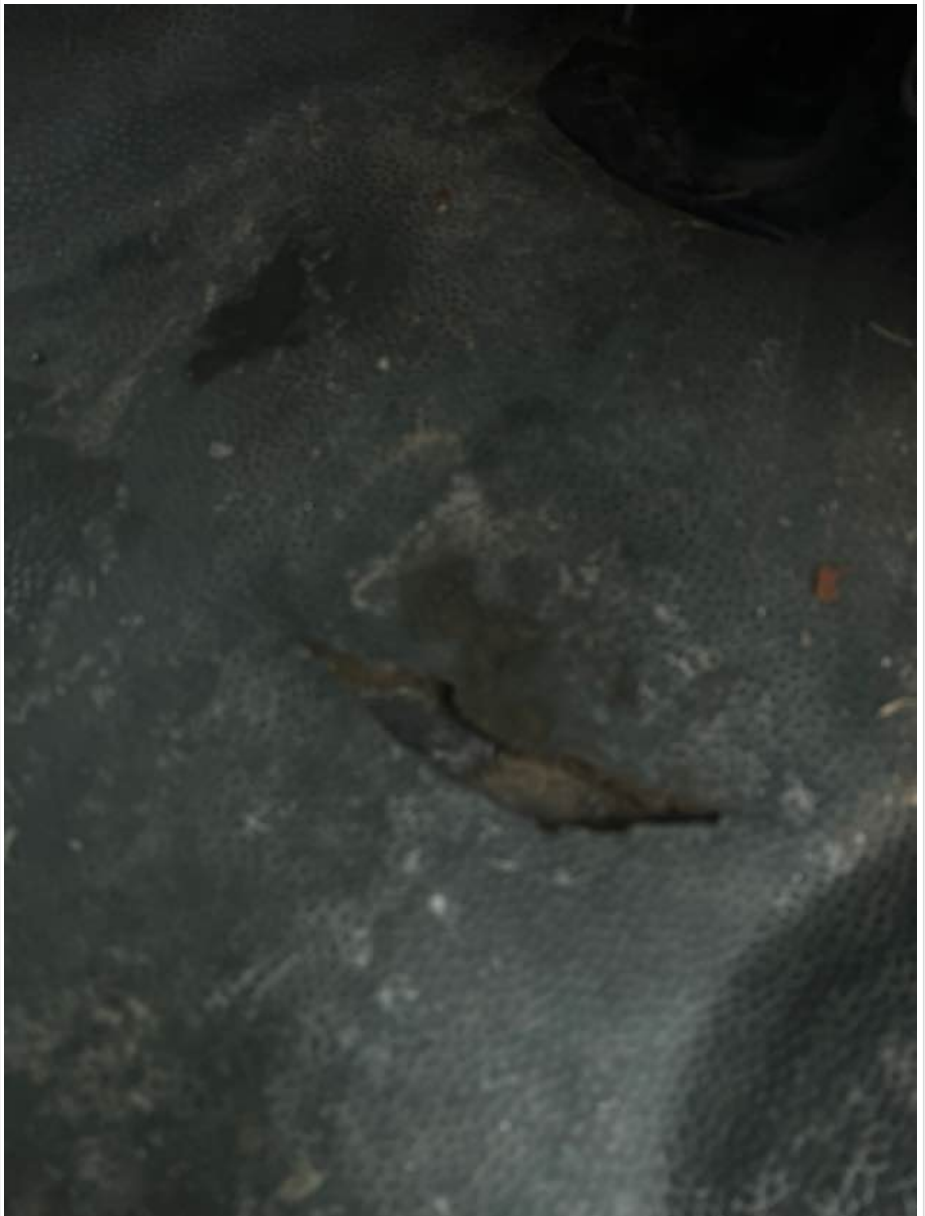
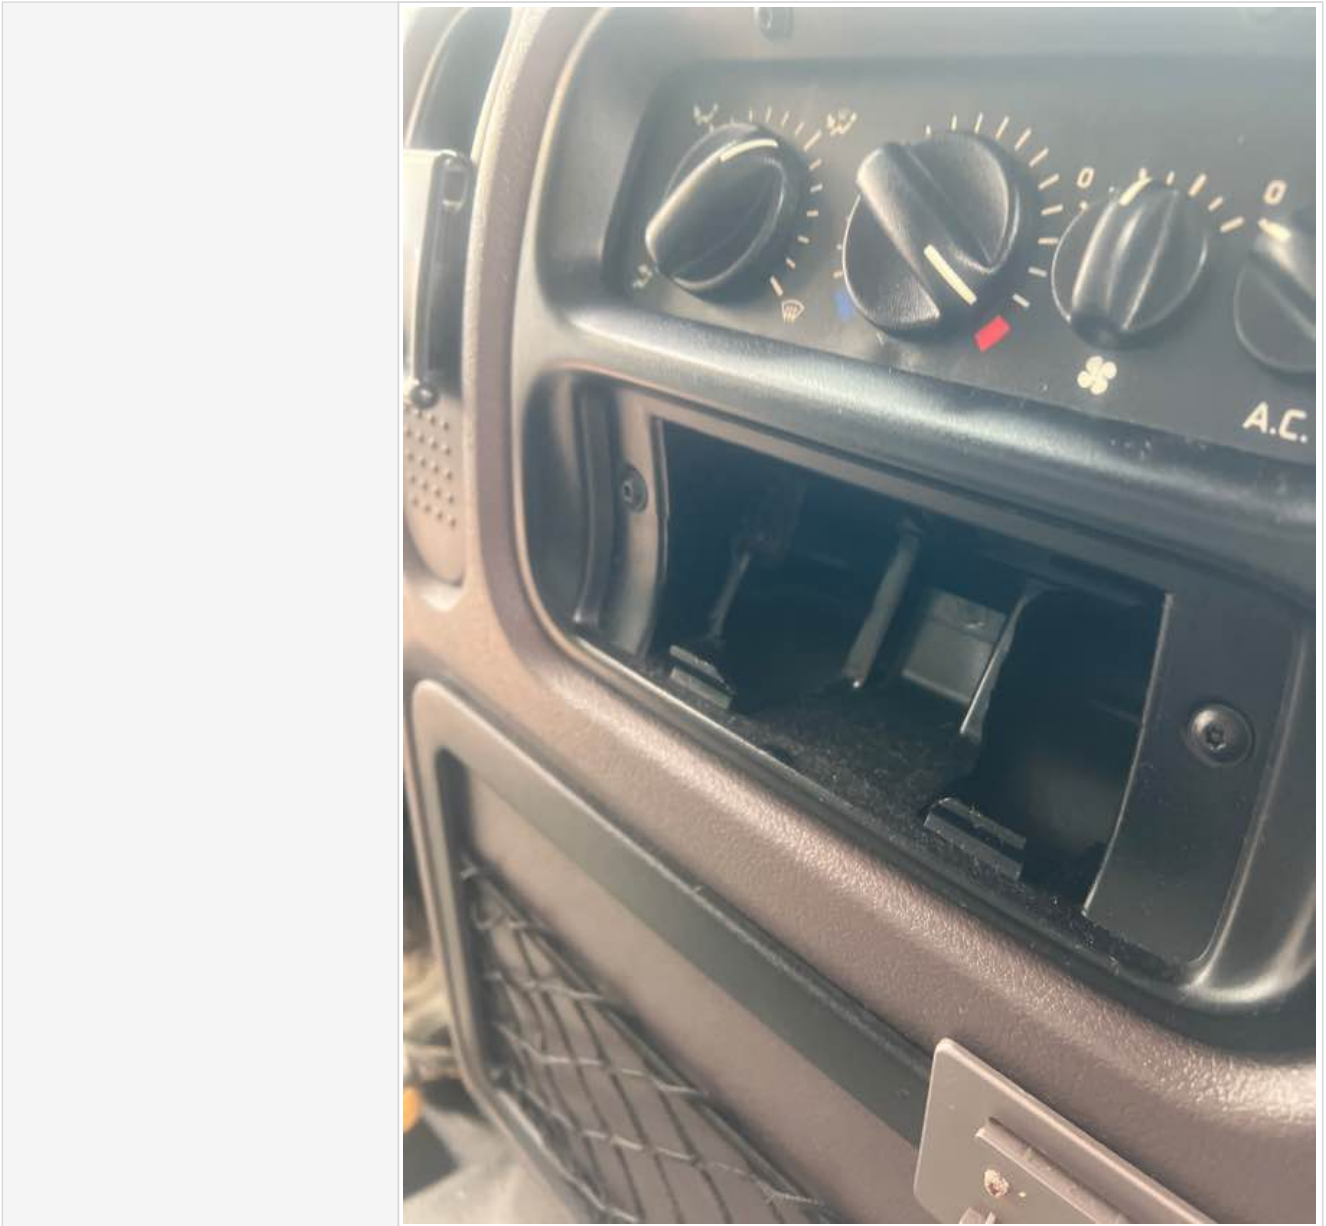
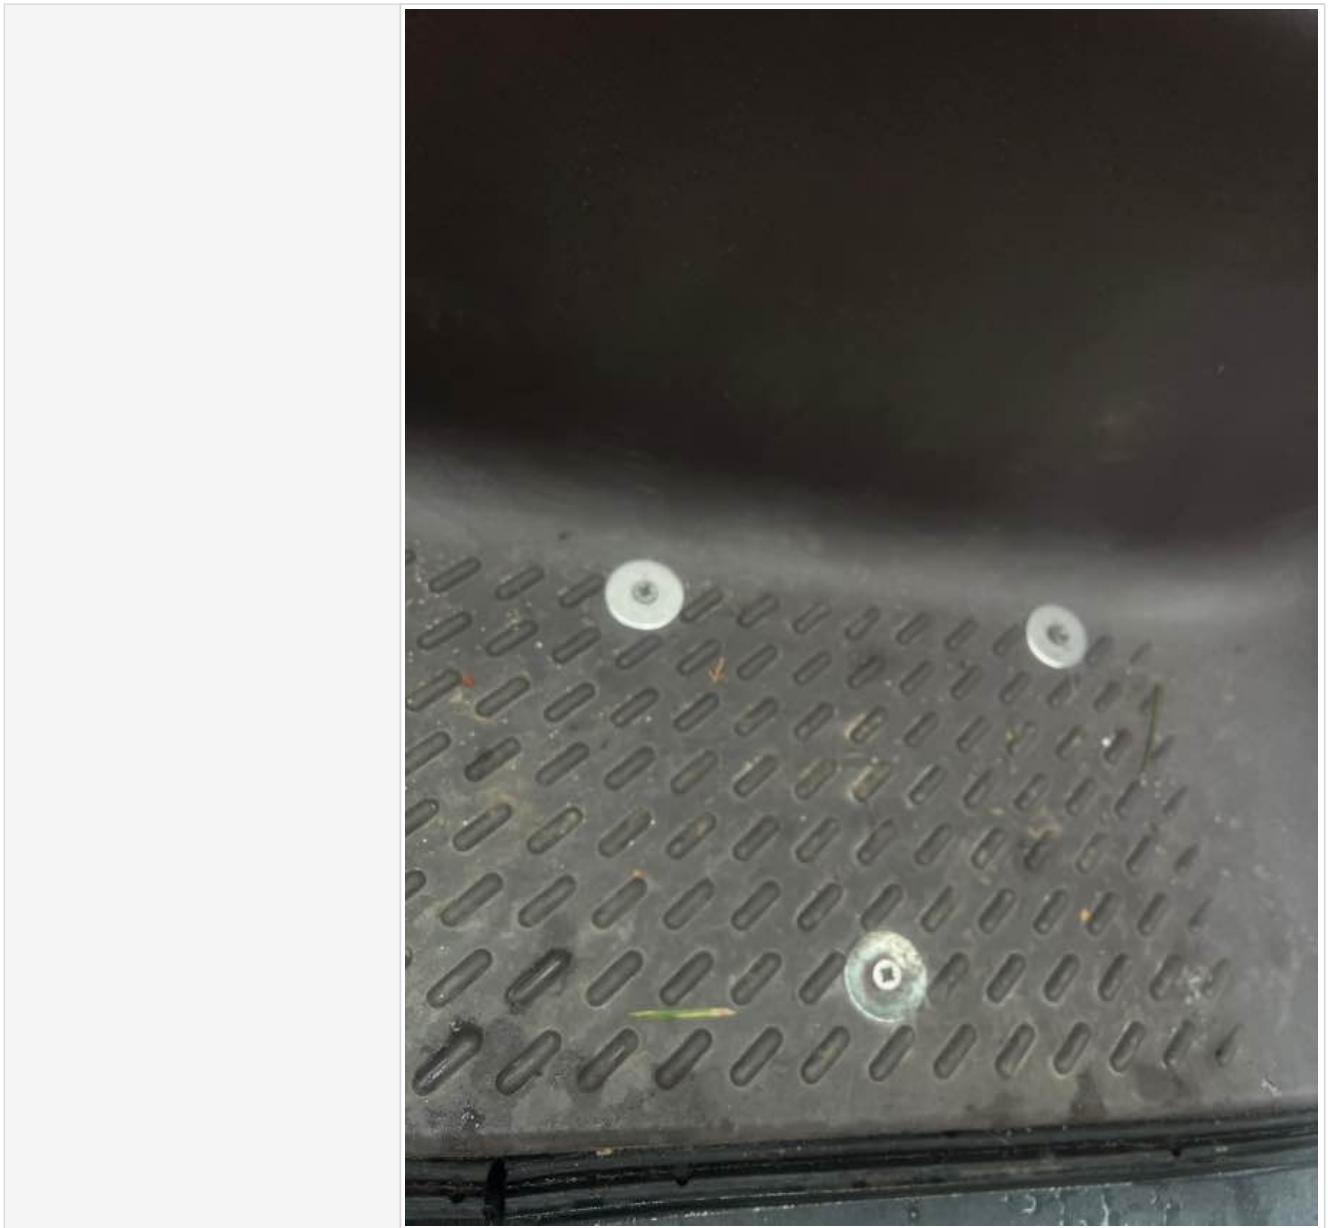
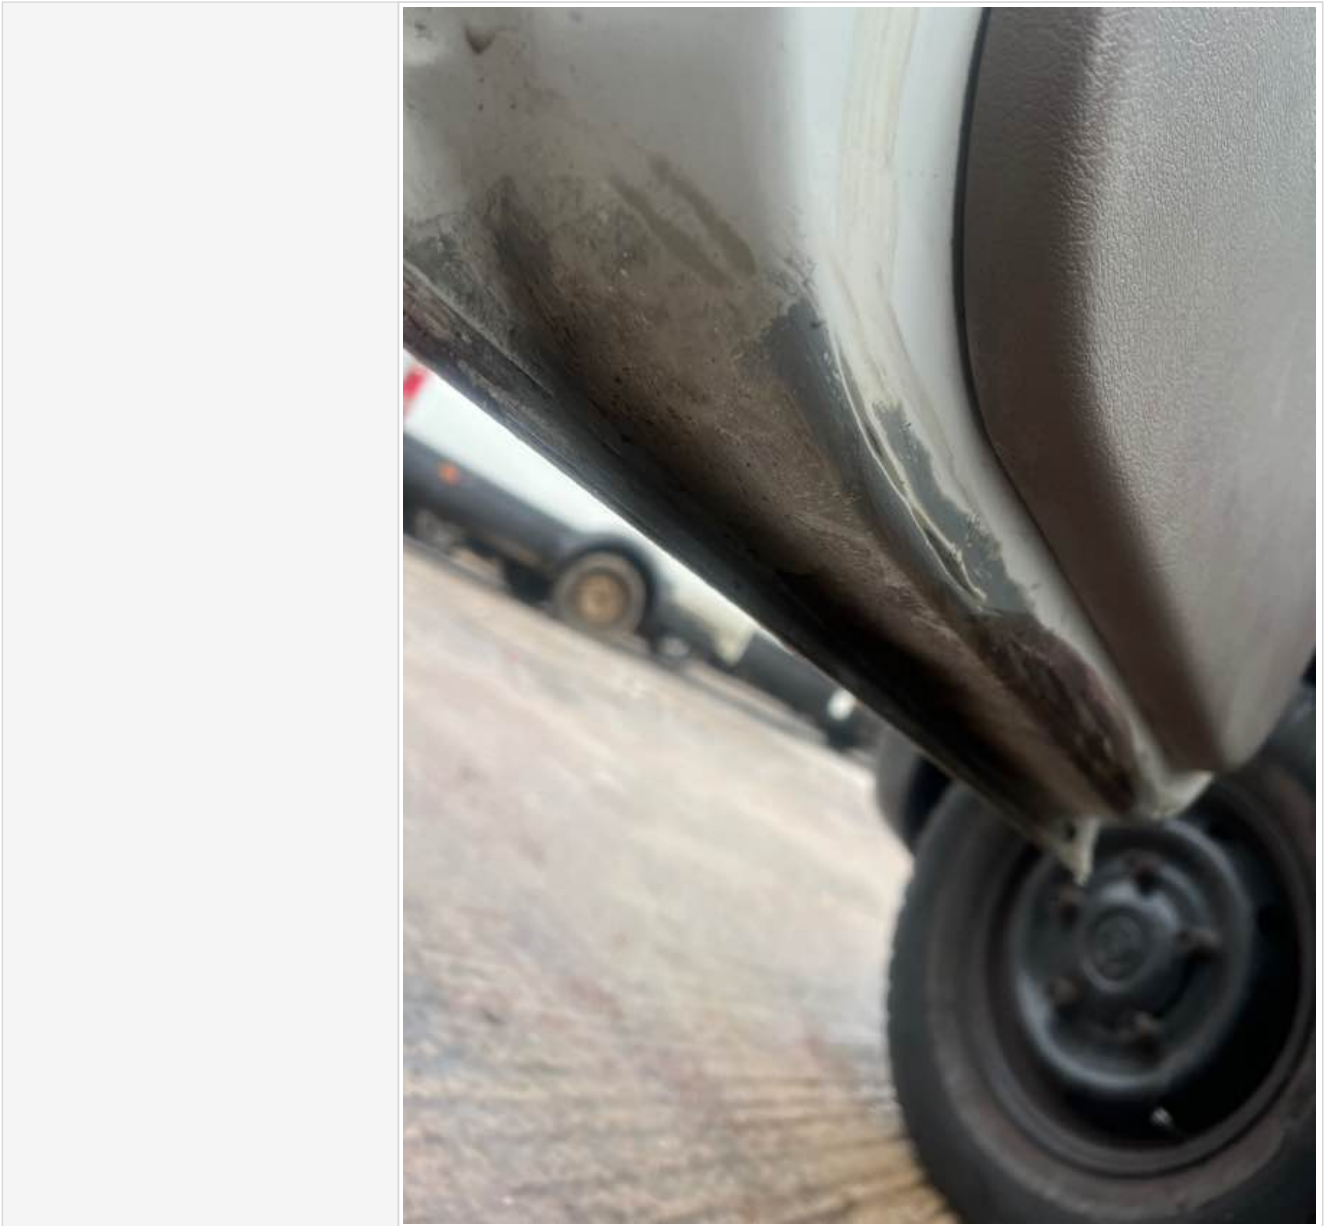
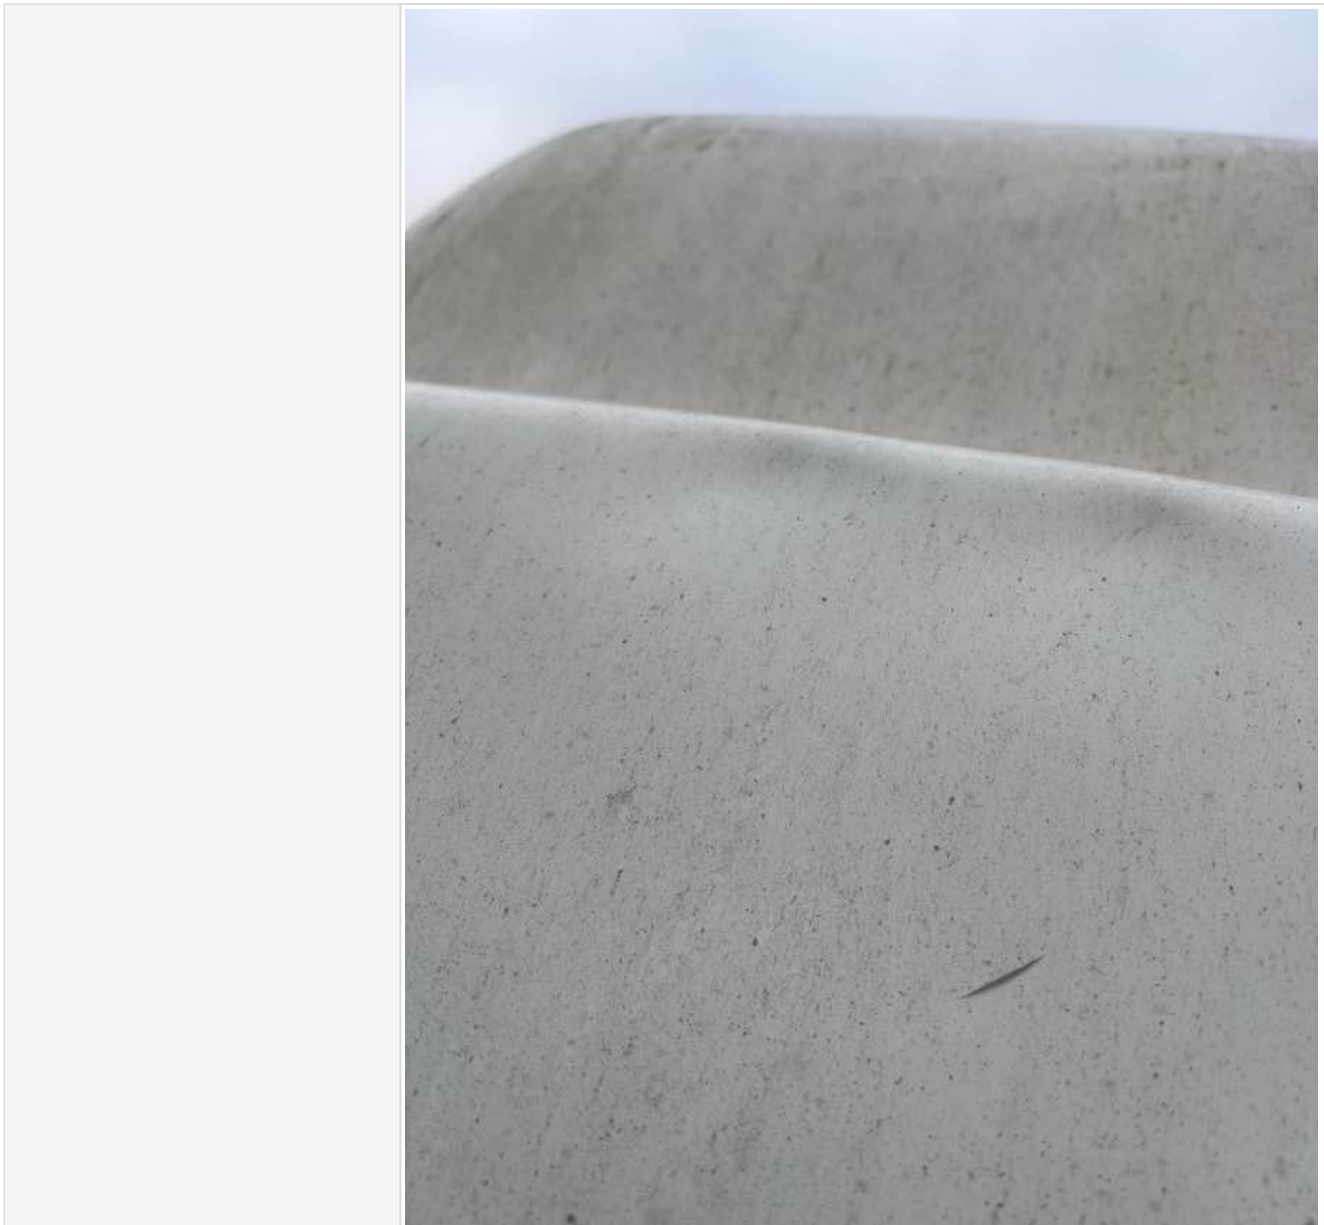
Electric windows present	Yes
Cab windows function check	Driver side function, Passenger side function
Air conditioning present	Yes
Charging socket present (cigarette lighter)	Yes
Function working?	Yes
Radio / Media system fitted?	Yes
Radio / media system check	Requires code
Reverse camera present?	No
Reverse camera functioning?	N/A
Show any damage or missing items

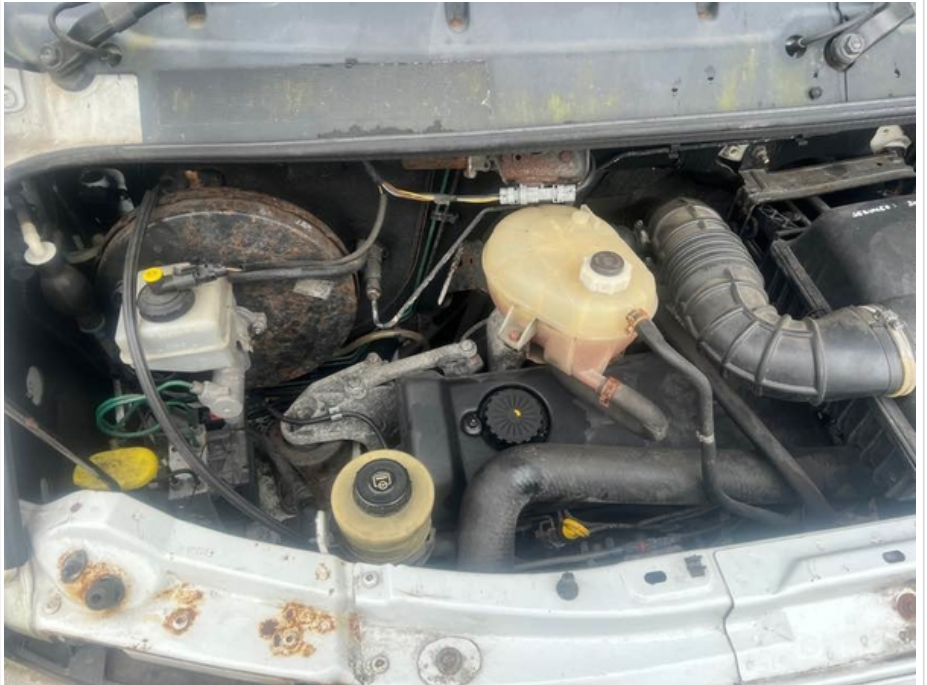
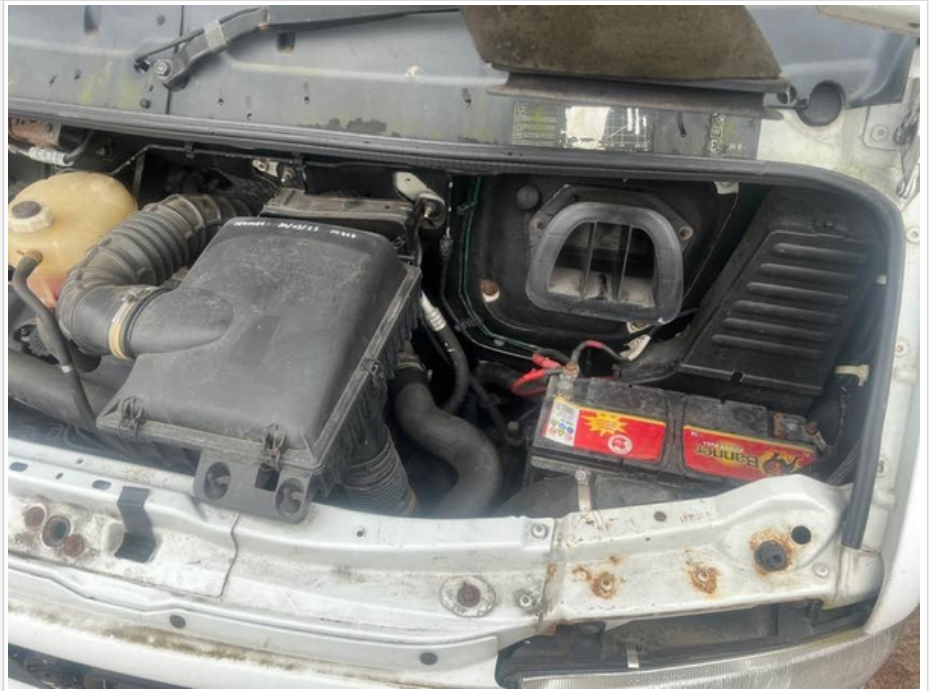
Coolant condition	Clean
Coolant level	Medium
Anti-freeze temperature check	
Washer fluid	Medium
Brake fluid	
Power steering fluid	
Dashboard warning light	No warning lights
OBD Scan results	
Engine bay photo

2.8L Sofim. Could do with a wash off
