## Basevan.com General Inspection

Vehicle registration	PO13DDU
Vehicle chassis no.	XLRAE4FF0L424069
Miles (if in km, multiply by 0.62)	718,536
Make	Daf
Model	Truck
Transmission	Manual, 5 speed
Factory immobiliser installed	Yes
Speed limiter installed	Yes
Drive configuration	RWD
Gross Vehicle Weight (kg)	7500
Towing capacity	N/A
Tow bar installed	No

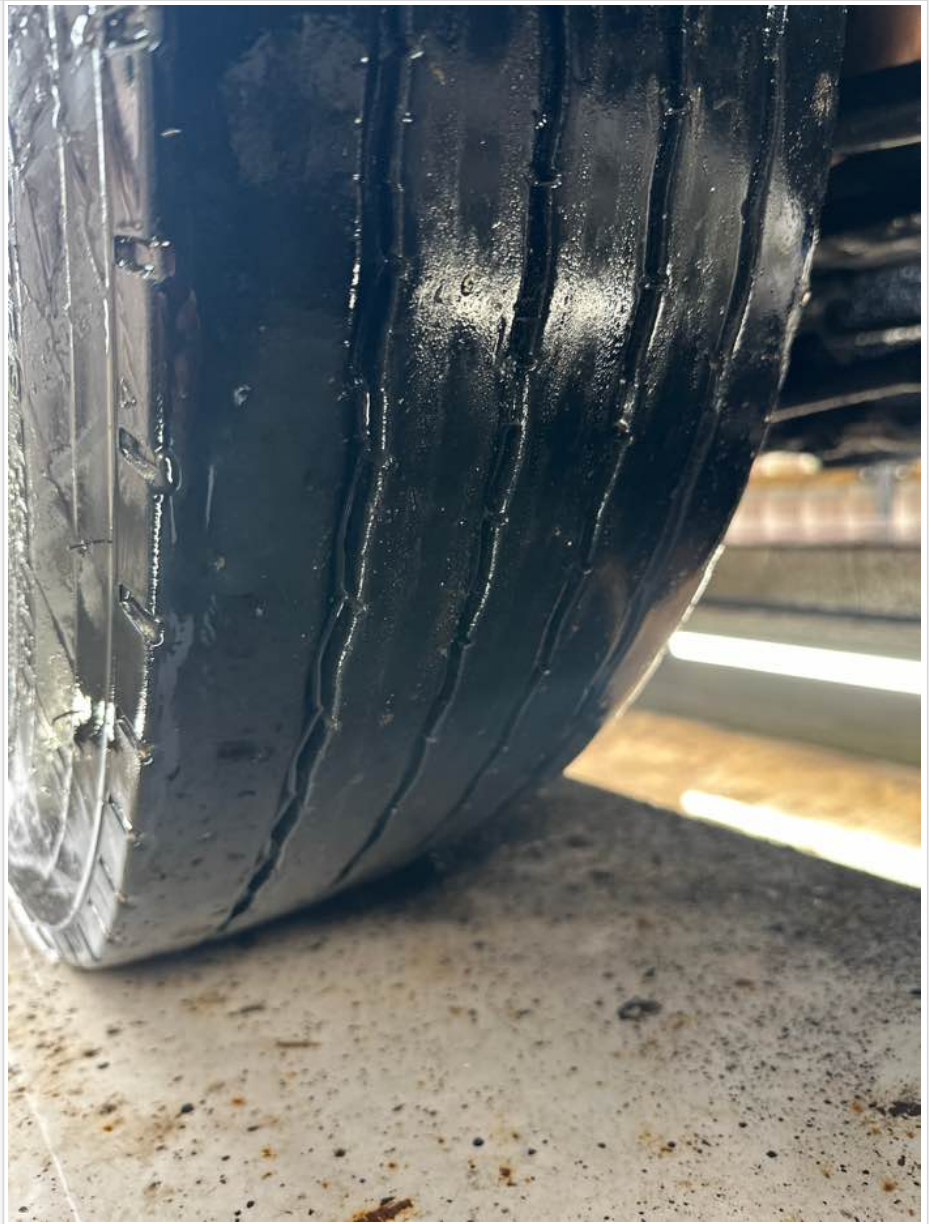
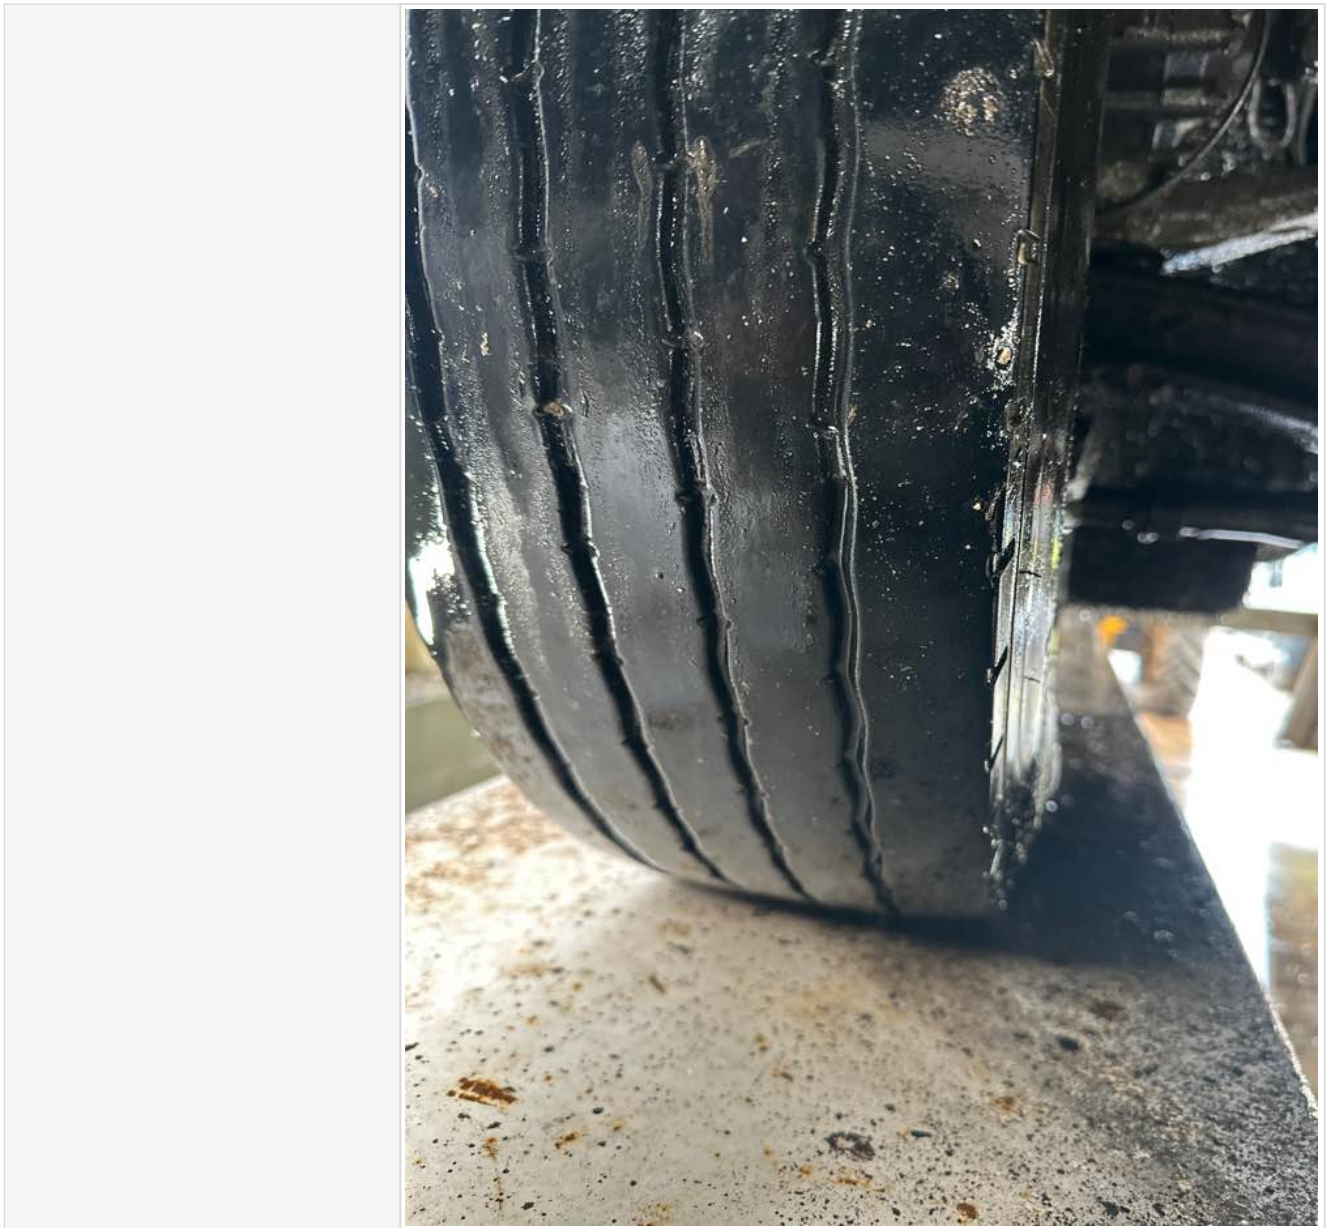
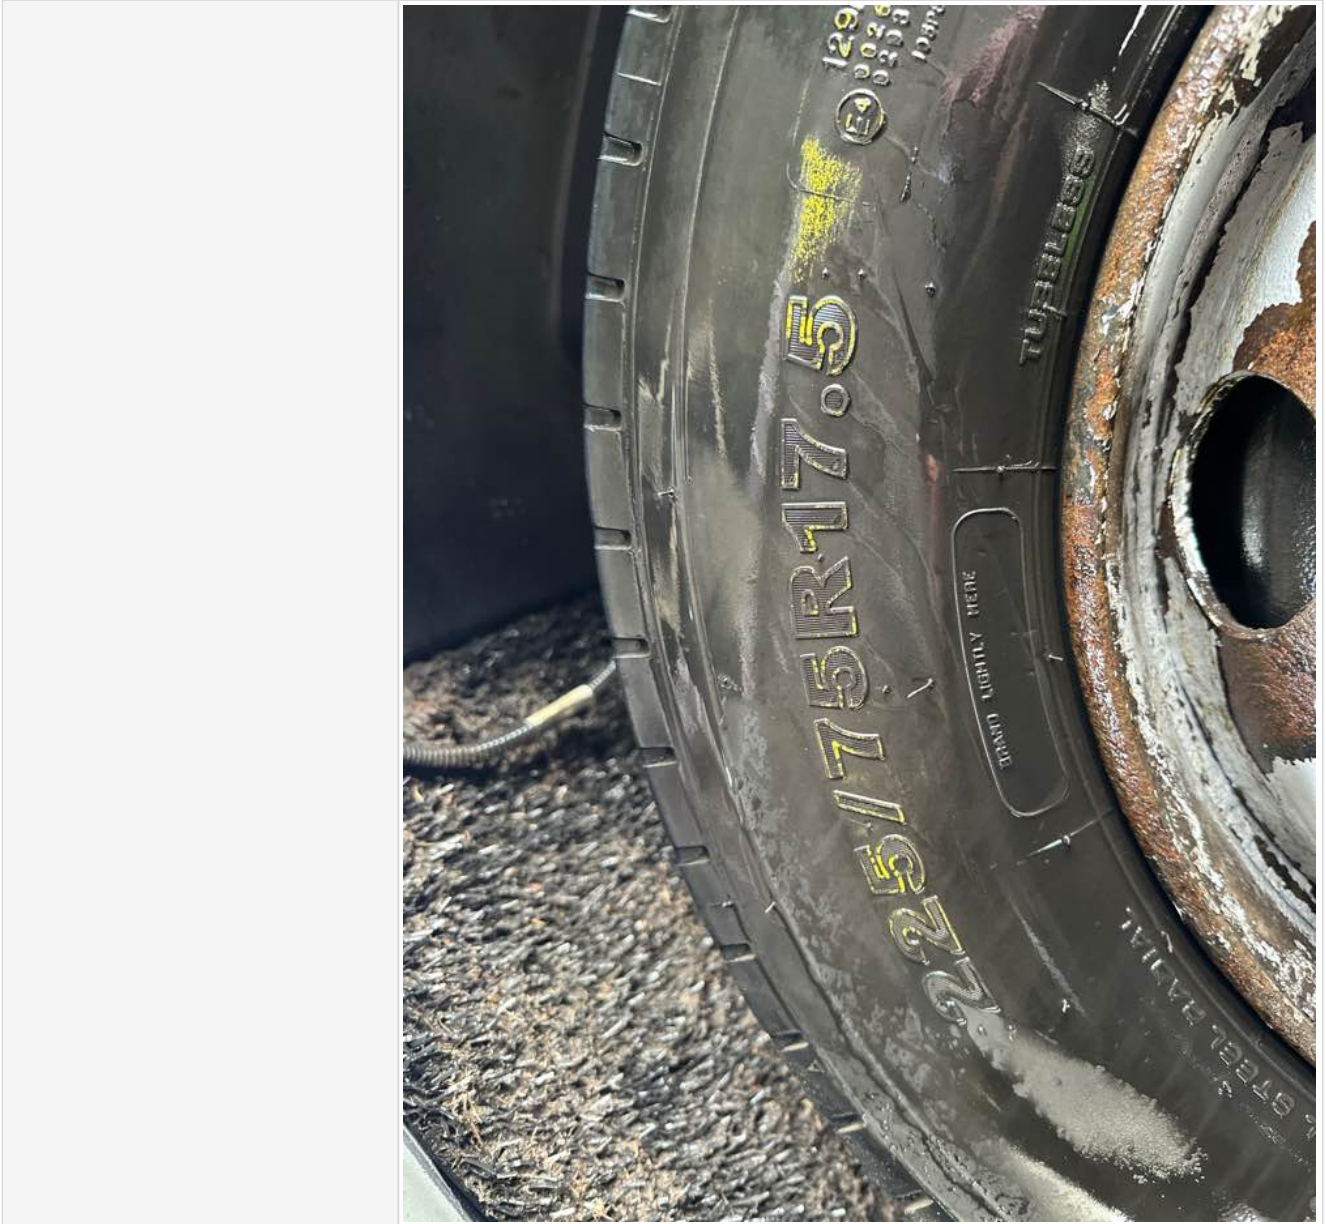
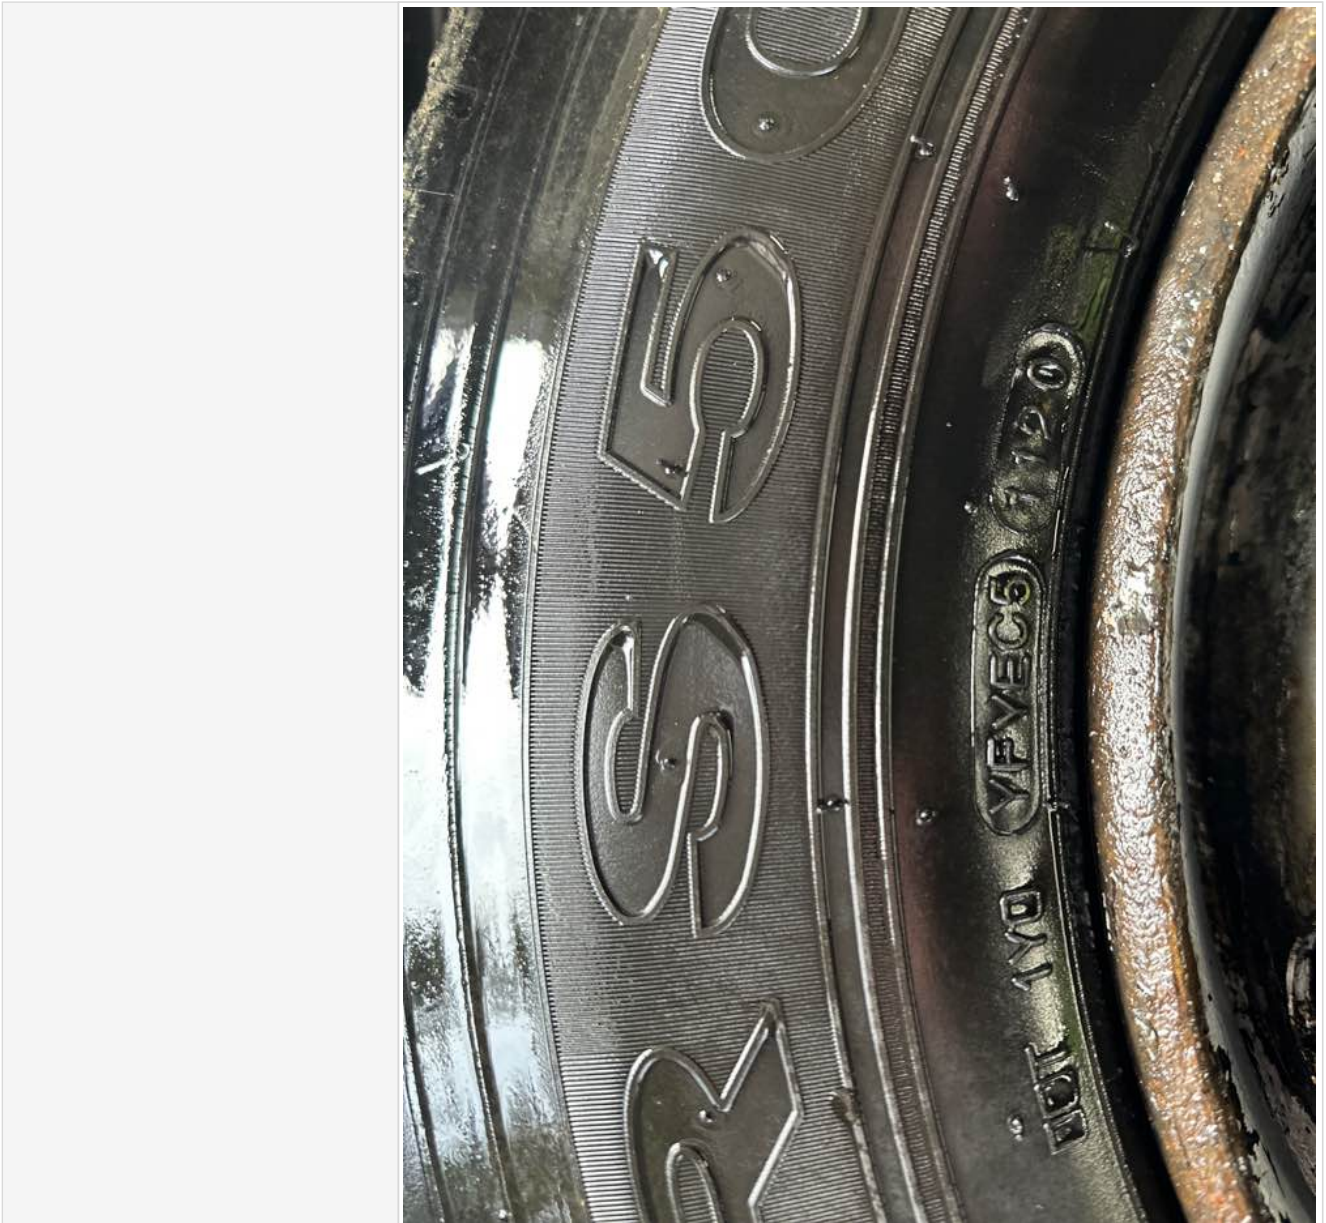
### Off side front

Age (month/year) Manufactured	11/20
Make, brand.	Other (comment)
Tyre size	Not here (see comment)
Pressure 1	98
Pressure 2	
Wearing / Perishing (inner)	Medium
Wearing / Perishing (outer)	Medium
tread depth (mm)	6
General comments	Marshal 225/75R17.5

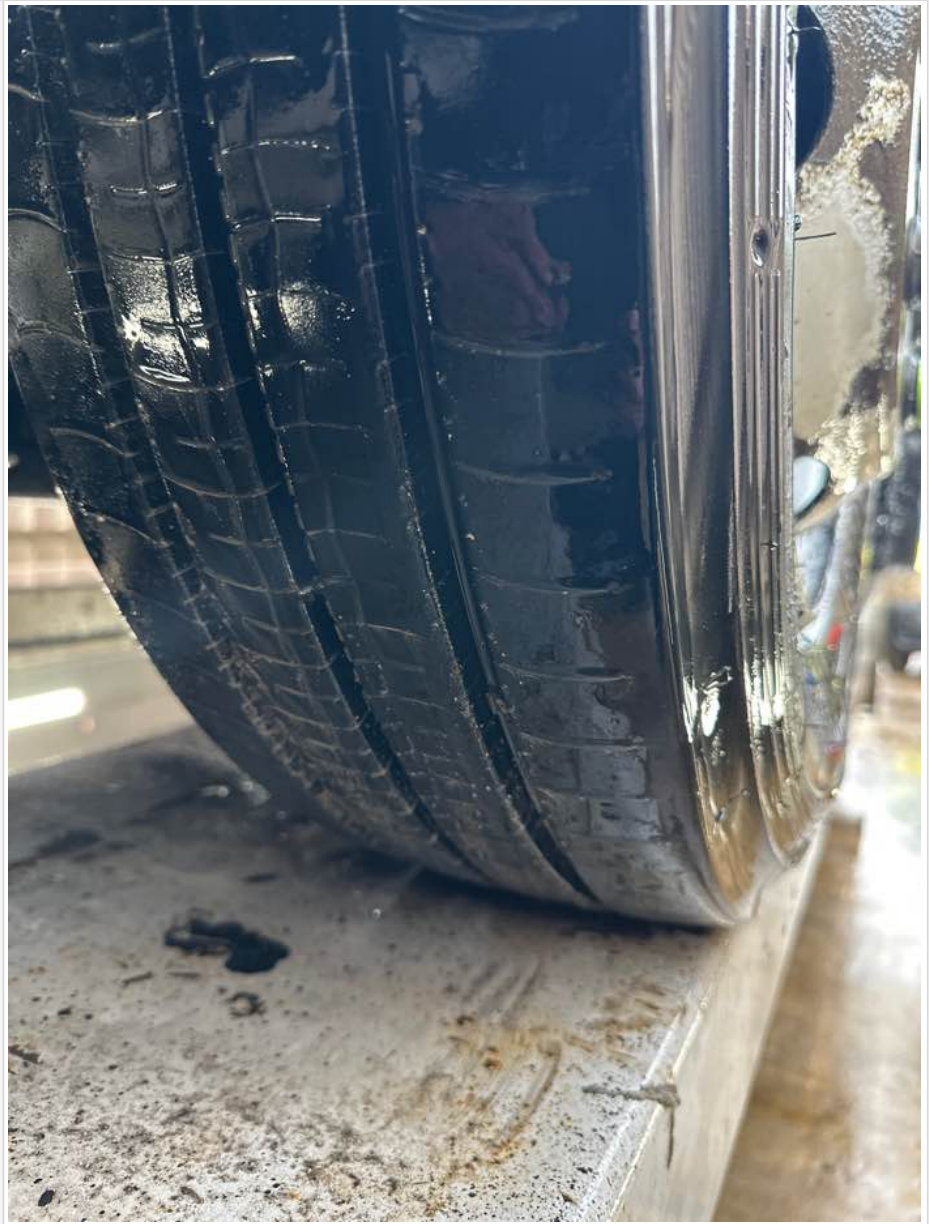
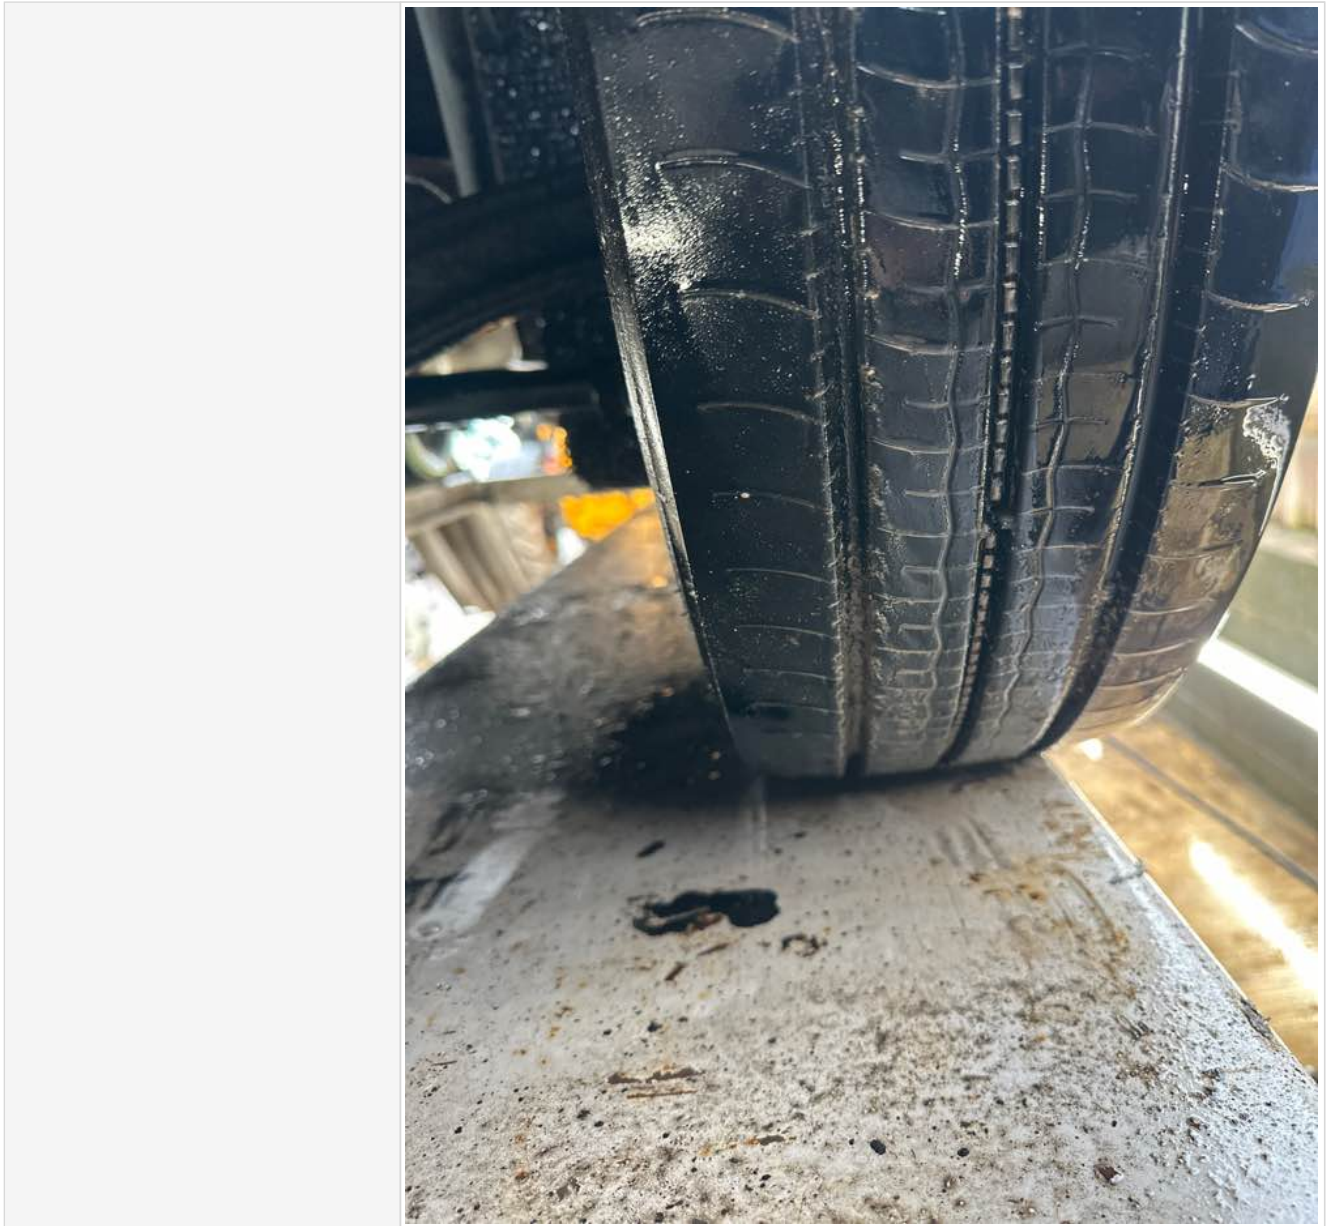
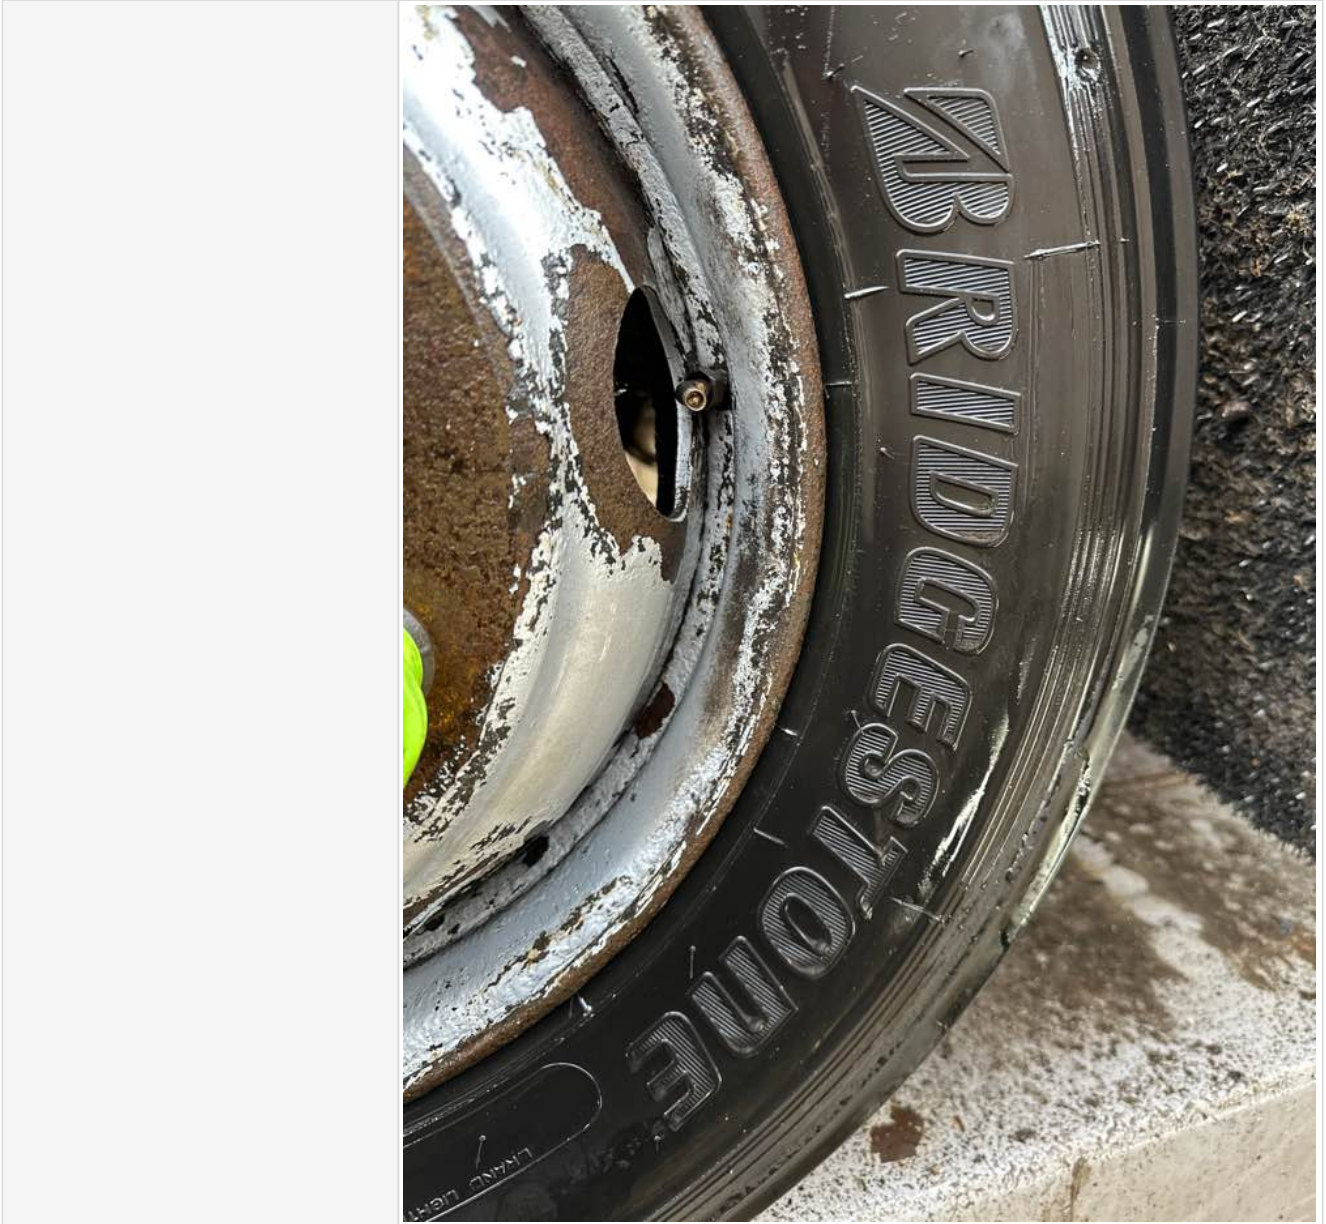
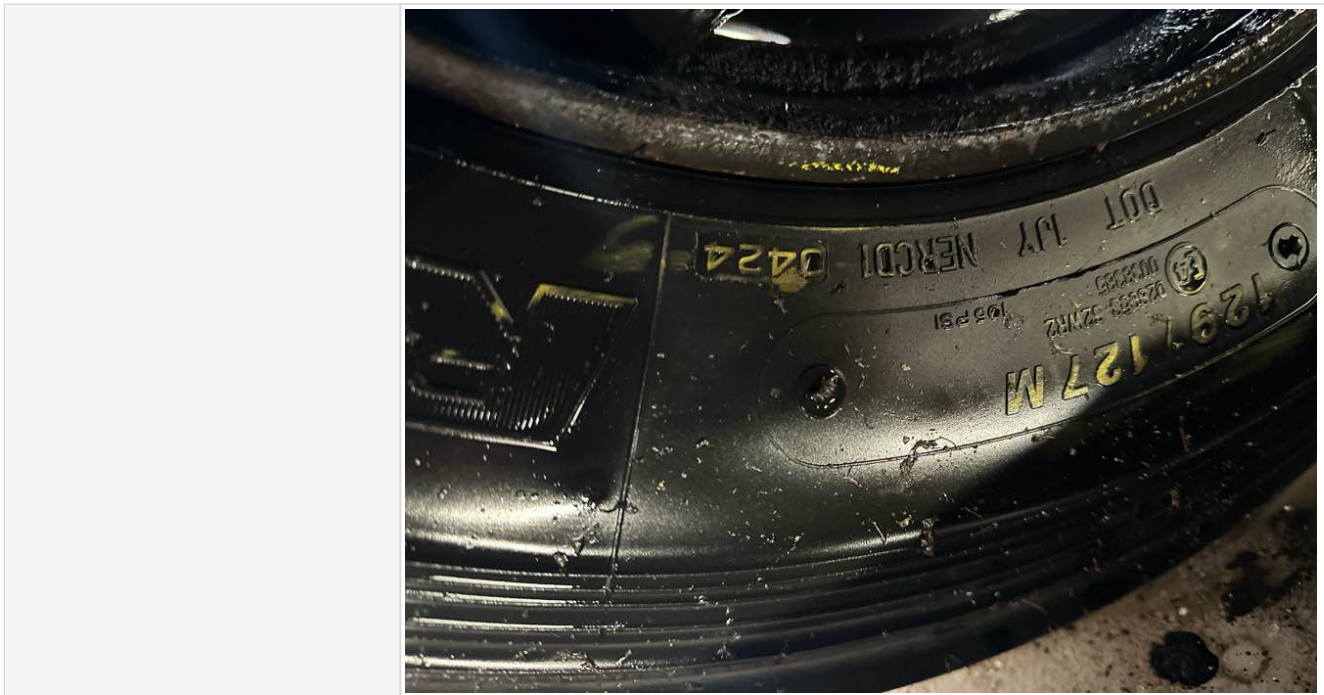
### Near side front

Age (month/year) Manufactured	04/24
Make, brand.	Other (comment)
Tyre size	Not here (see comment)
Pressure 1	97
Pressure 2	
Wearing / Perishing (inner)	none
Wearing / Perishing (outer)	None
tread depth (mm)	10
General comments	Bridgestone 225/75R17.5

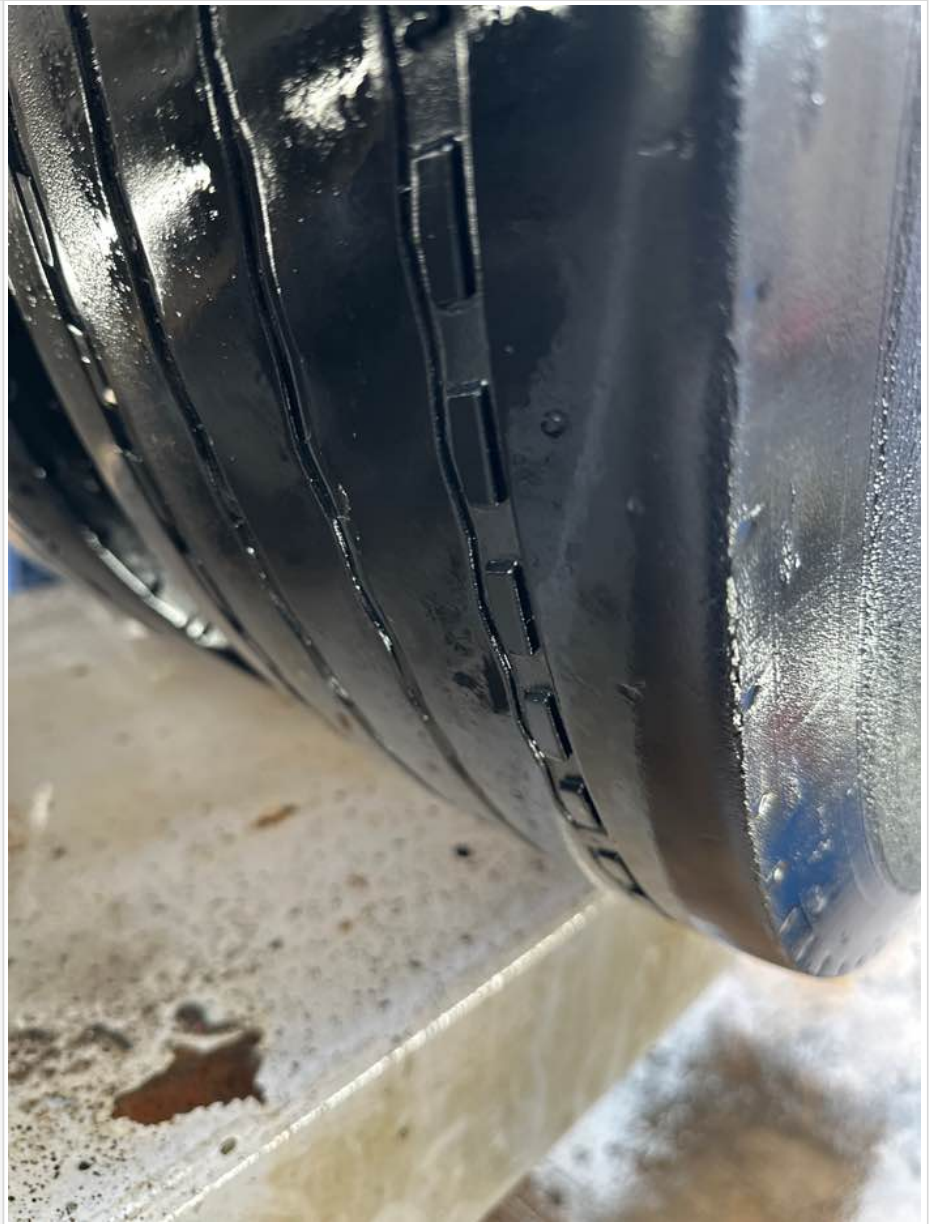
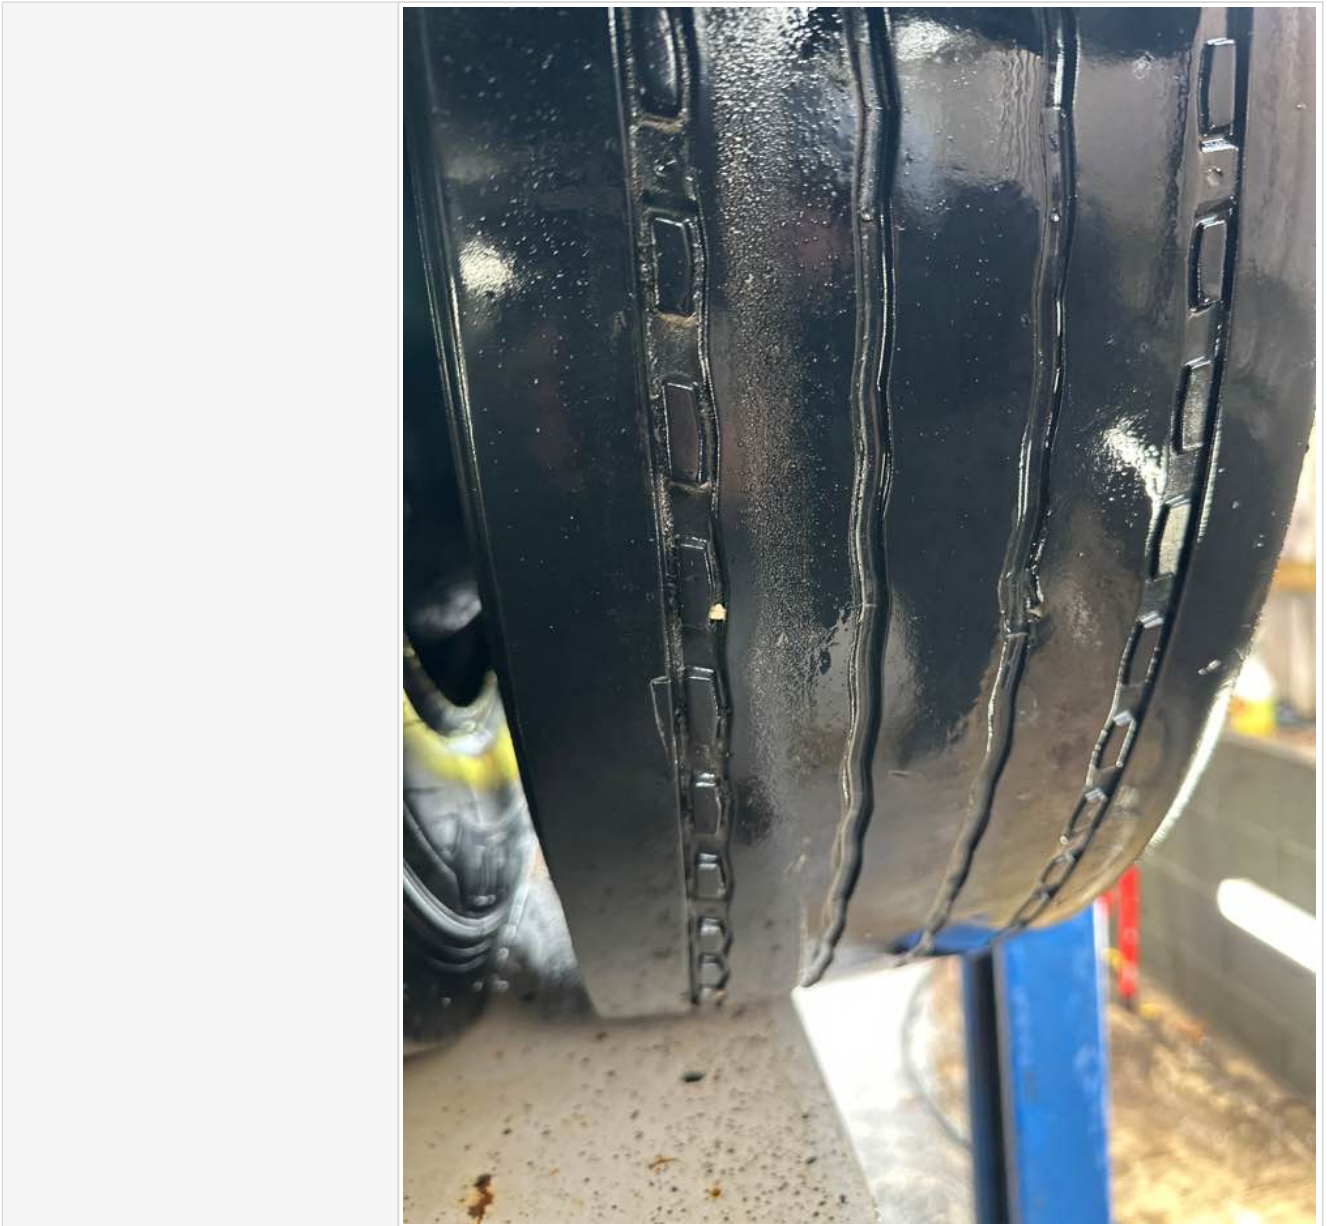
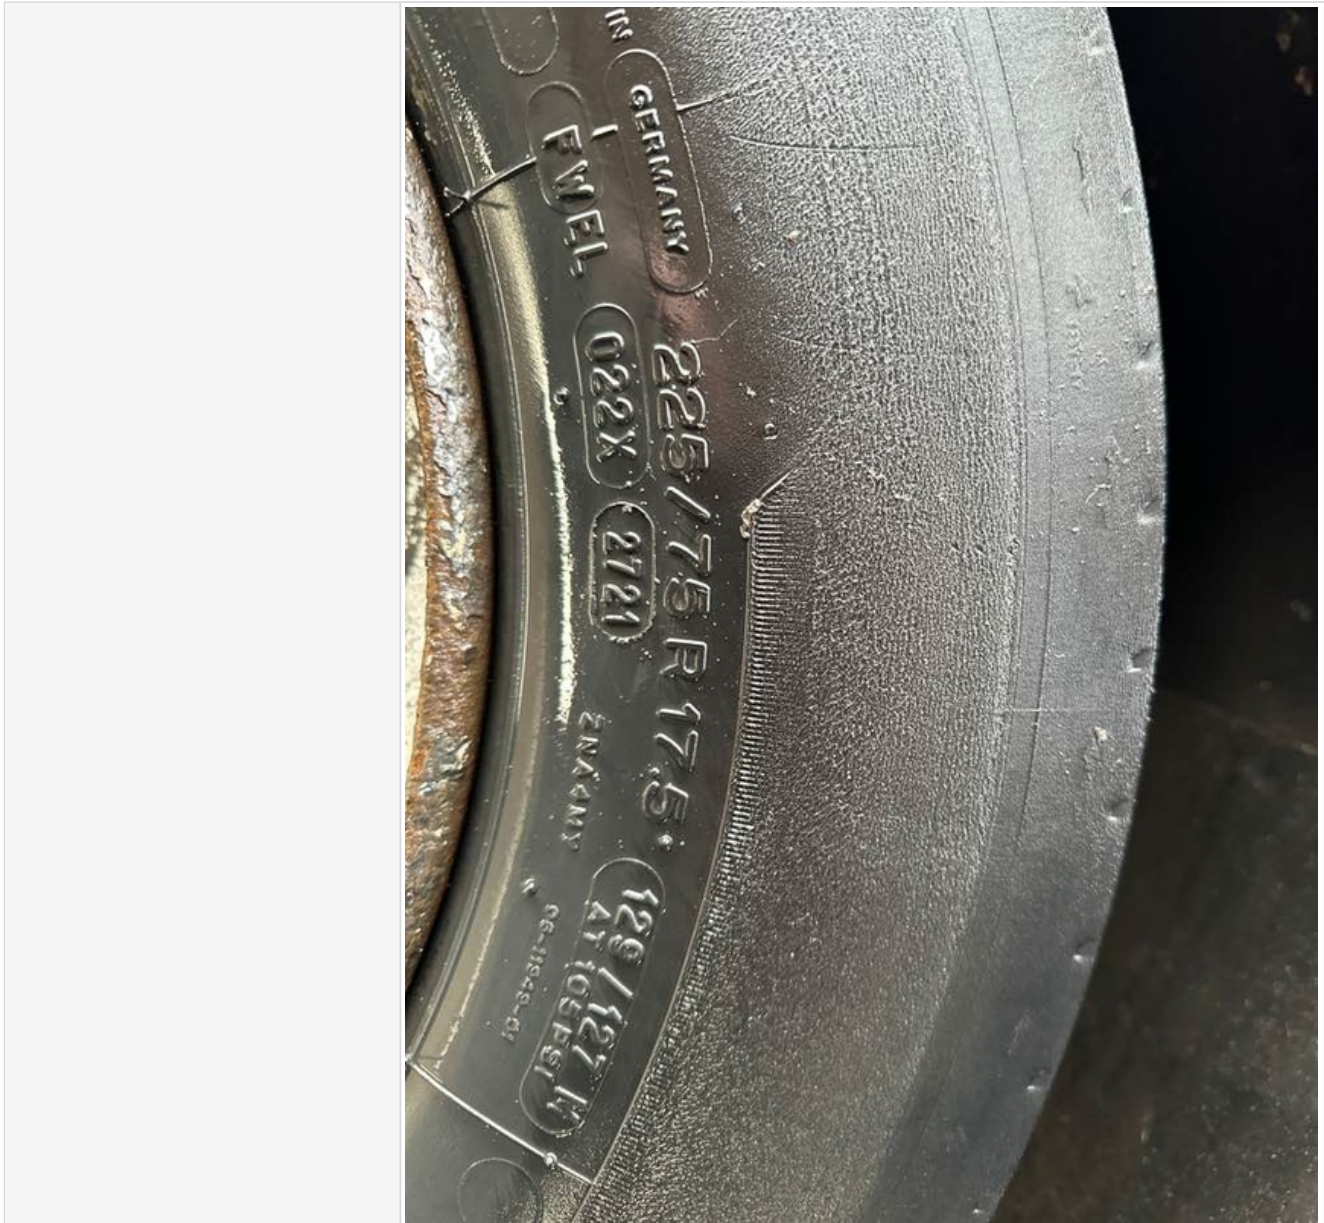
### near side rear

Age (month/year) Manufactured	27/21
Make, brand.	Michelin
Tyre size	Not here (see comment)
Pressure 1	90
Pressure 2	
Wearing / Perishing (inner)	Replace soon
Wearing / Perishing (outer)	Replace soon
tread depth (mm)	3
General comments	225/75R17.5

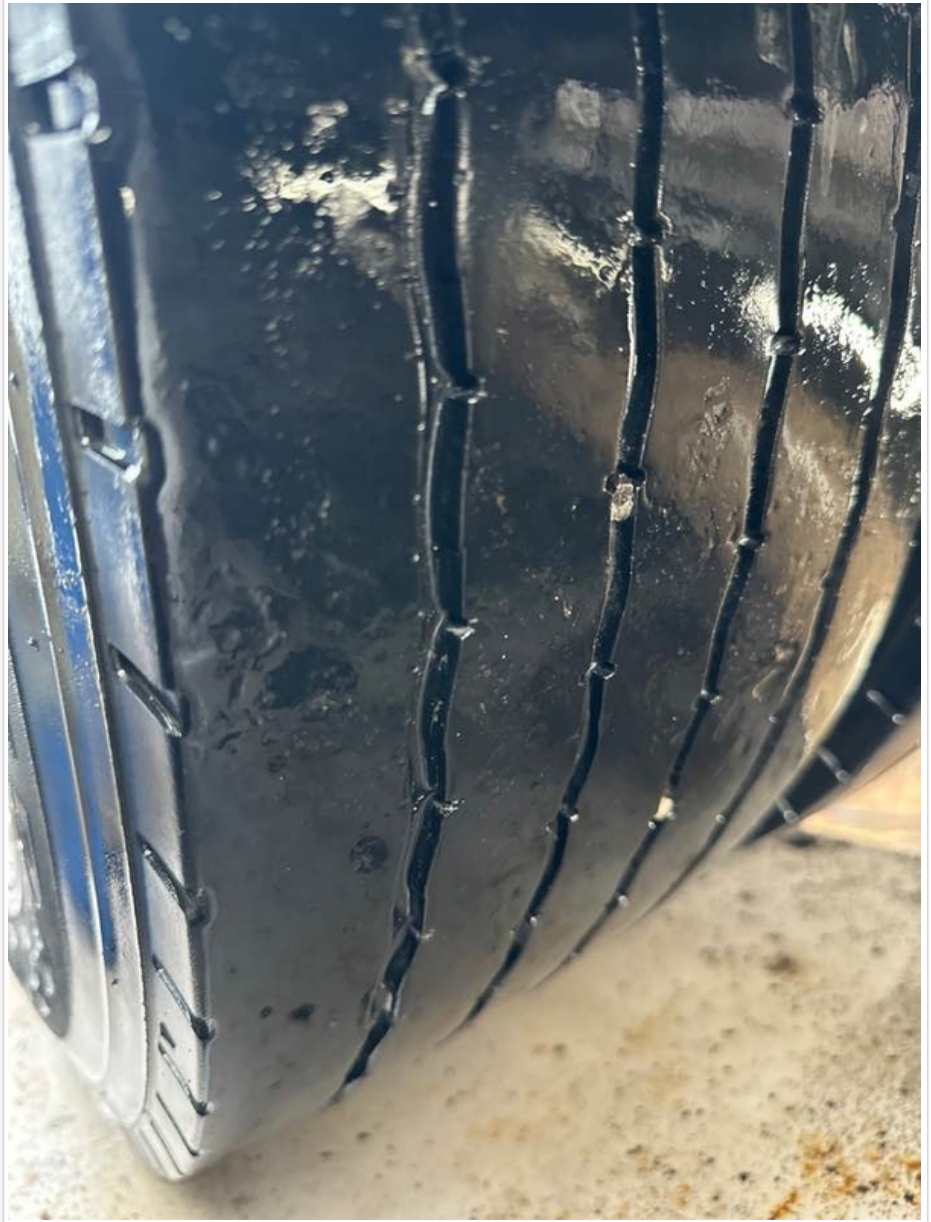
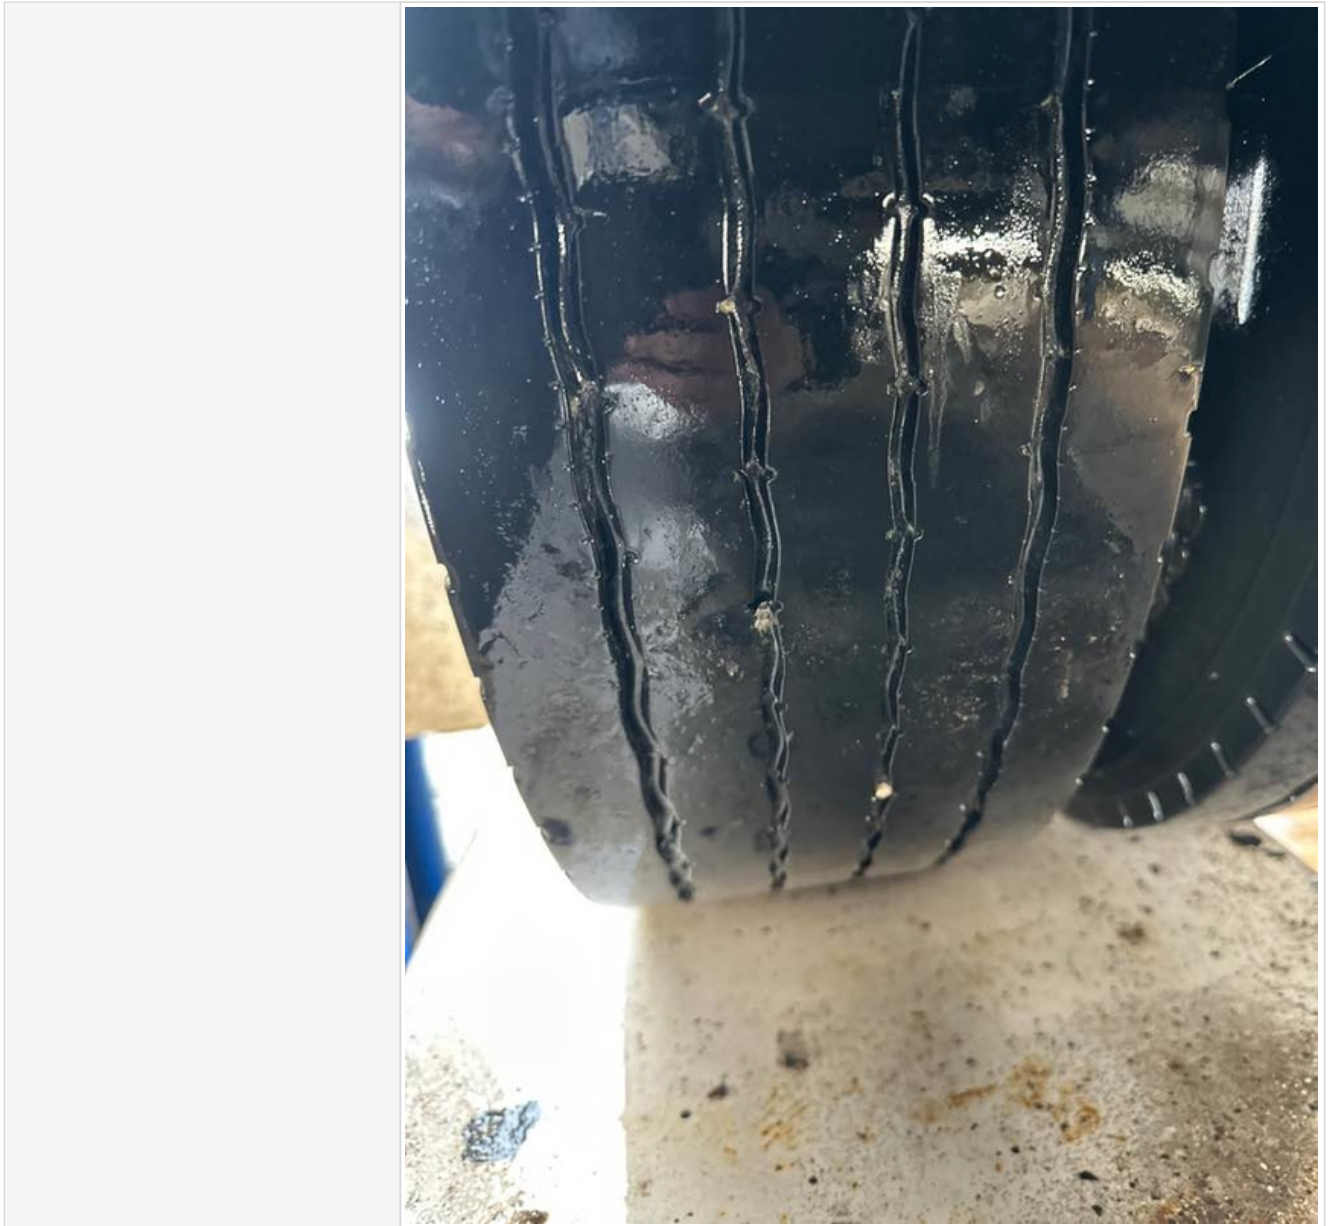
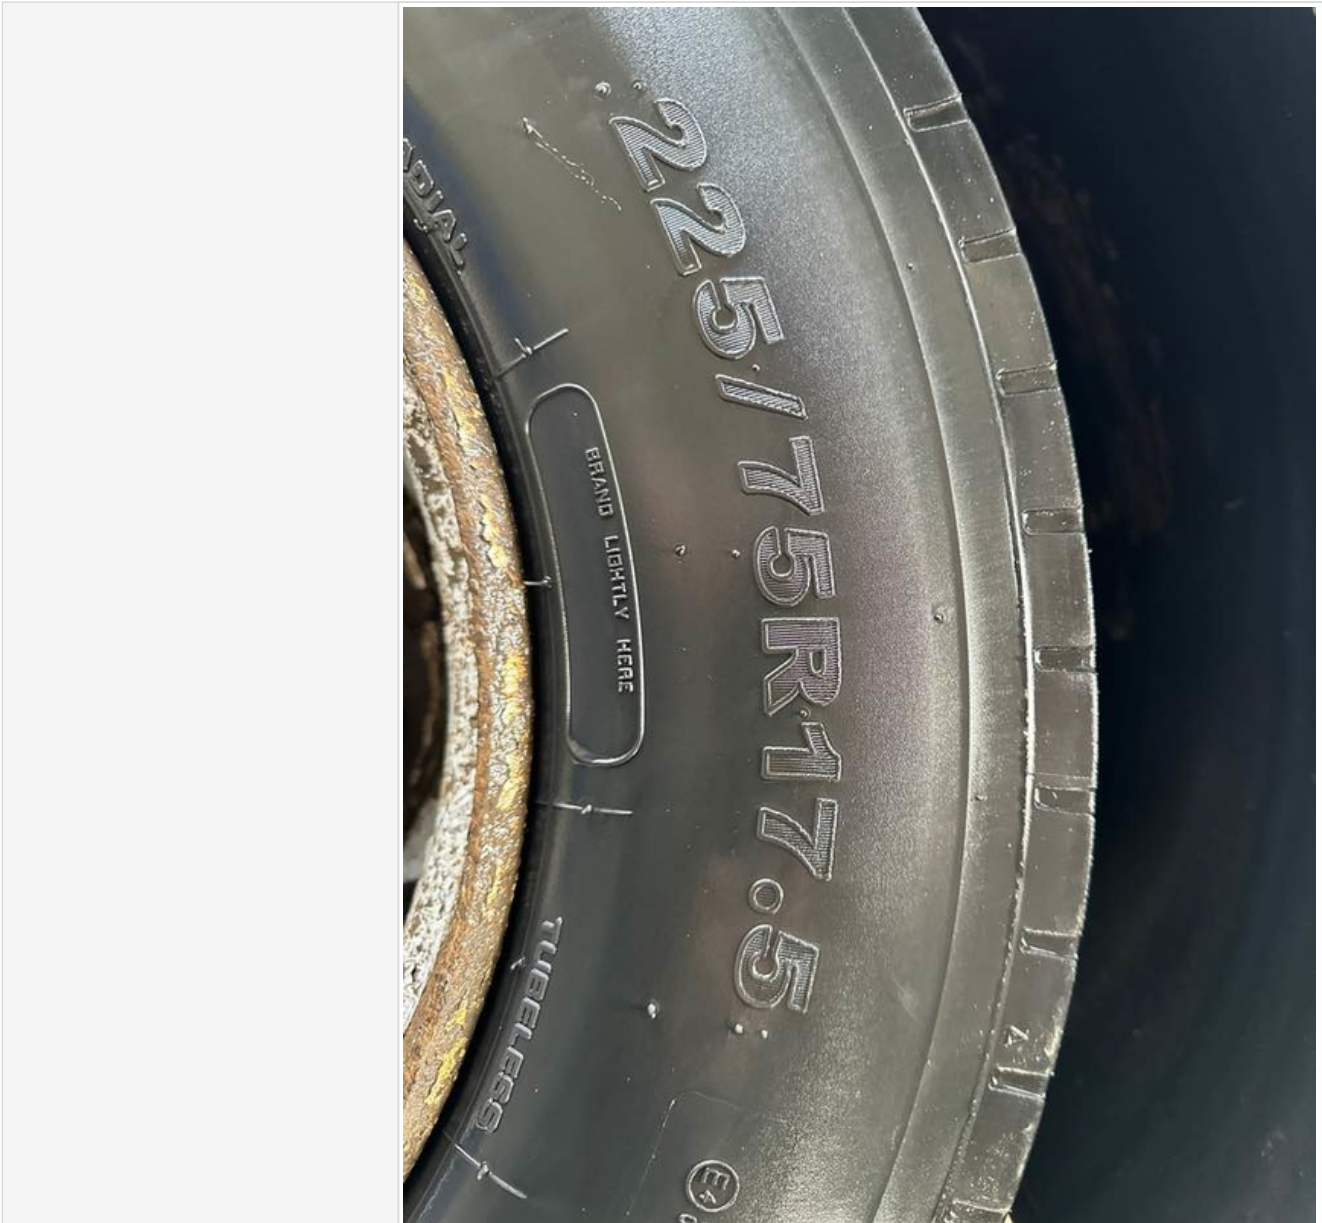
### Off side rear

Age (month/year) Manufactured	10/20
Make, brand.	Other (comment)
Tyre size	Not here (see comment)
Pressure 1	90
Pressure 2	
Wearing / Perishing (inner)	Medium
Wearing / Perishing (outer)	Medium
tread depth (mm)	5
General comments	Marshal 225/75R17.5
