## Basevan.com General Inspection

Vehicle registration	PO13DDU
Vehicle chassis no.	XLRAE4FF0L424069
Miles (if in km, multiply by 0.62)	718,536
Make	Daf
Model	Truck
Transmission	Manual, 5 speed
Factory immobiliser installed	Yes
Speed limiter installed	Yes
Drive configuration	RWD
Gross Vehicle Weight (kg)	7500
Towing capacity	N/A
Tow bar installed	No

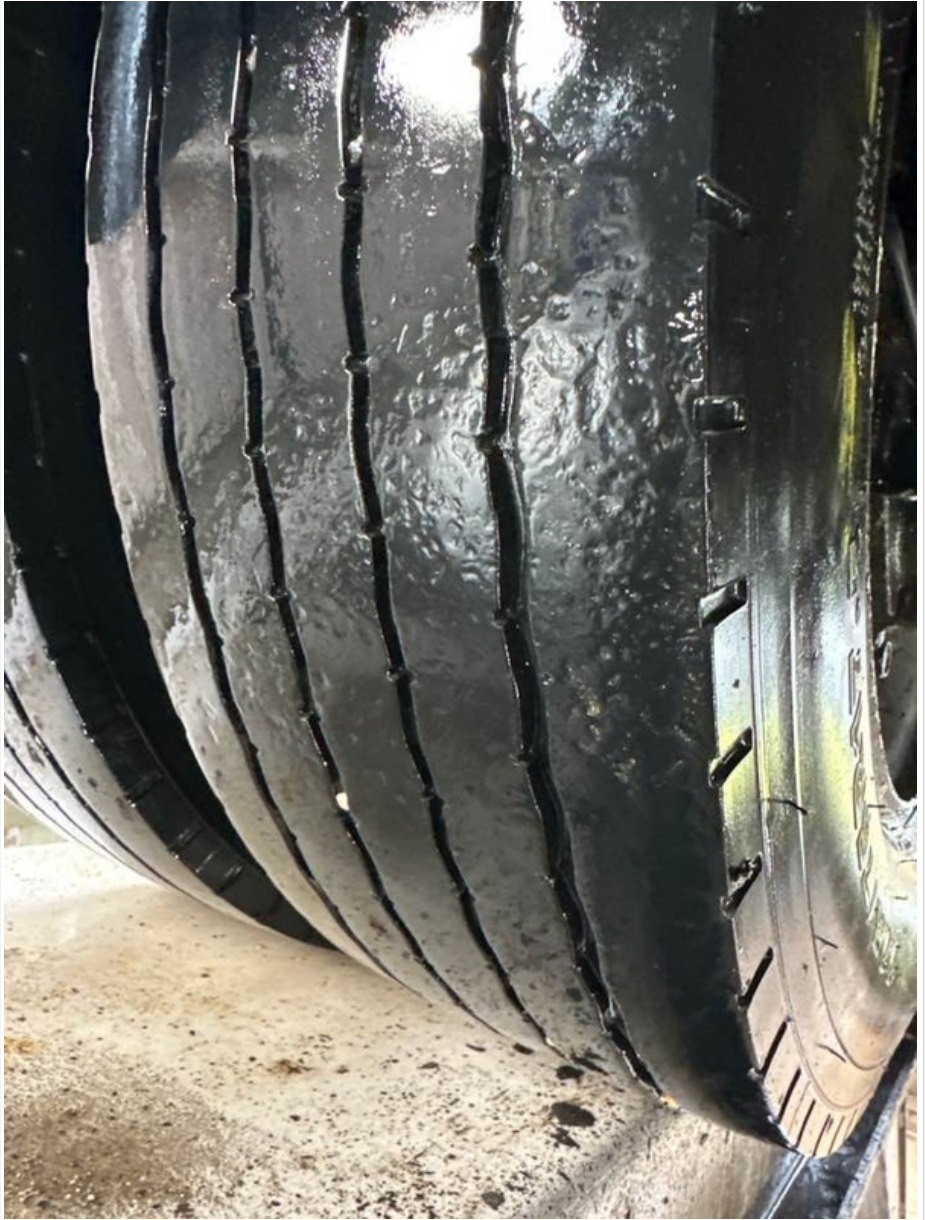
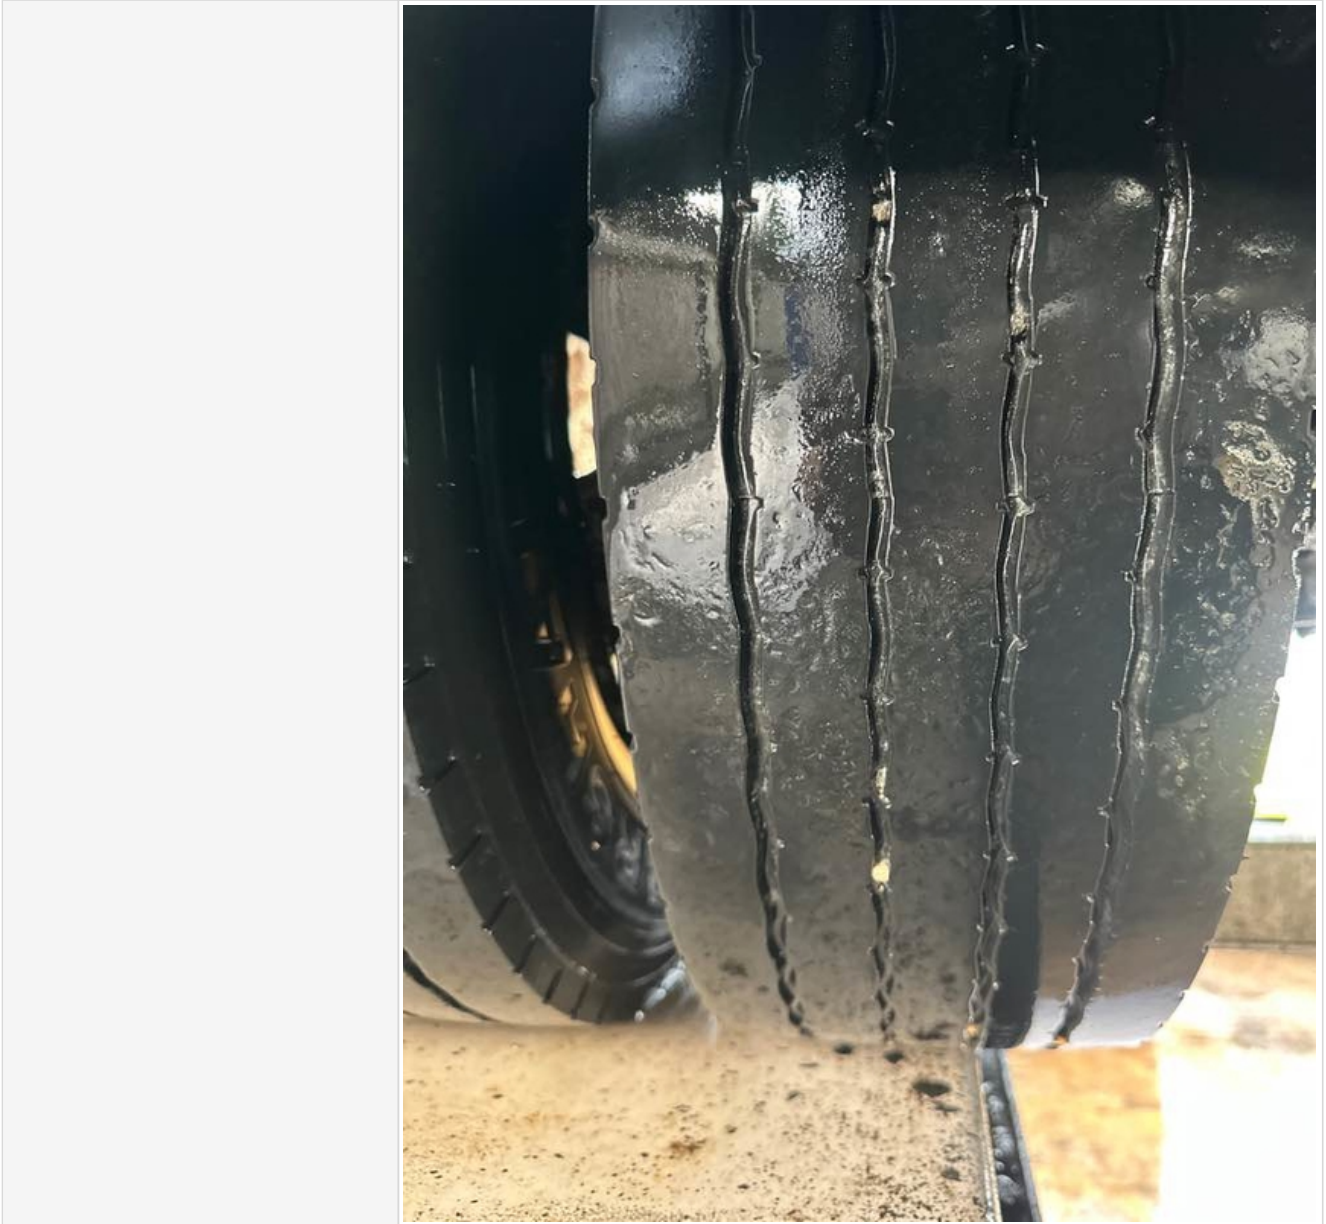
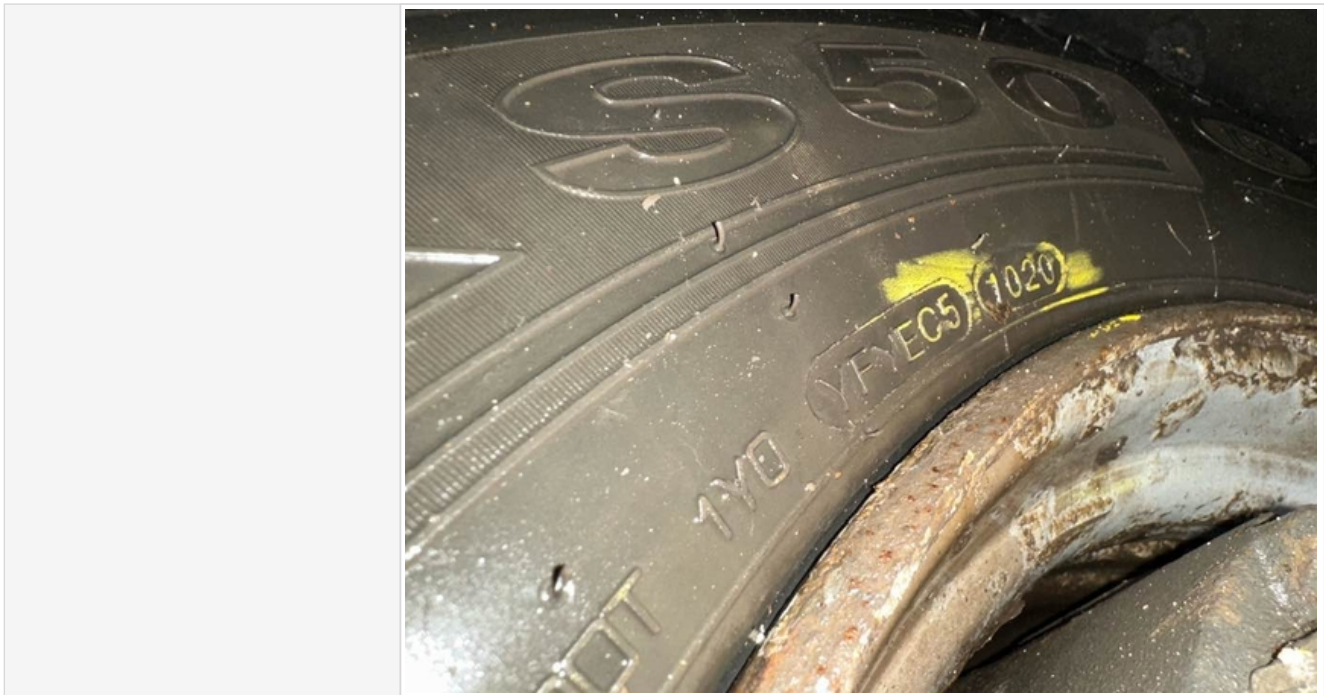
### off side Inner (for twin wheel vans)

Is the vehicle a twin wheel axle? (if no don't fill out)	Yes
Age (month/year) Manufactured	10/20
Make, brand.	Other (comment)
Tyre size	Not here (see comment)
Pressure 1	80
Pressure 2	
Wearing / Perishing (inner)	Medium
Wearing / Perishing (outer)	Medium

tread depth (mm)	5
General comments	Marshal 225/75R17.5
Images of tyre

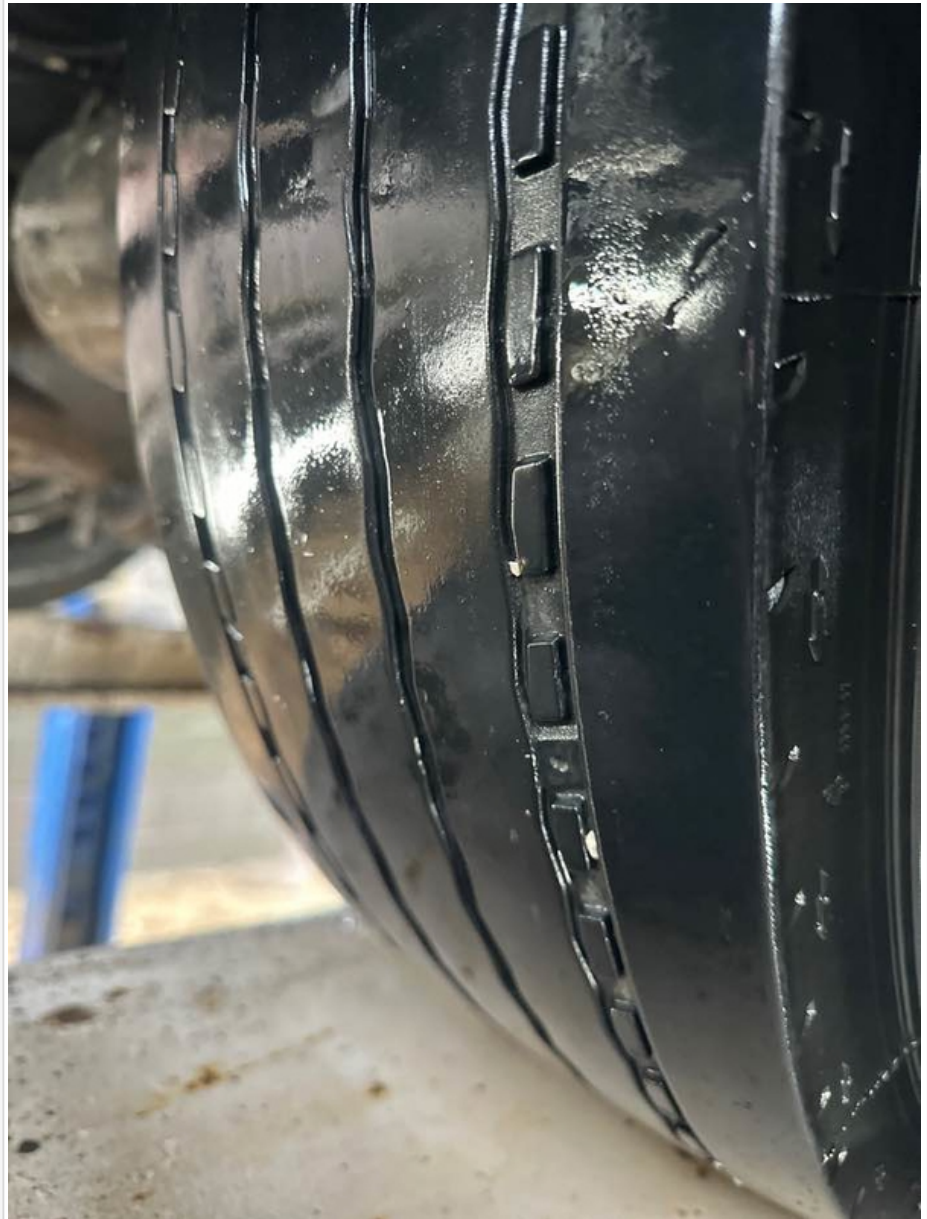
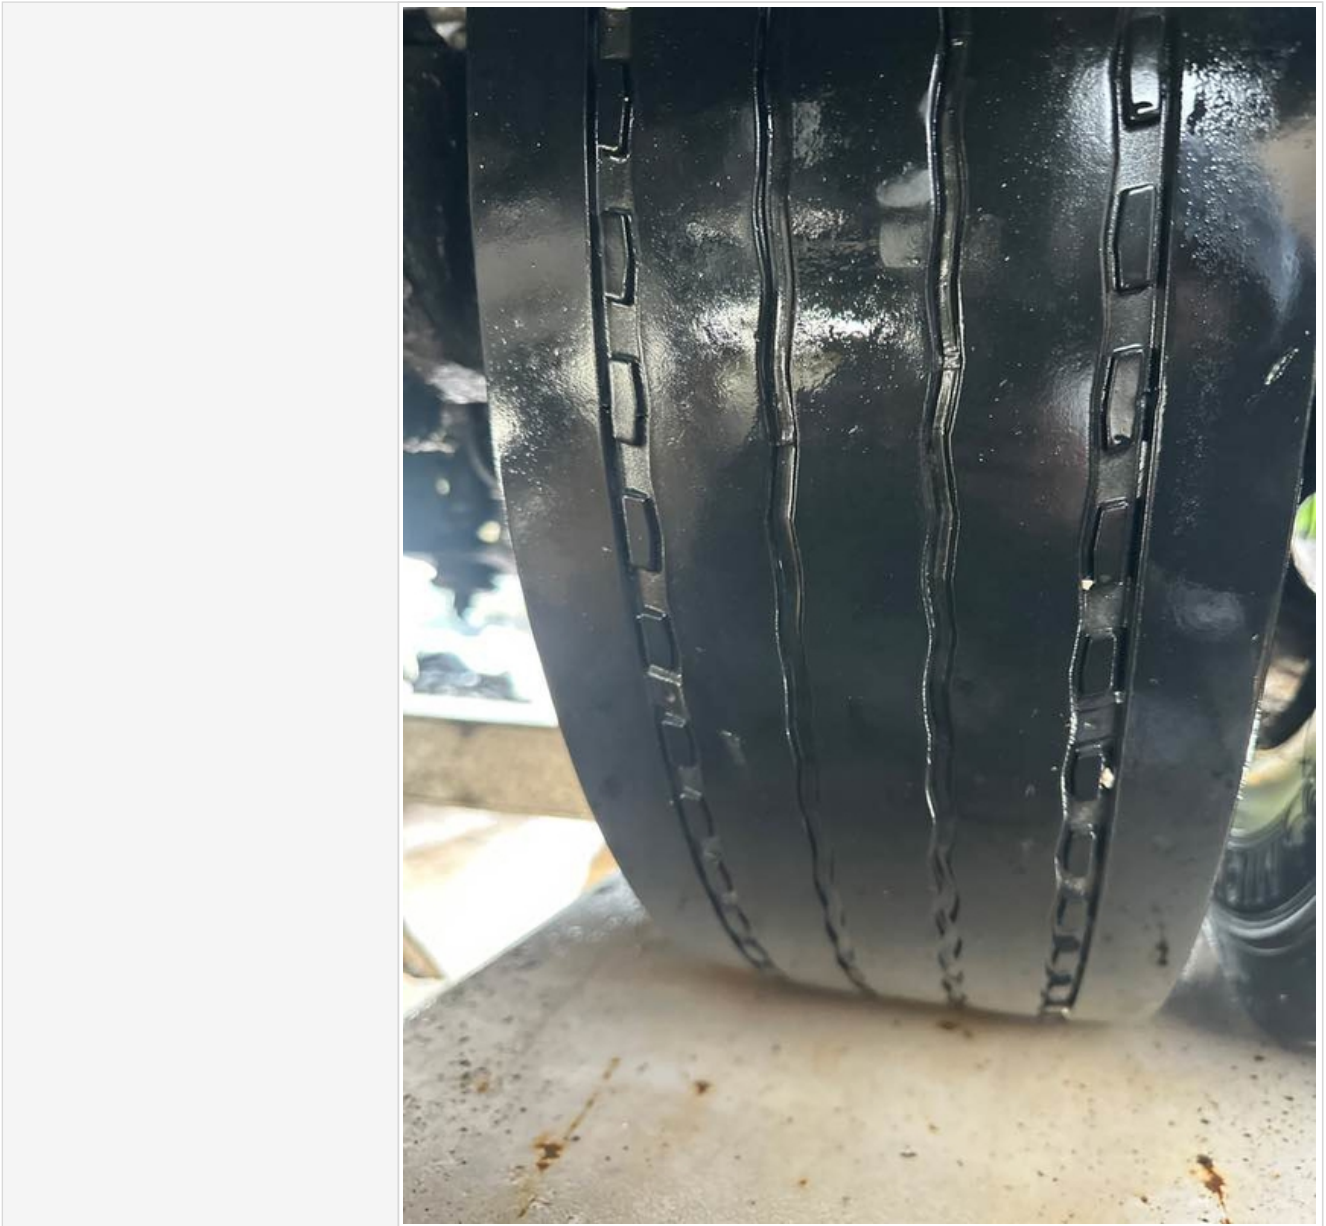
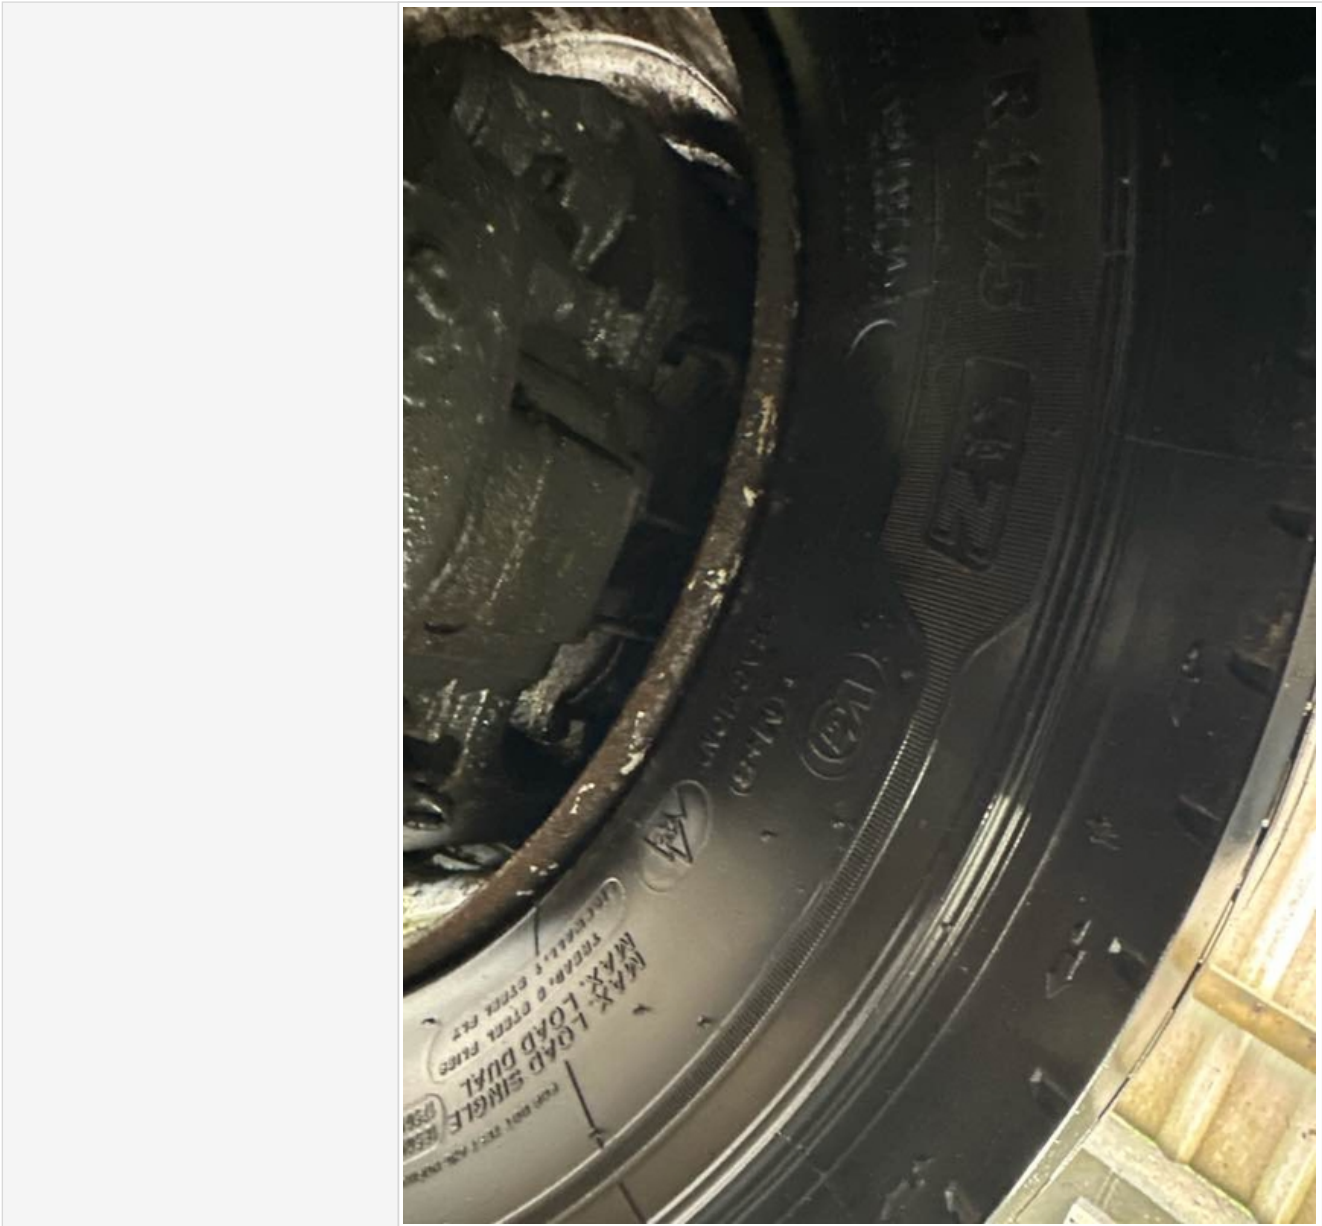
### near side Inner (for twin wheel vans)

Is the vehicle a twin wheel axle? (if no don't fill out)	Yes
Age (month/year) Manufactured	25/21
Make, brand.	Michelin
Tyre size	Not here (see comment)
Pressure 1	90
Pressure 2	
Wearing / Perishing (inner)	Medium
Wearing / Perishing (outer)	Medium
tread depth (mm)	4
General comments

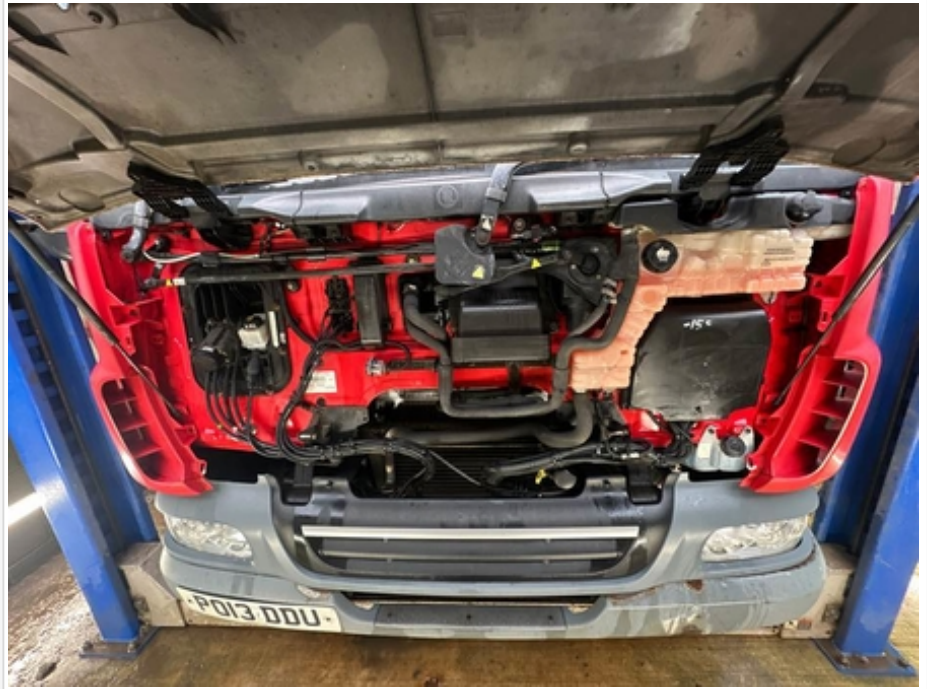
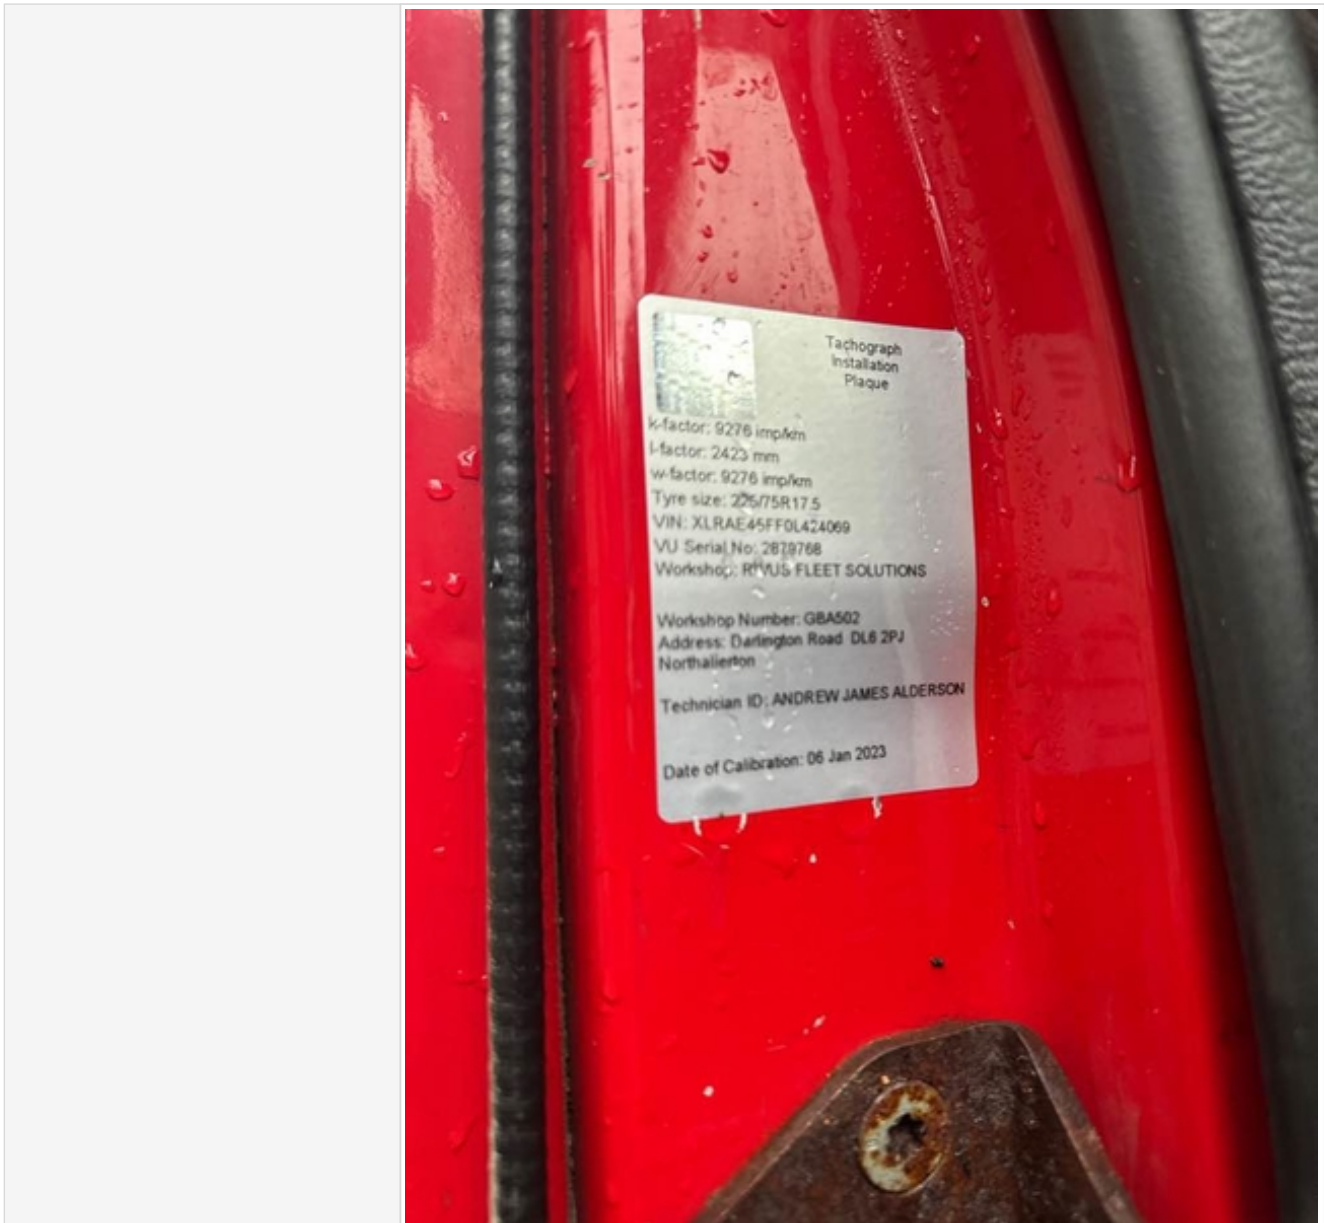
Engine bay photo

Fuel level	3/4 Full
Oil level	Full
Oil conditon	Clean
Start up, chassis battery check	Started, but required boost pack
Start-up from cold	3 seconds
Exhaust smoke from cold	Normal
Output Voltage of Alternator test	14
Chain or Belt driven engine?	Chain
If belt any proof of change?	N/A
Coolant condition	Clean
Coolant level	Full
Anti-freeze temperature check	-15
Washer fluid	Full
Brake fluid	Full
Power steering fluid	Maximum
Dashboard warning light	No warning lights
OBD Scan results
