Basevan.com General Inspection

Vehicle registration	CU12EBA
Vehicle chassis no.	
Miles (if in km, multiply by 0.62)	
Make	Renault
Model	Master
Transmission	Manual, 6 speed
Factory immobiliser installed	Yes
Speed limiter installed	Yes
Drive configuration	FWD
Gross Vehicle Weight (kg)	3500
Towing capacity	2500
Tow bar installed	No

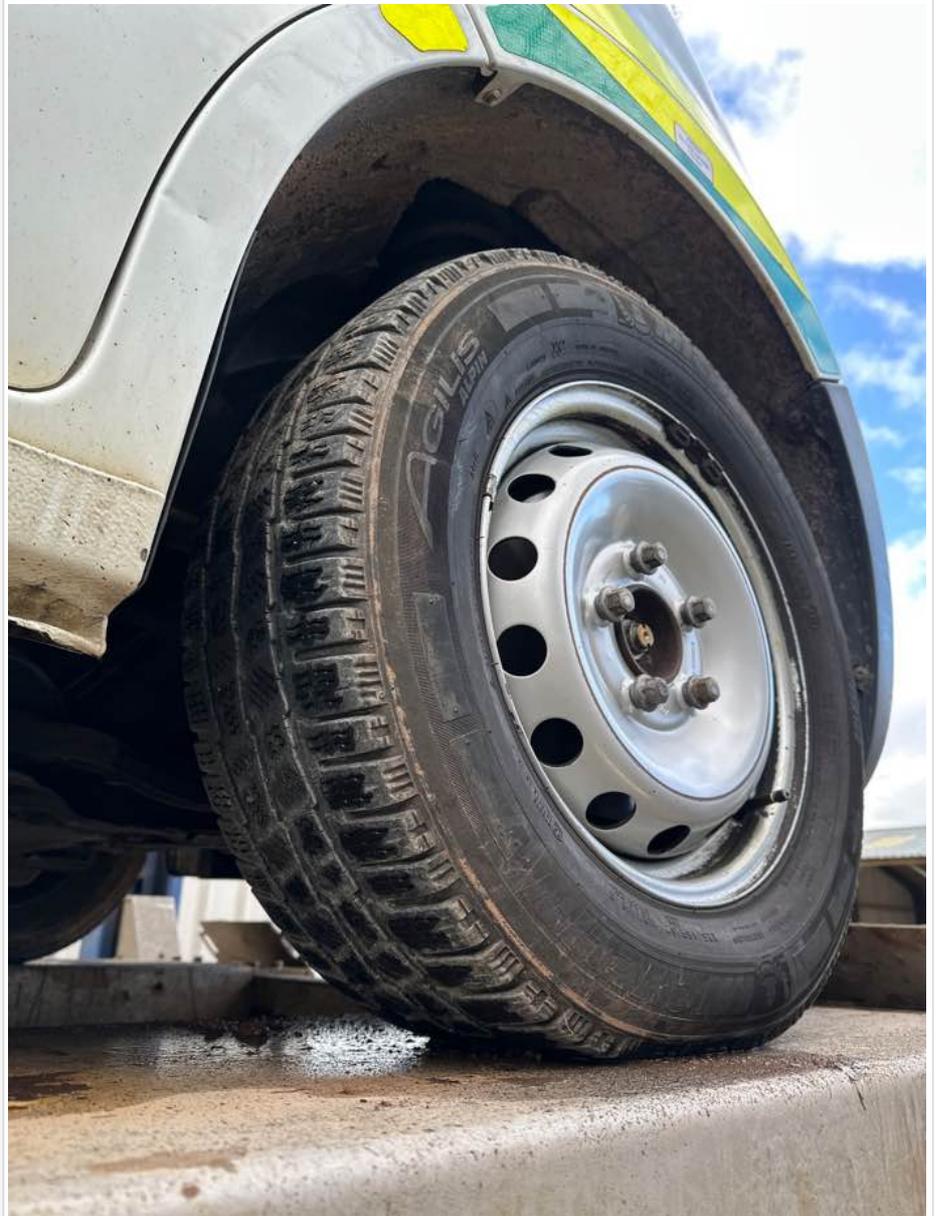
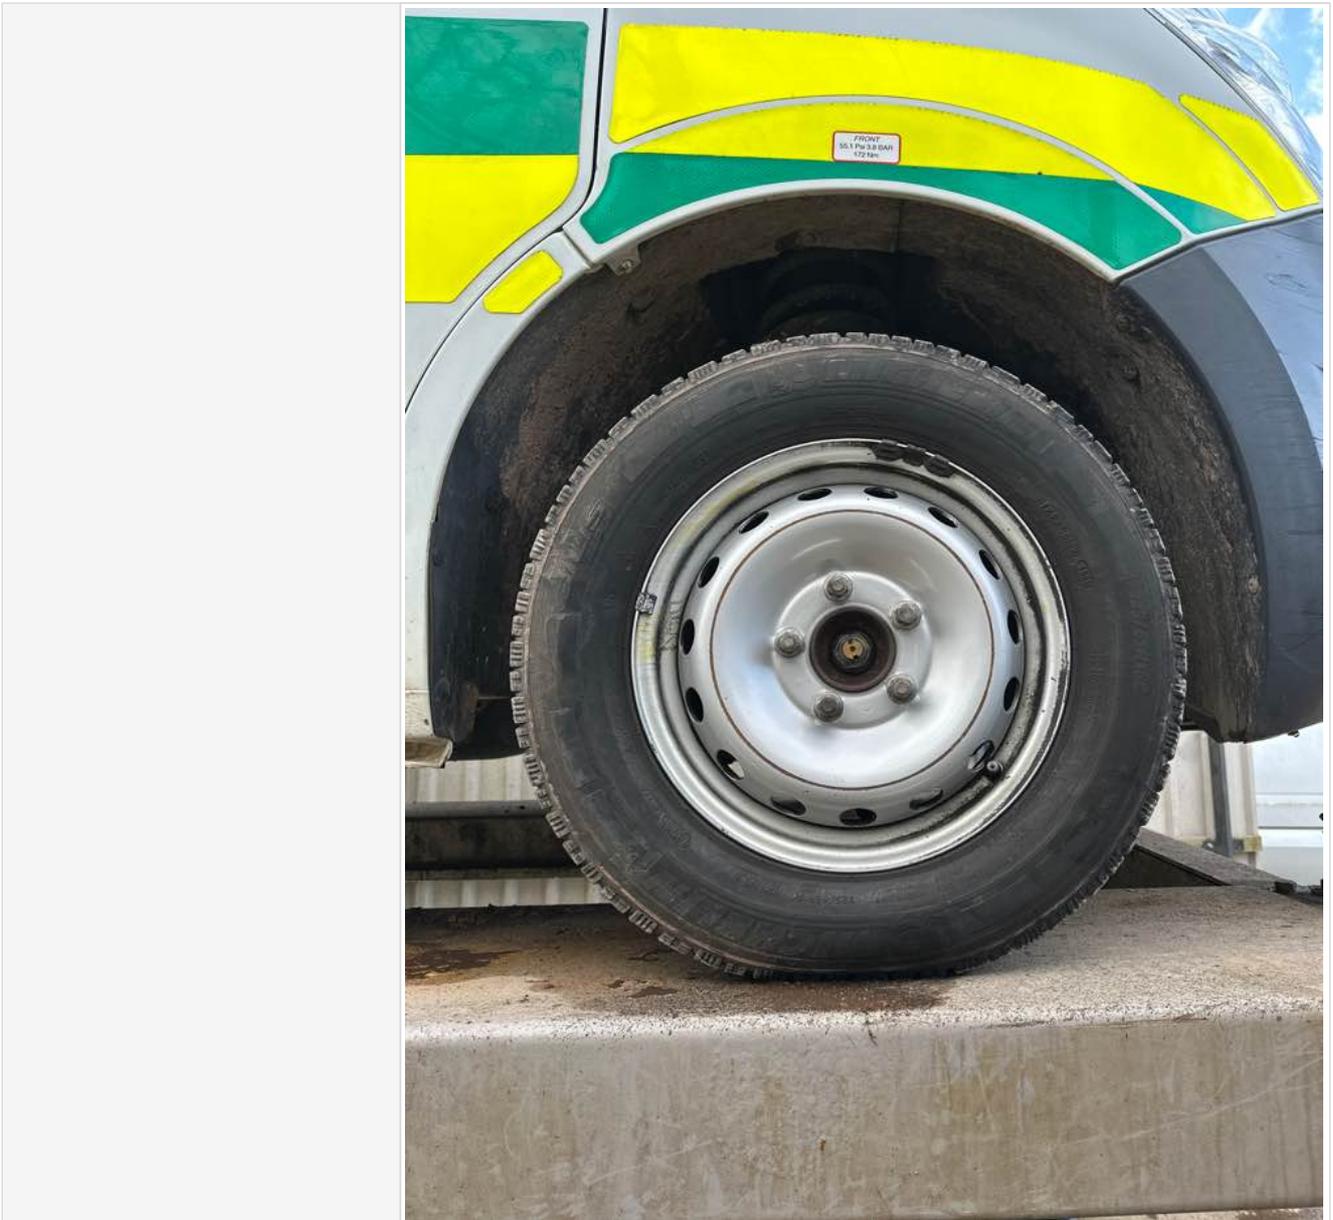
Off side front

Age (month/year) Manufactured	29/21
Make, brand.	Michelin
Tyre size	225/65/R16
Pressure 1	
Pressure 2	
Wearing / Perishing (inner)	none
Wearing / Perishing (outer)	None
tread depth (mm)	5
General comments	Nice recent tyre

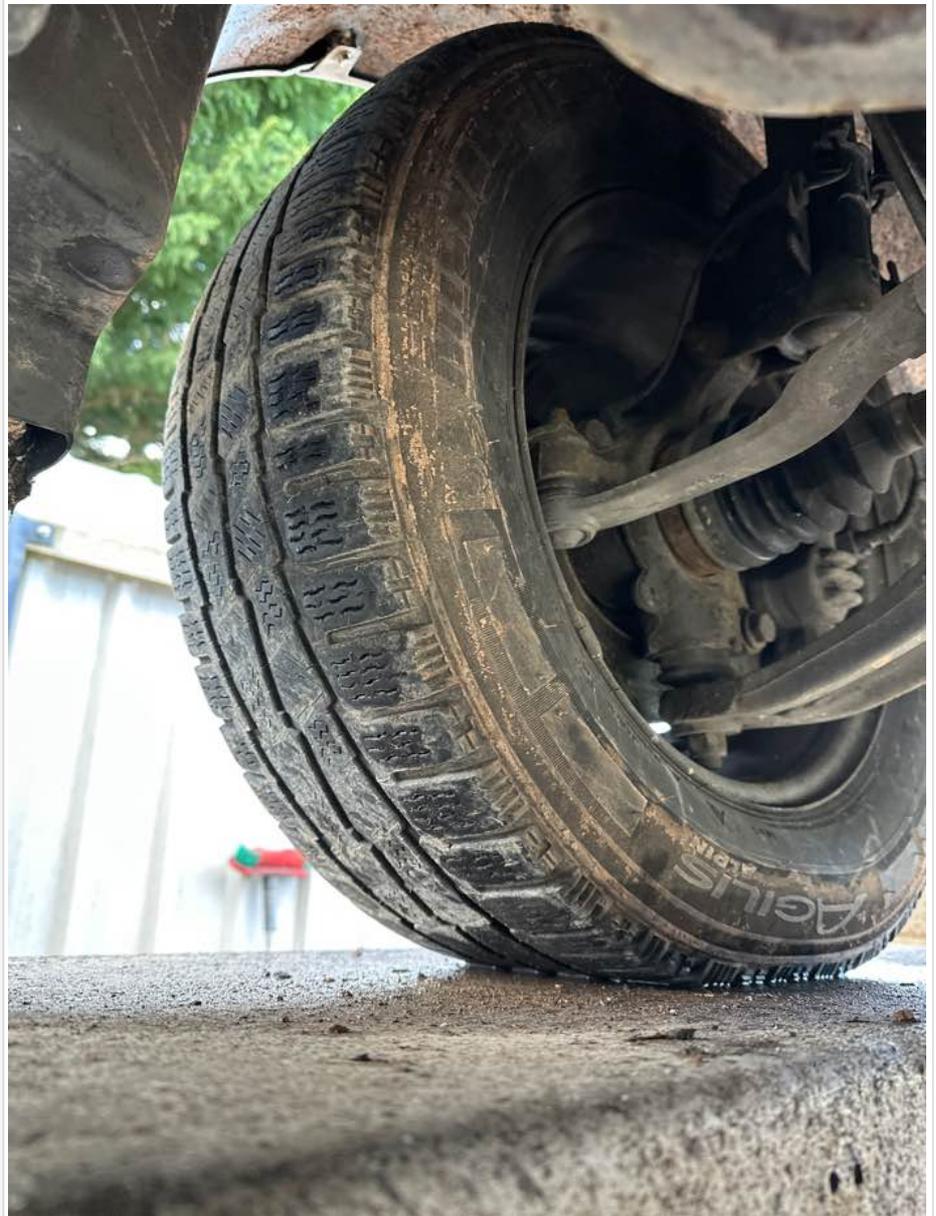
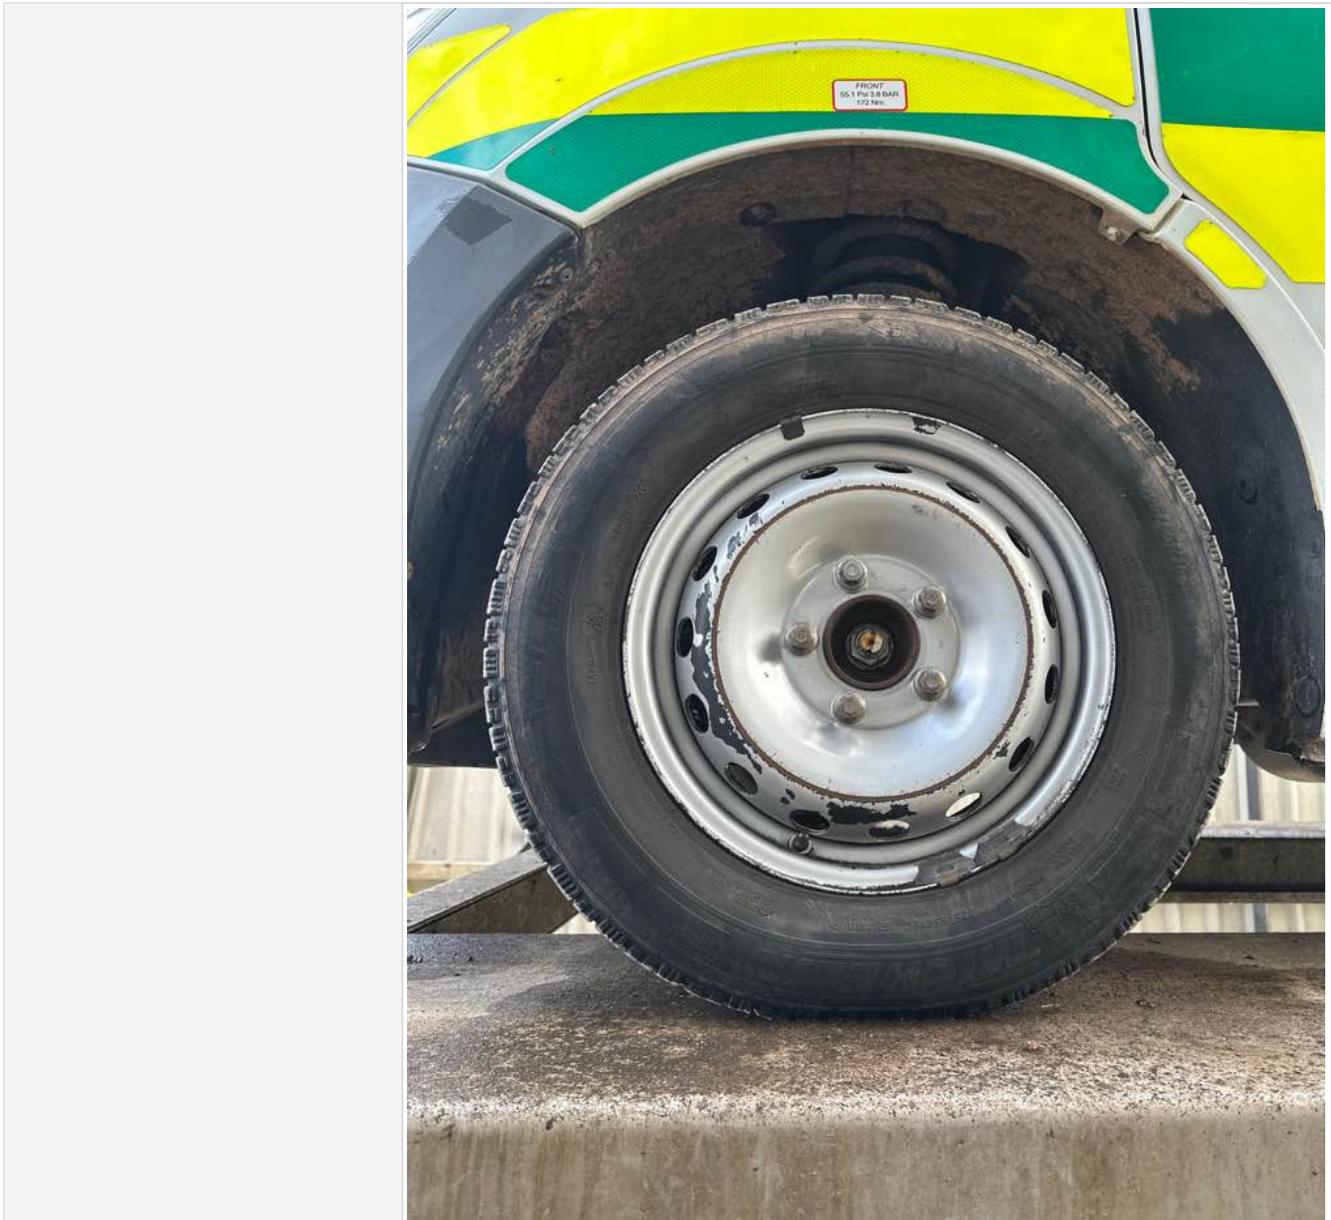
Near side front

Age (month/year) Manufactured	37/21
Make, brand.	Michelin
Tyre size	225/65/R16
Pressure 1	
Pressure 2	
Wearing / Perishing (inner)	none
Wearing / Perishing (outer)	None
tread depth (mm)	5
General comments	good recent tyre

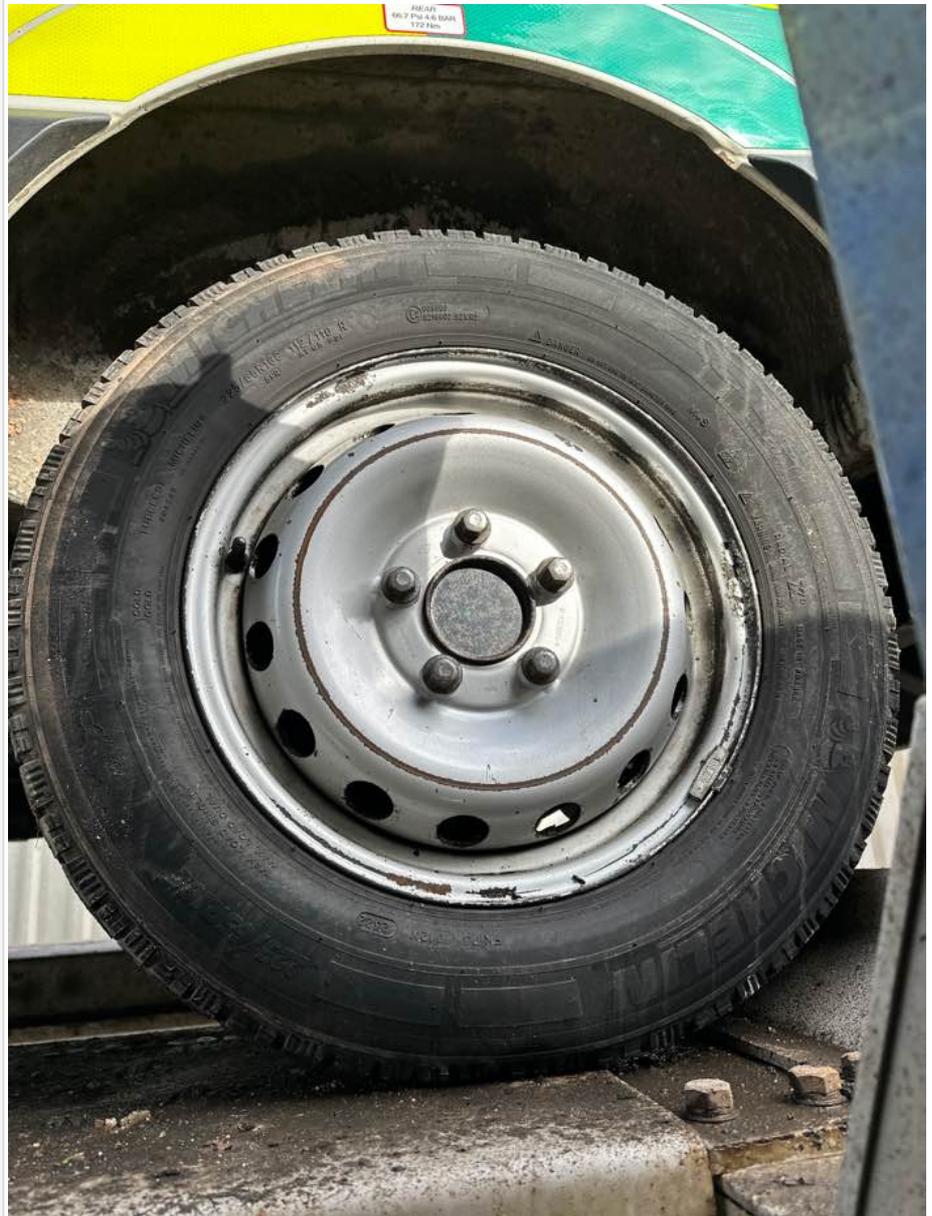
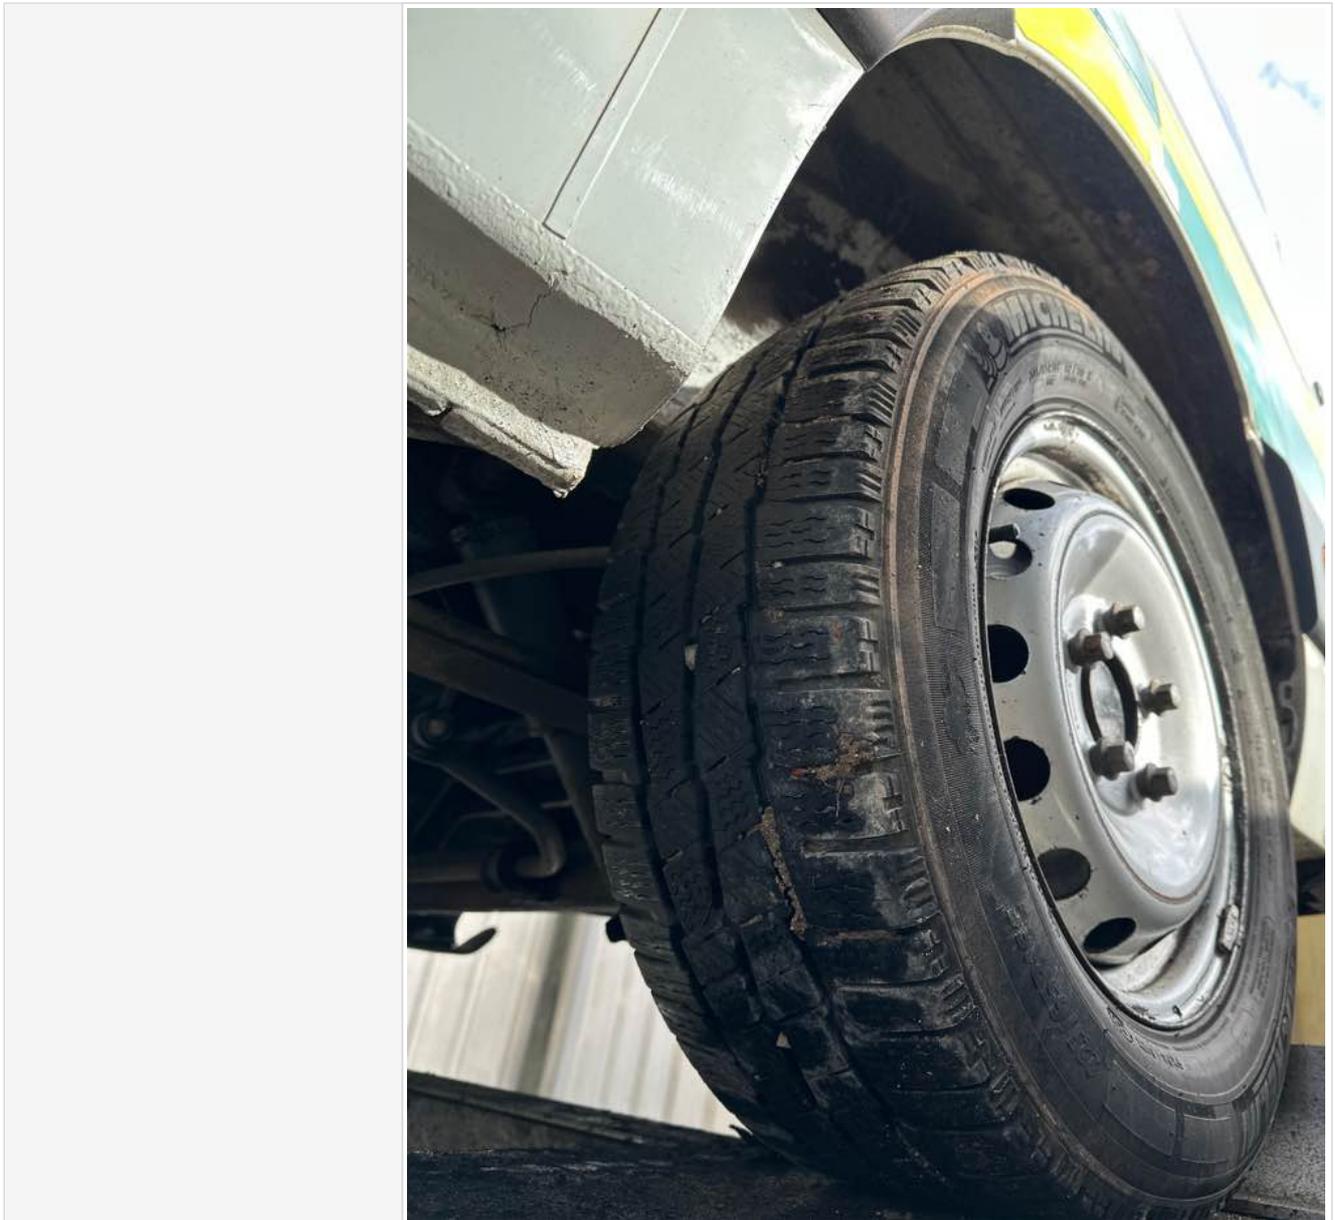
near side rear

Age (month/year) Manufactured	23/22
Make, brand.	Michelin
Tyre size	225/65/R16
Pressure 1	
Pressure 2	
Wearing / Perishing (inner)	none
Wearing / Perishing (outer)	None
tread depth (mm)	6
General comments	top condition

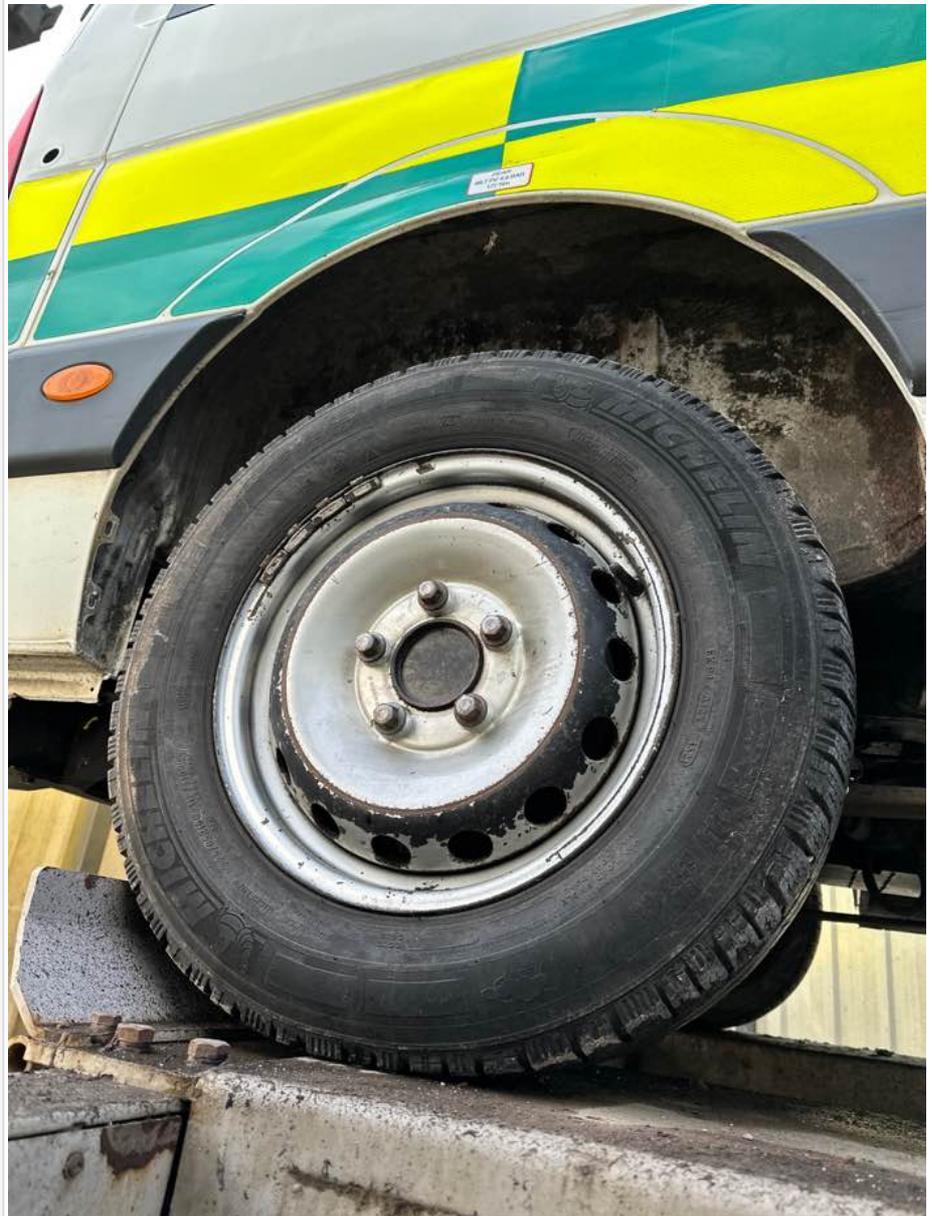
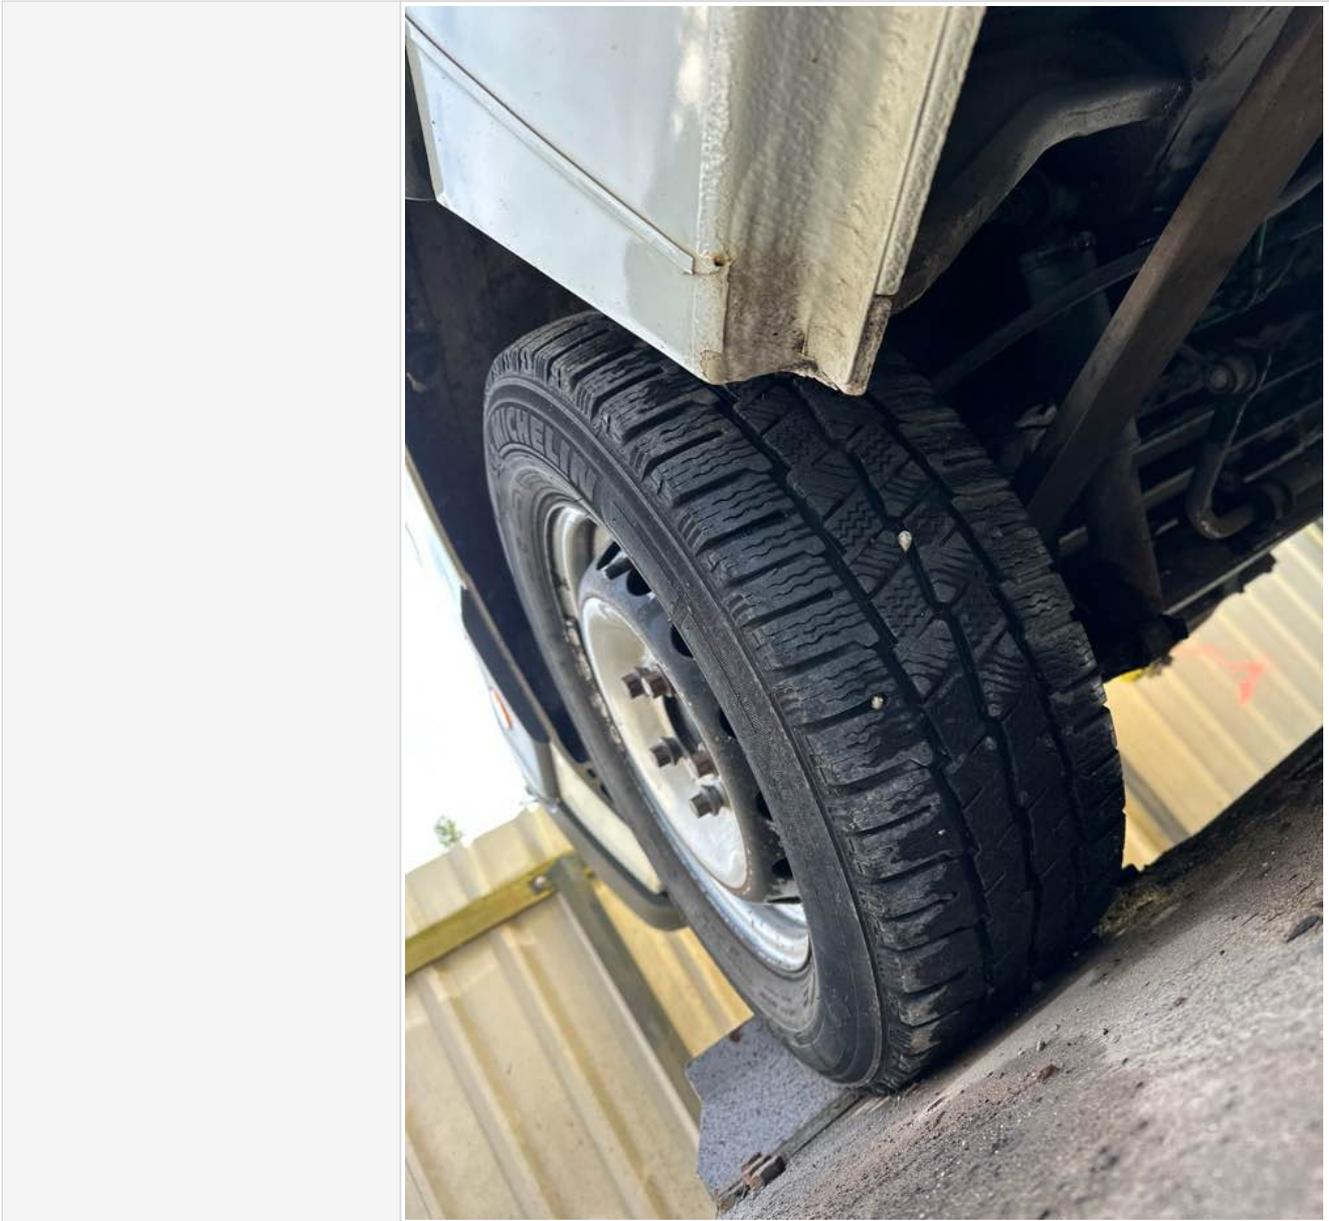
Off side rear

Age (month/year) Manufactured	45/21
Make, brand.	Michelin
Tyre size	225/65/R16
Pressure 1	
Pressure 2	
Wearing / Perishing (inner)	none
Wearing / Perishing (outer)	None
tread depth (mm)	7
General comments	good tyre!

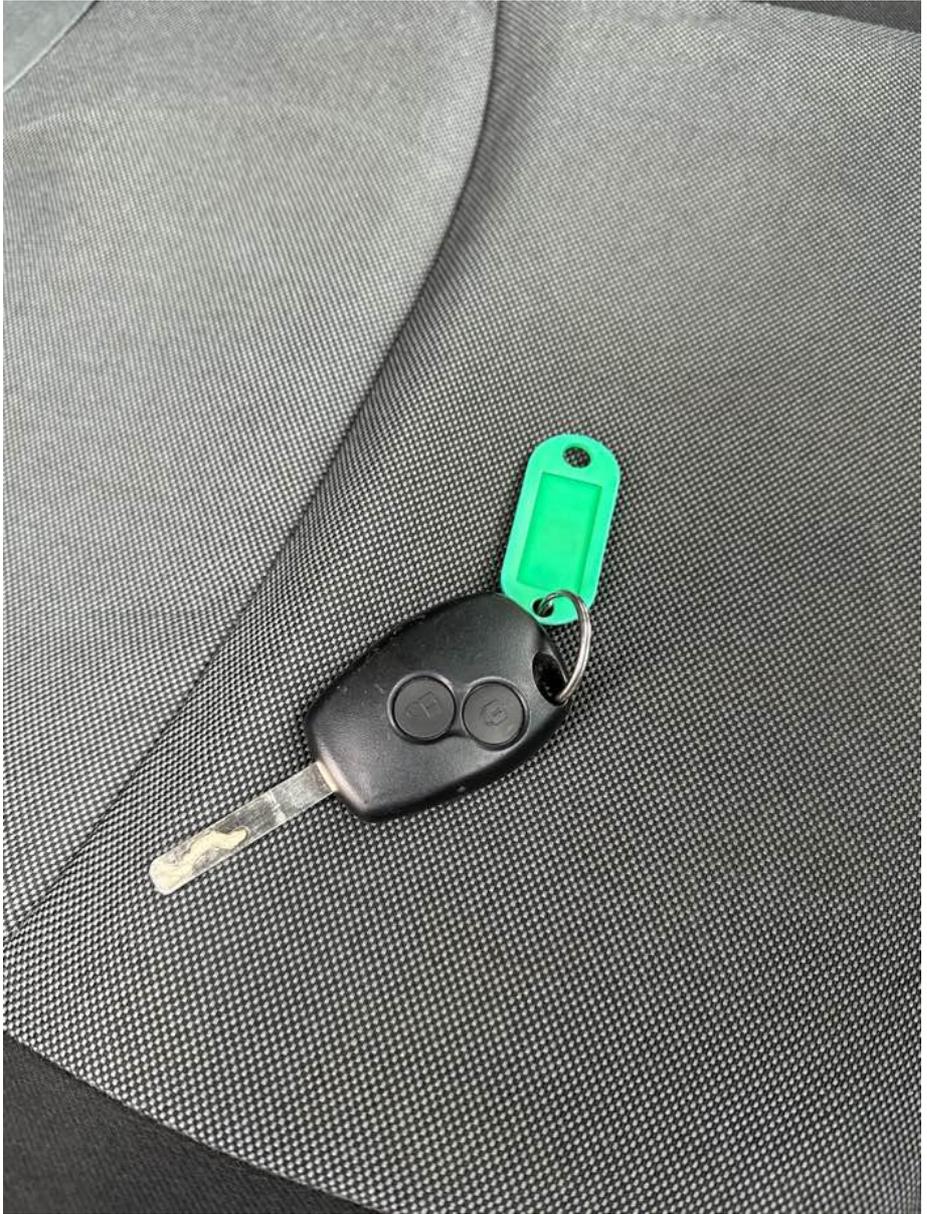
Select the following doors that lock.	O/S Front, N/S Front, N/S SL, N/S Rear, O/S Rear
Method of locking	Fob
In conclusion can all the doors be locked in some way and thus the vehicle can be left unattended at night safely?	Yes
How many keys present at time of inspection?

Comment	works as should

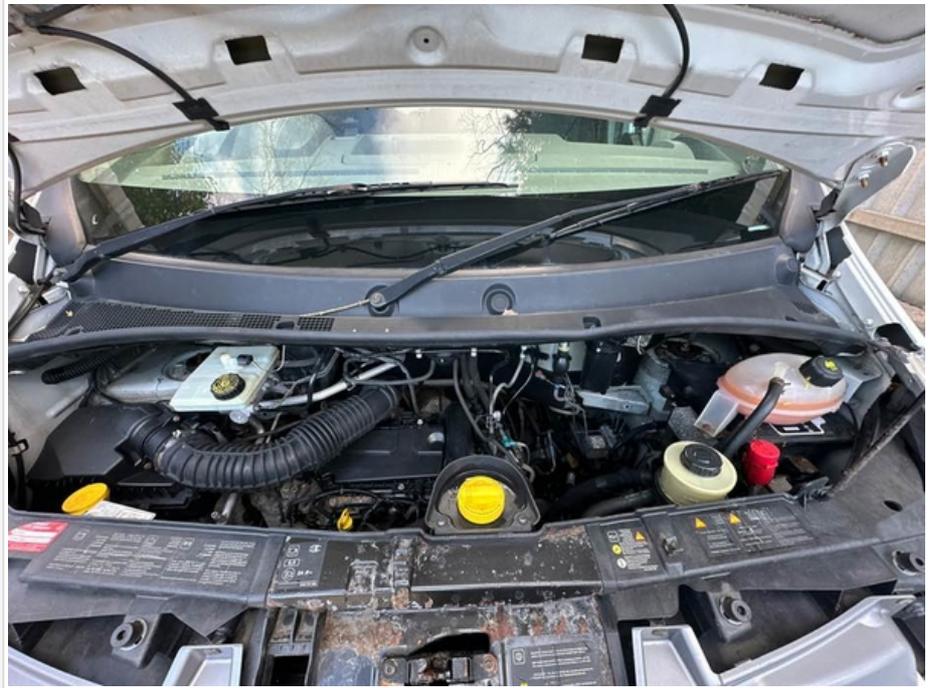
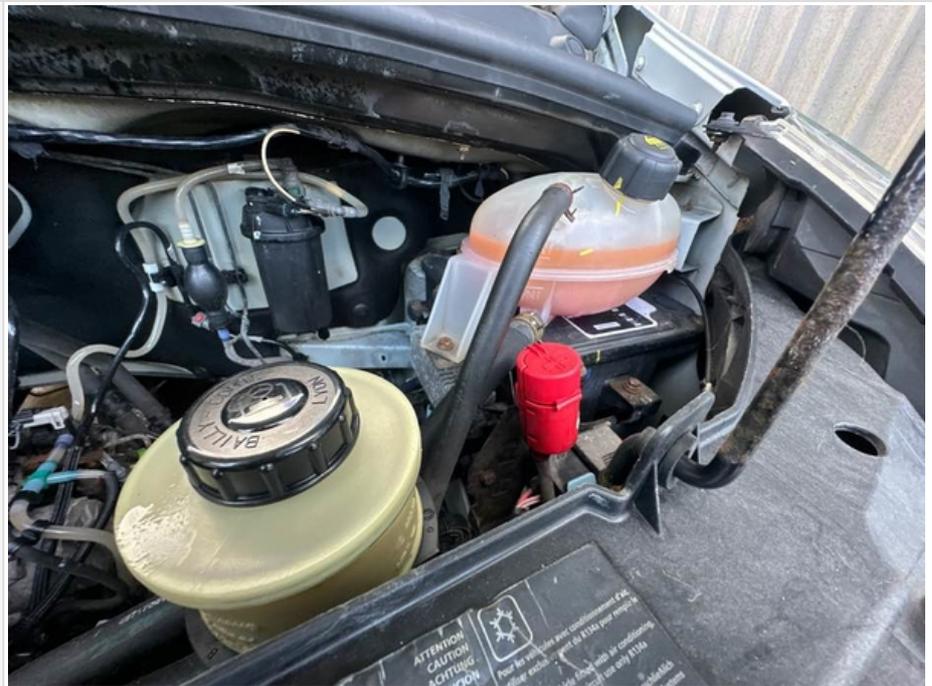
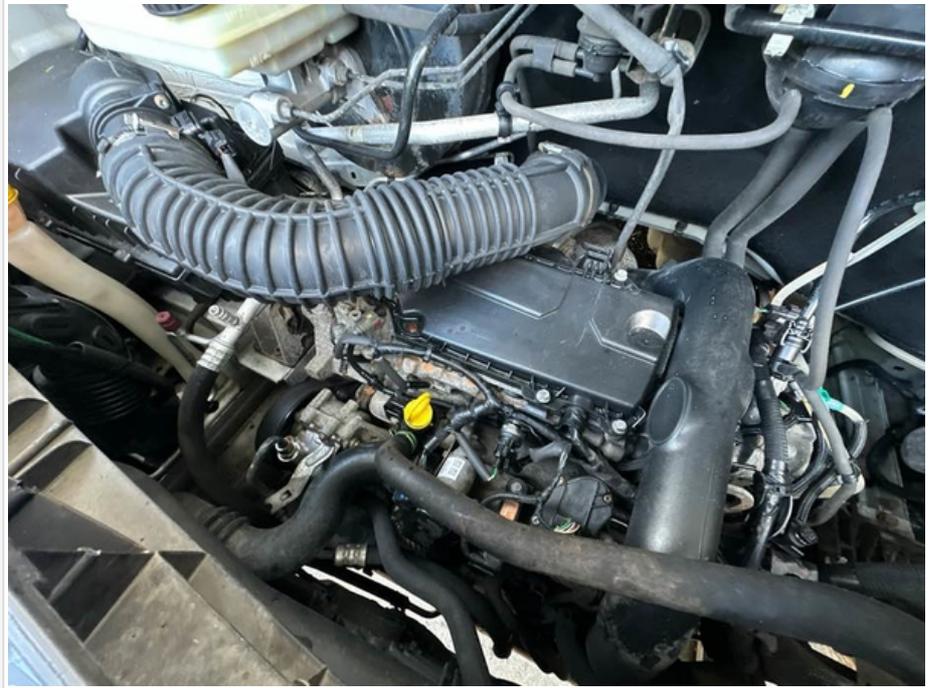
Engine bay photo

Fuel level	1/2 Full
Oil level	Full
Oil conditon	Clean
Start up, chassis battery check	Started without jump pack
Start-up from cold	Instant
Exhaust smoke from cold	Normal
Output Voltage of Alternator test	13.7
Chain or Belt driven engine?	Chain
If belt any proof of change?	n/a
Coolant condition	Clean
Coolant level	Full
Anti-freeze temperature check	-16
Washer fluid	Full
Brake fluid	Full
Power steering fluid	Maximum
Dashboard warning light	No warning lights
OBD Scan results

mechanically well, Air suspension blew up during report, repair needed
