Basevan.com General Inspection

Vehicle registration	WX59MEU
Vehicle chassis no.	VF1FLBHD6AY332031
Miles (if in km, multiply by 0.62)	89694
Make	Renault
Model	Trafic
Transmission	Manual, 6 speed
Factory immobiliser installed	Yes
Speed limiter installed	No
Drive configuration	FWD
Gross Vehicle Weight (kg)	3010
Towing capacity	5010kg
Tow bar installed	No

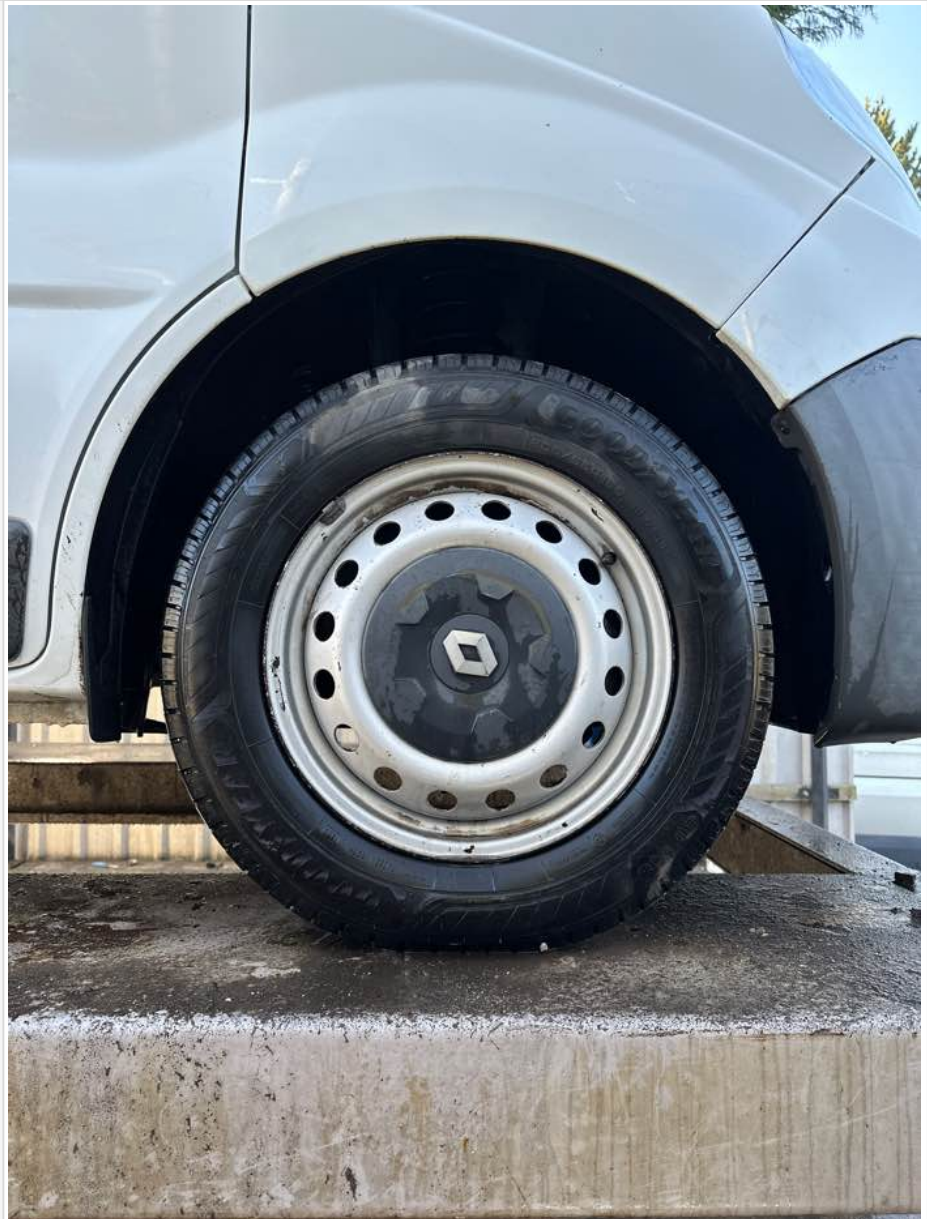
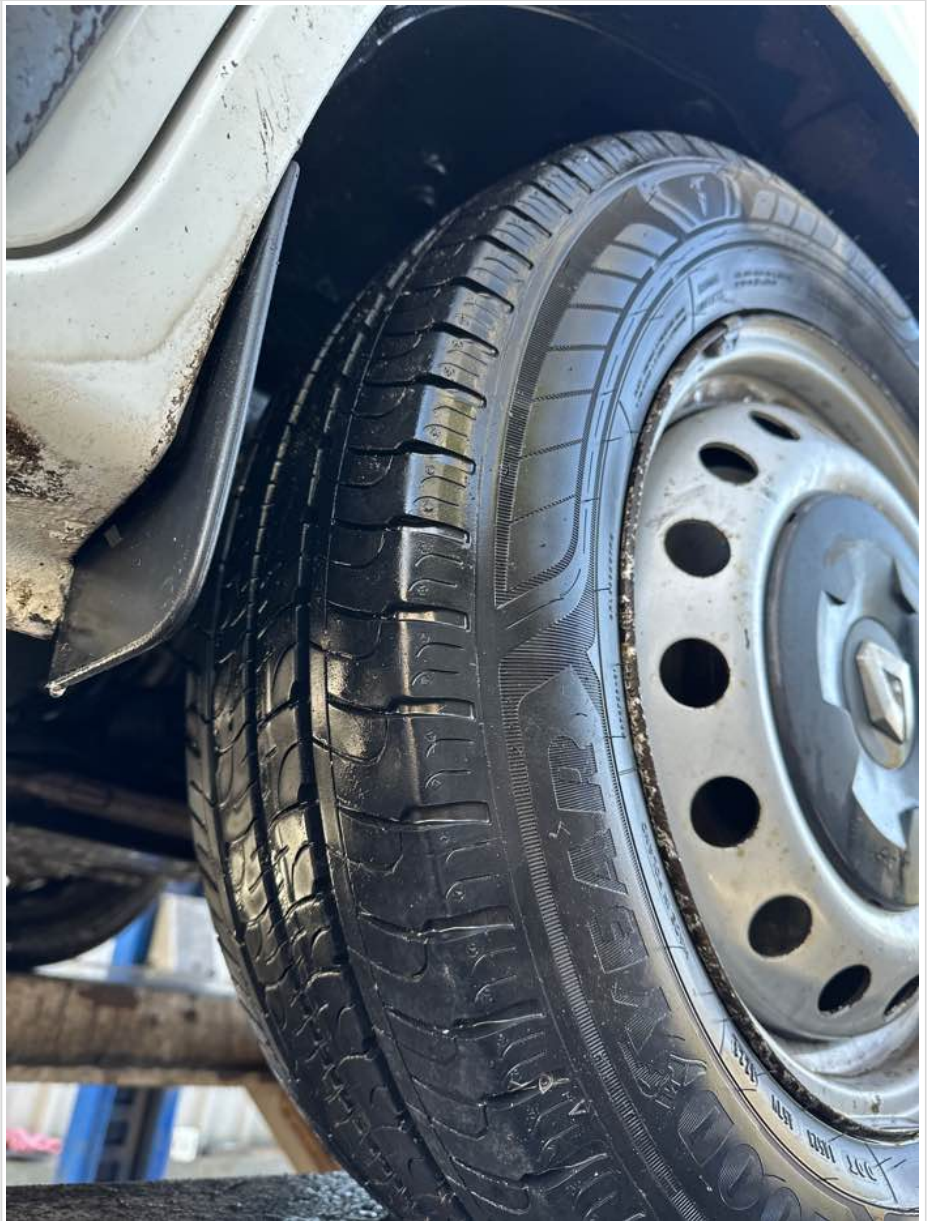
Off side front

Age (month/year) Manufactured	12/23
Make, brand.	Good Year
Tyre size	205/65/R16
Pressure 1	
Pressure 2	
Wearing / Perishing (inner)	none
Wearing / Perishing (outer)	None
tread depth (mm)	7
General comments	Great, virtually brand new

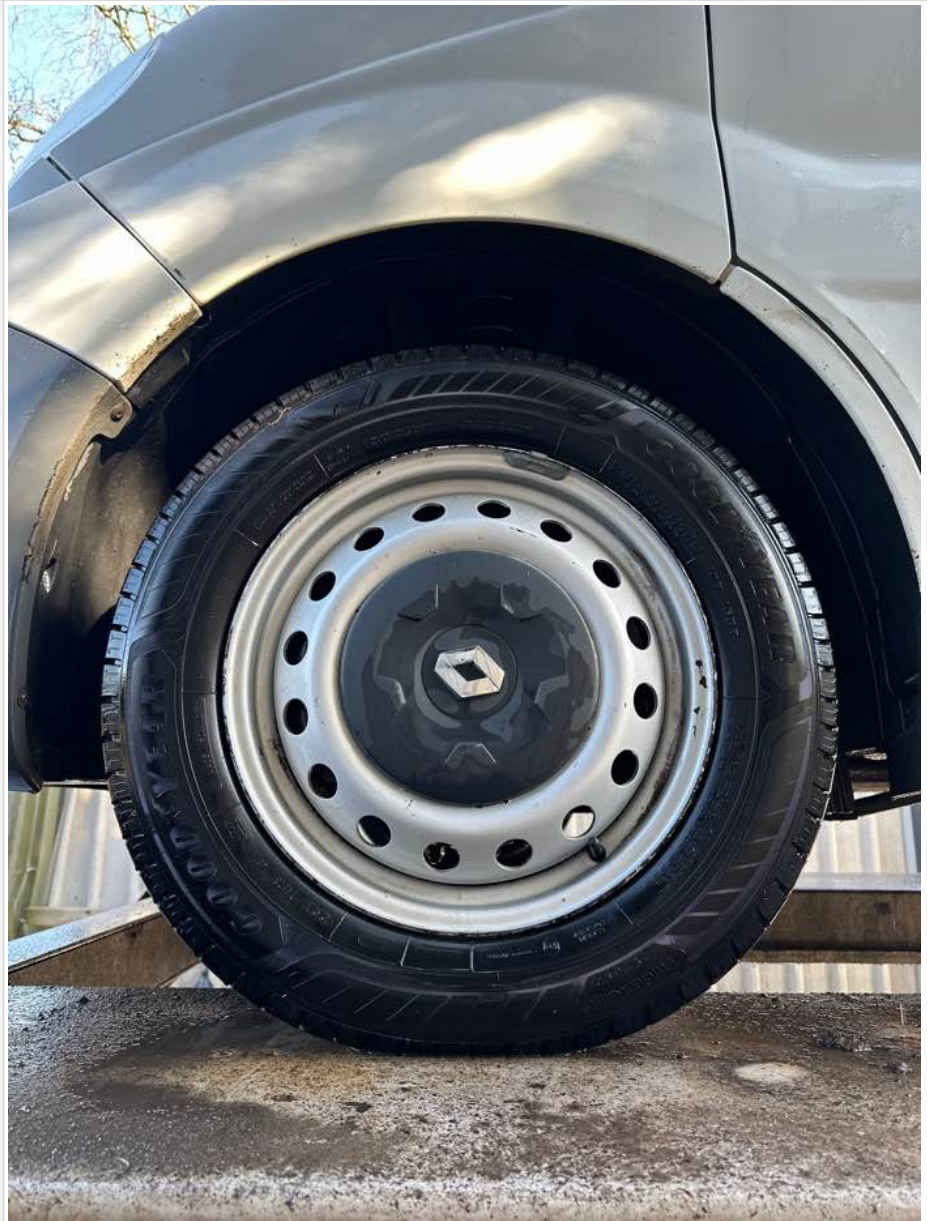
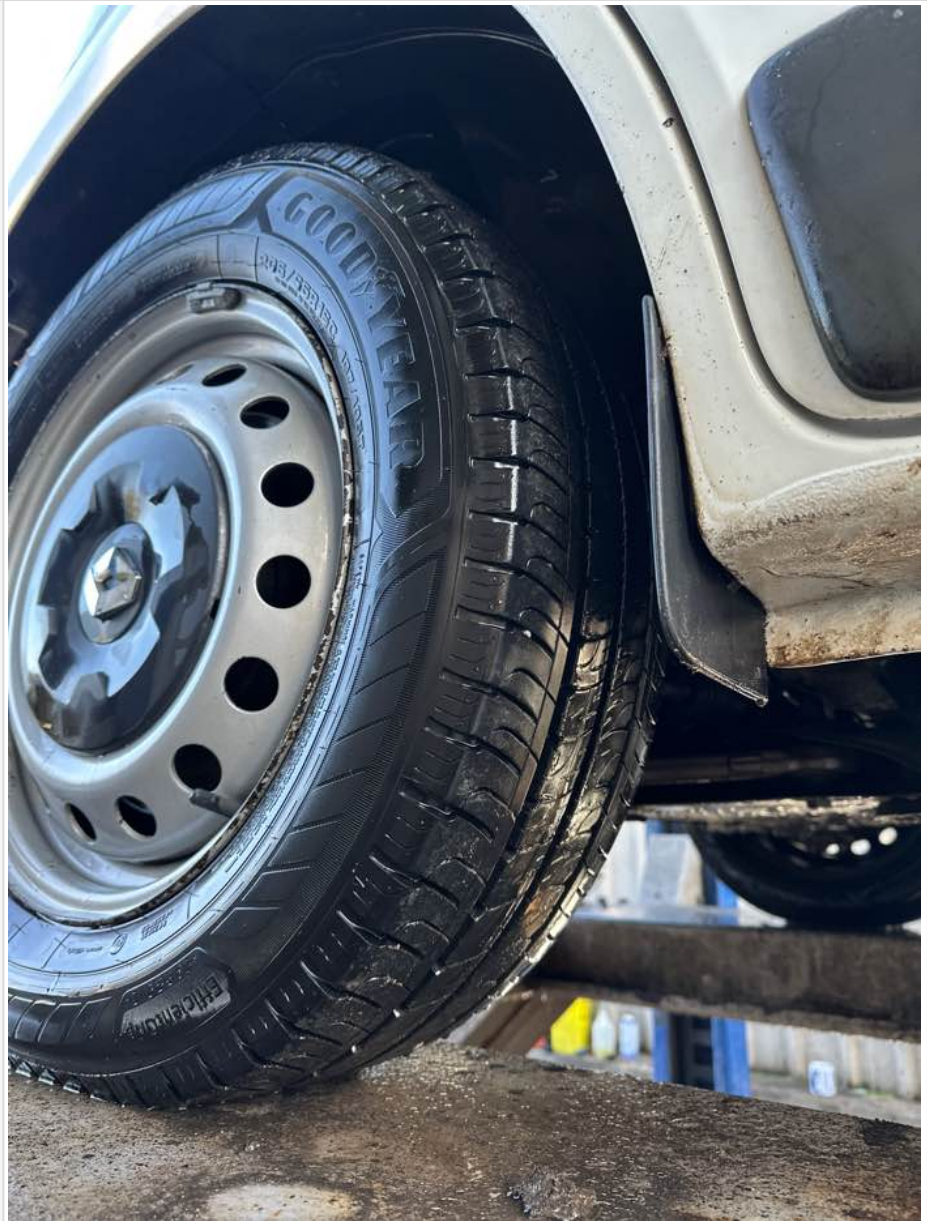
Near side front

Age (month/year) Manufactured	12/23
Make, brand.	Good Year
Tyre size	205/65/R16
Pressure 1	
Pressure 2	
Wearing / Perishing (inner)	none
Wearing / Perishing (outer)	None
tread depth (mm)	7
General comments	virtually brand new again!

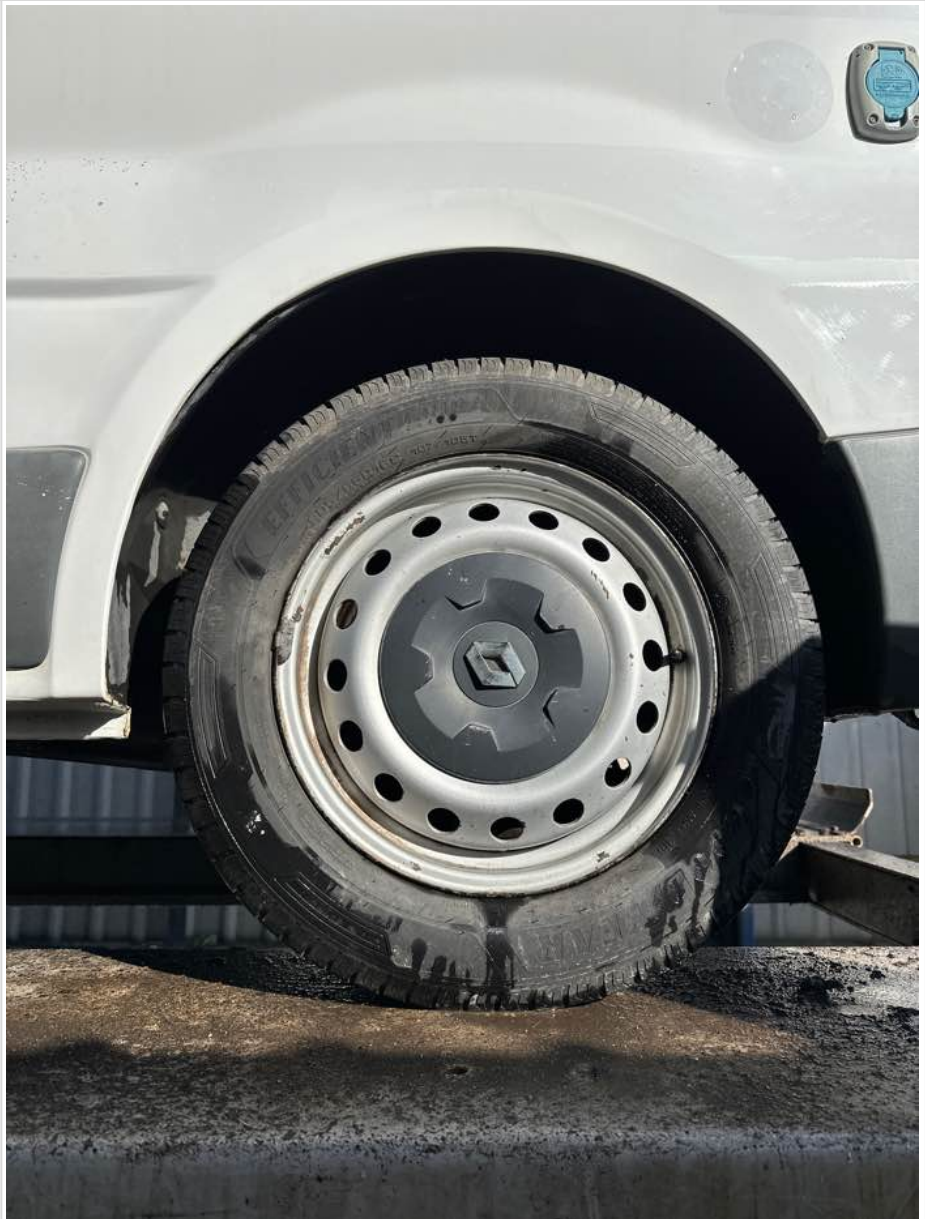
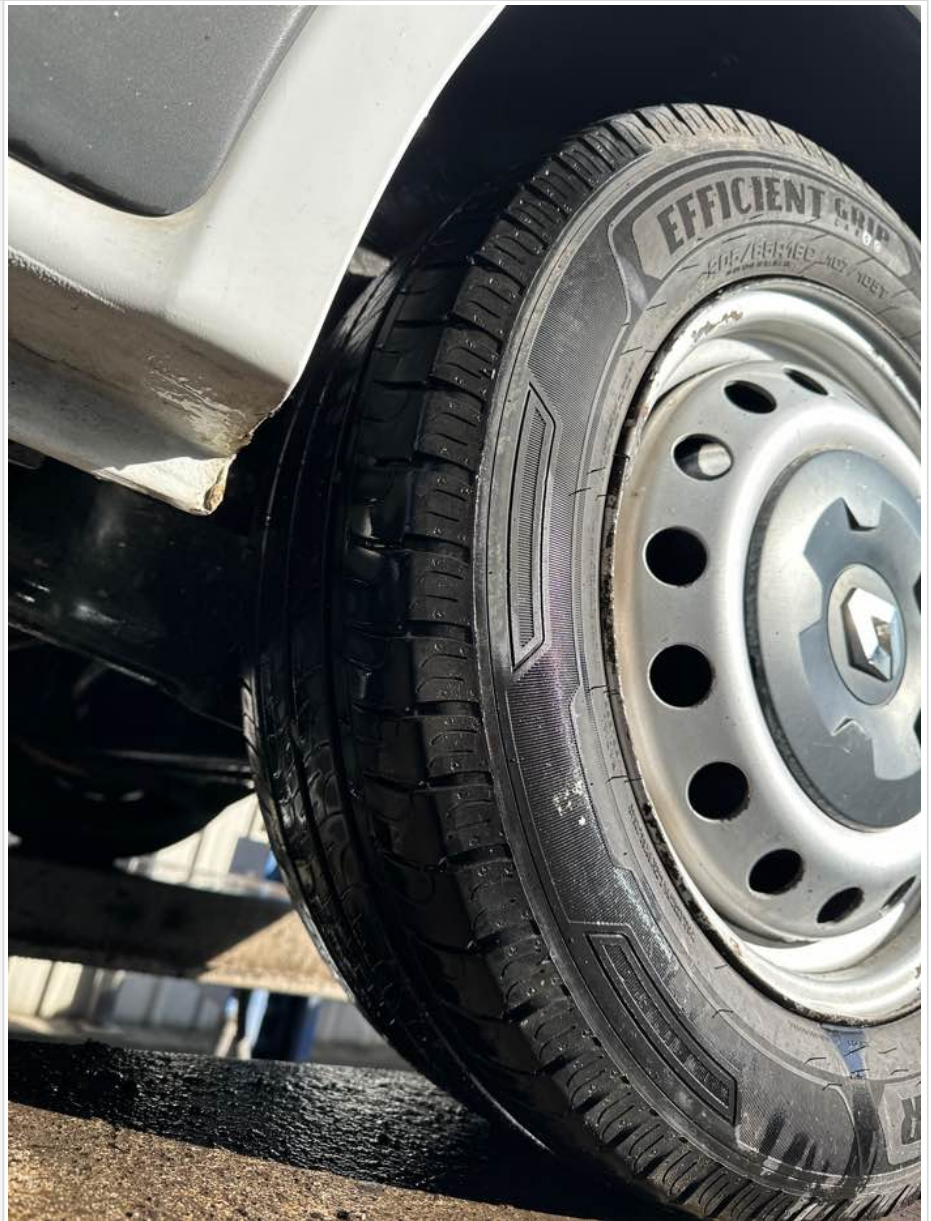
near side rear

Age (month/year) Manufactured	44/21
Make, brand.	Good Year
Tyre size	205/65/R16
Pressure 1	
Pressure 2	
Wearing / Perishing (inner)	none
Wearing / Perishing (outer)	None
tread depth (mm)	7
General comments	virtually brand new, again

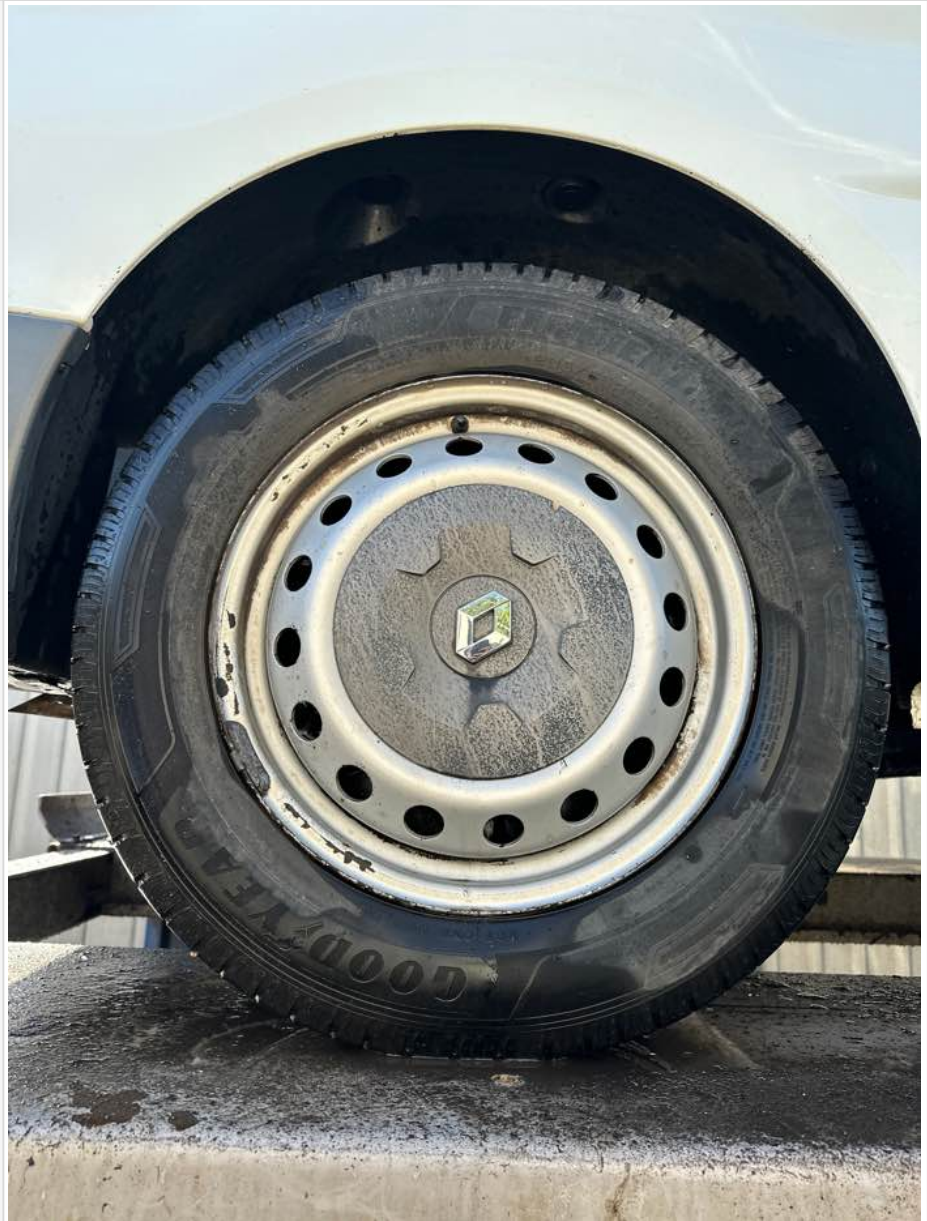
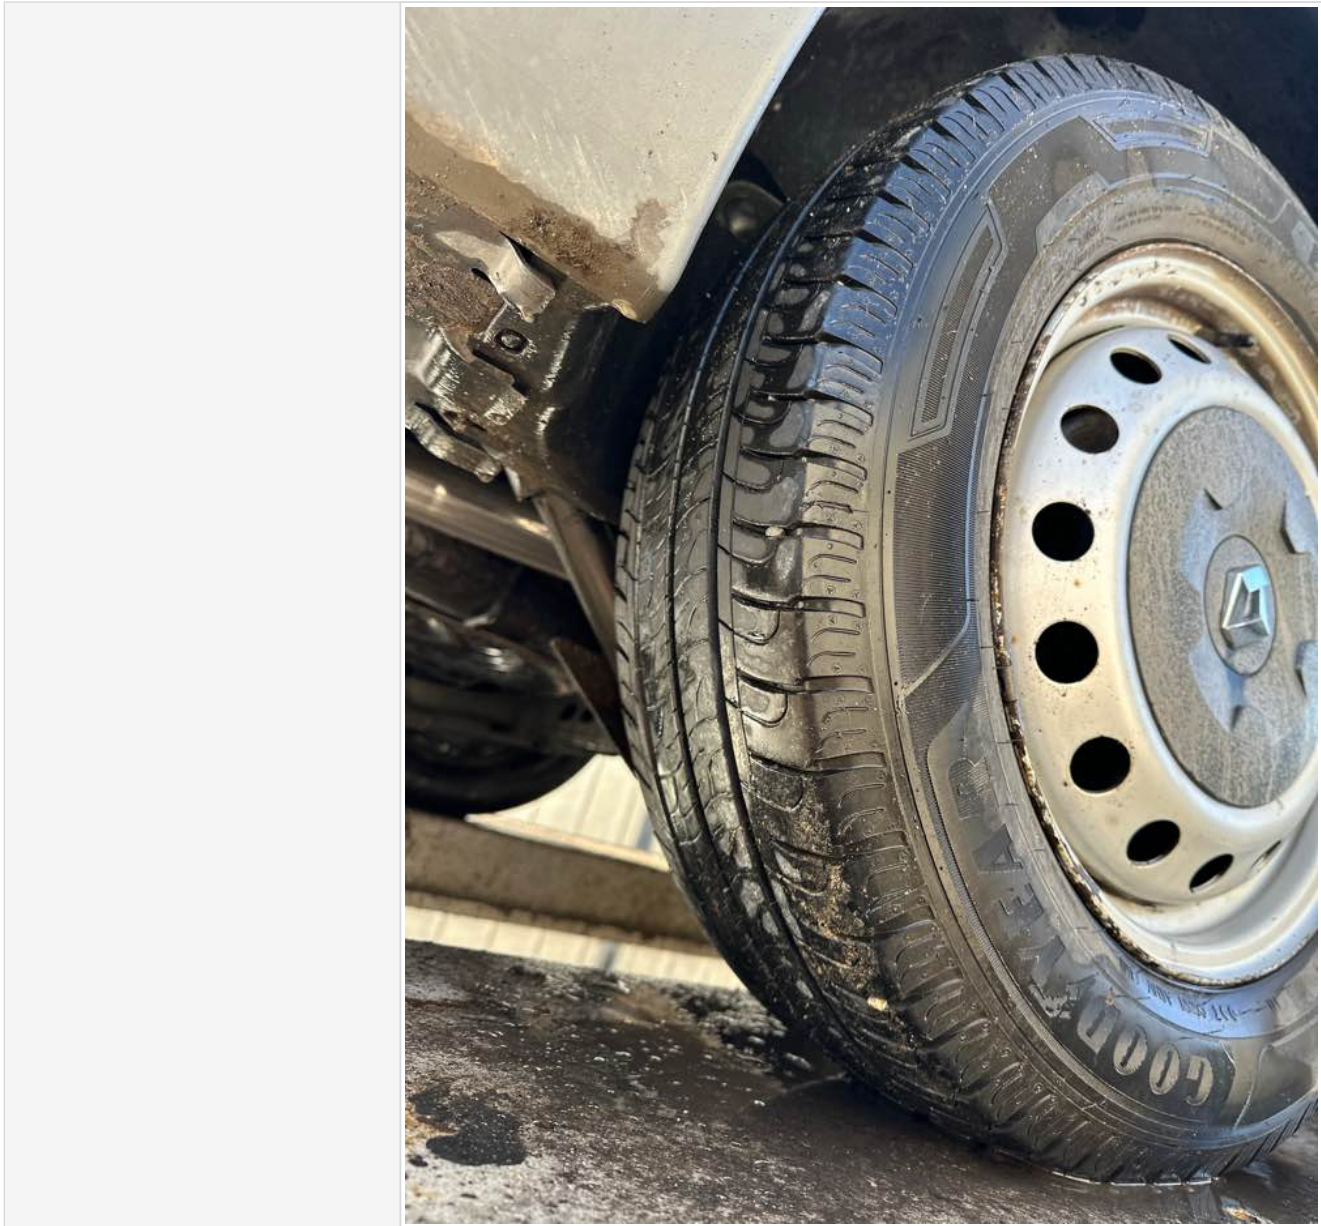
Off side rear

Age (month/year) Manufactured	45/21
Make, brand.	Good Year
Tyre size	205/65/R16
Pressure 1	
Pressure 2	
Wearing / Perishing (inner)	none
Wearing / Perishing (outer)	None
tread depth (mm)	6
General comments	great set, plastic wheel trim damaged (wheel cleaner)

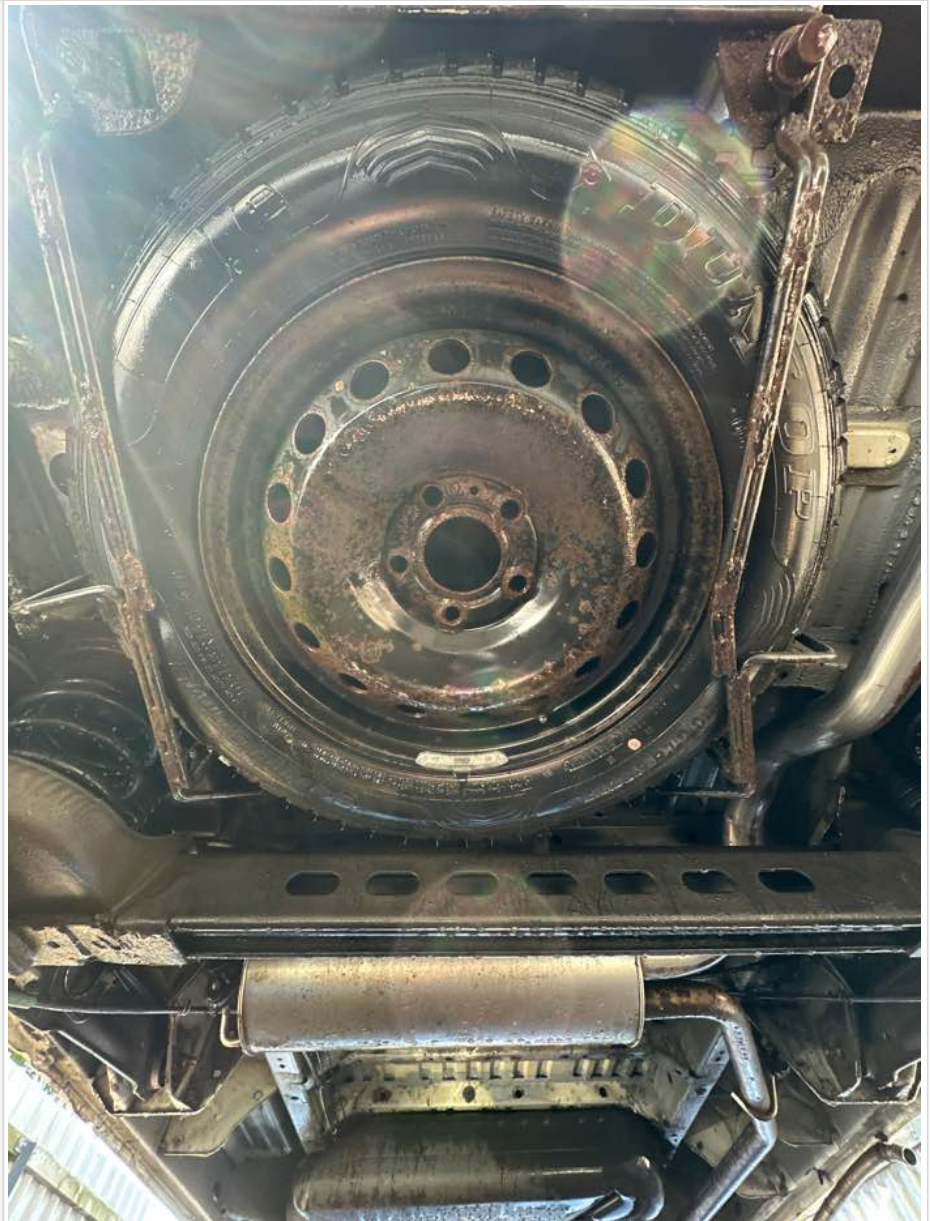
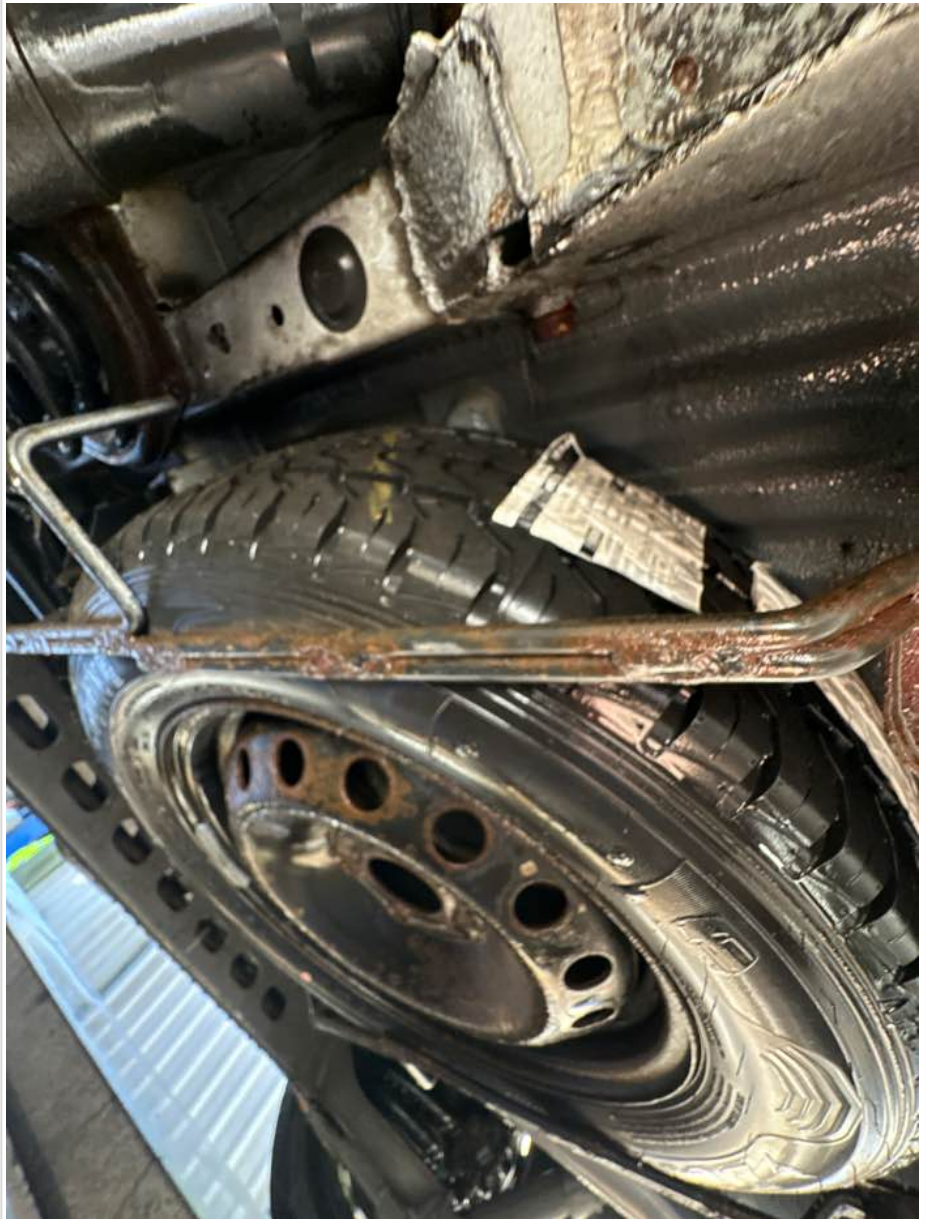
Spare wheel

Spare installed? (If no, don't fill out)	Yes
Age (month/year) Manufactured	30/13
Make, brand.	Dunlop
Tyre size	205/65/R16
Pressure 1	
Pressure 2	
Wearing / Perishing (inner)	none
Wearing / Perishing (outer)	None
tread depth (mm)	10
General comments	BRAND NEW CONDITION STICKER STILL ON TYRE

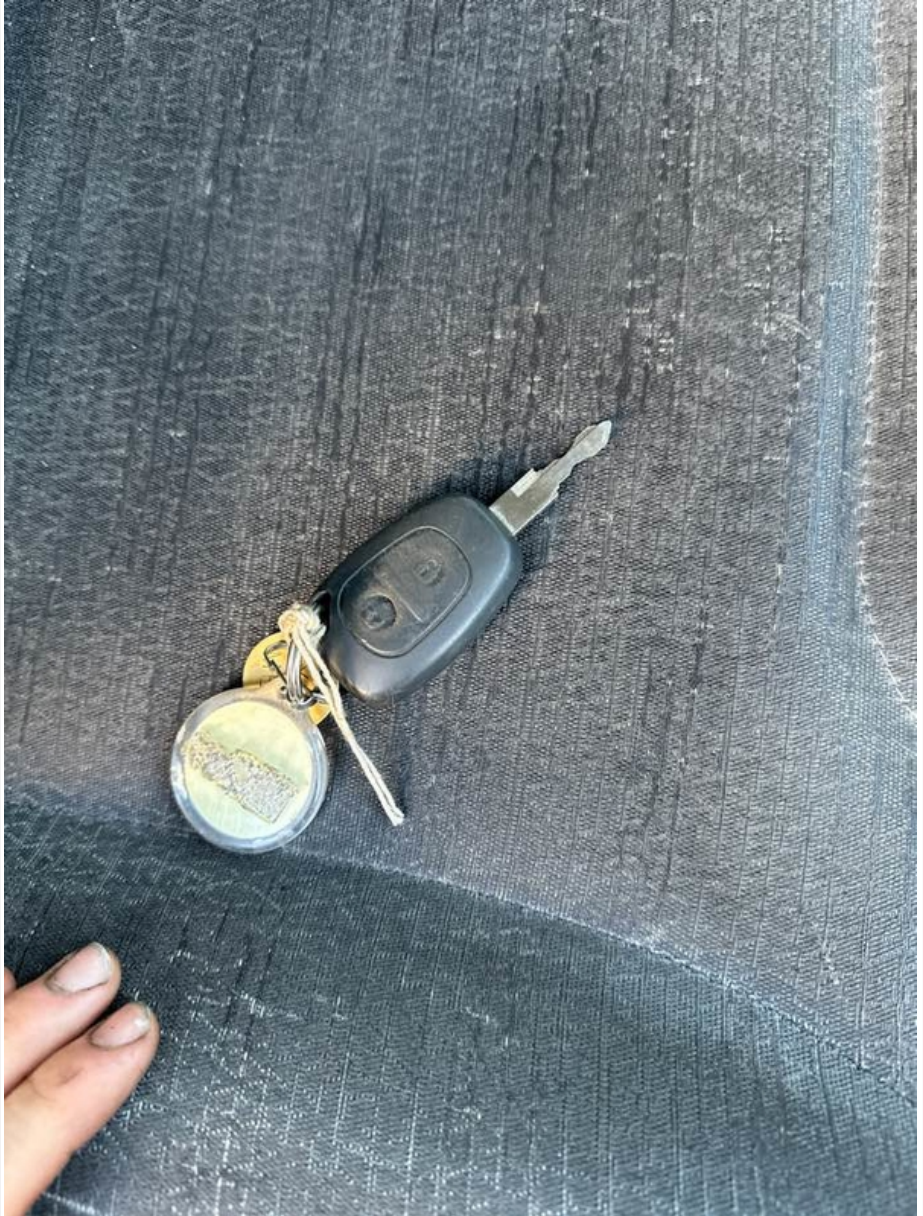
In conclusion can all the doors be locked in some way and thus the vehicle can be left unattended at night safely?	Yes
How many keys present at time of inspection?

Comment	works as should

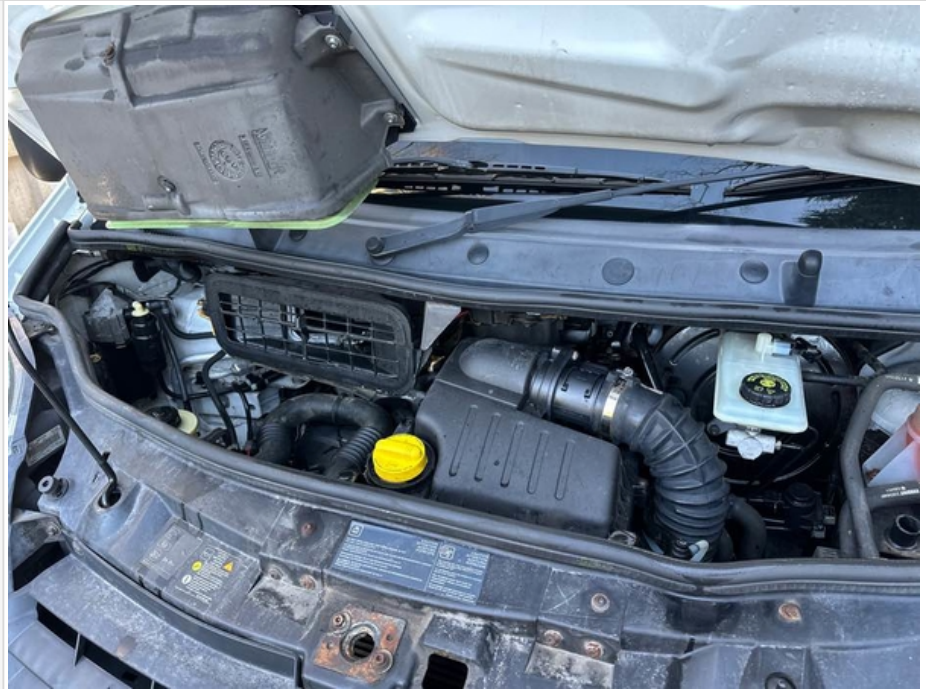
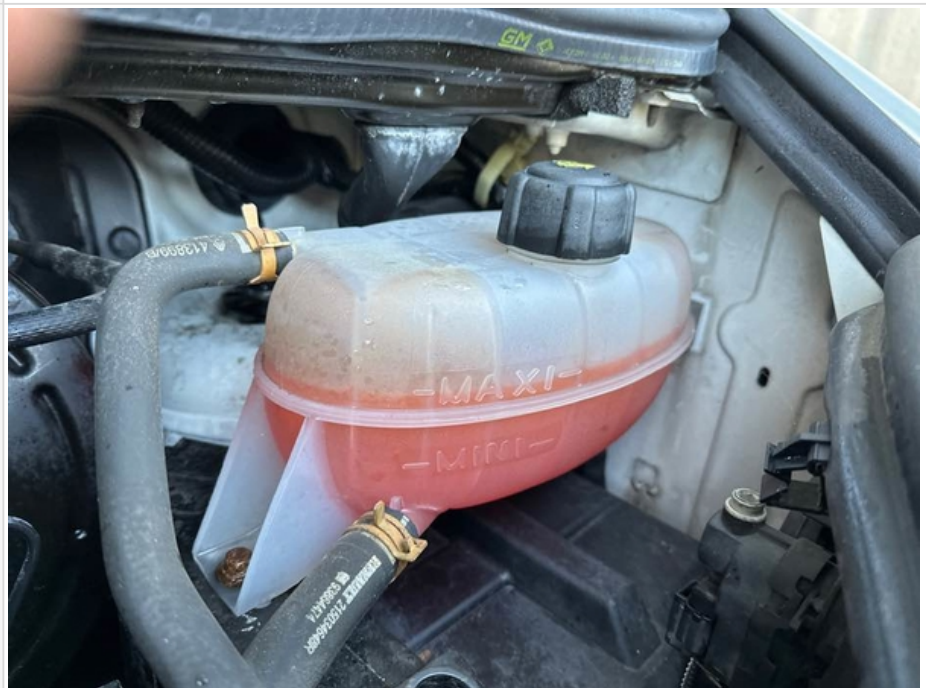
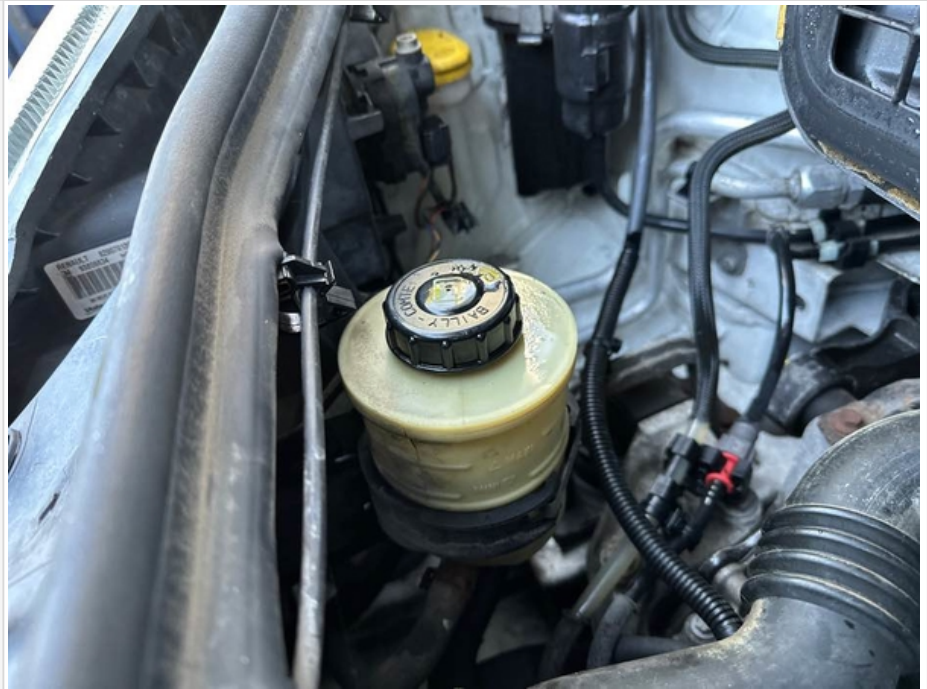
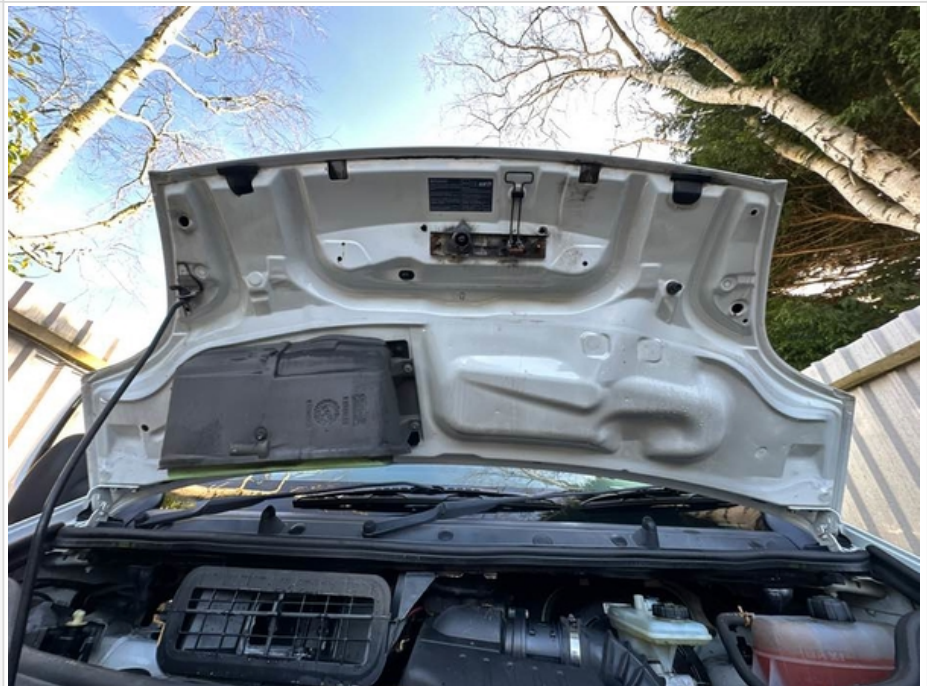
Engine bay photo

clean van, engine is good
