Basevan.com General Inspection

Vehicle registration	LJ15LJY
Vehicle chassis no.	WOLMTF8ZWFB069068
Miles (if in km, multiply by 0.62)	52915mi
Make	Vauxhall
Model	Movano
Transmission	Manual, 6 speed
Factory immobiliser installed	Yes
Speed limiter installed	No
Drive configuration	RWD
Gross Vehicle Weight (kg)	4500
Towing capacity	3000kg
Tow bar installed	No

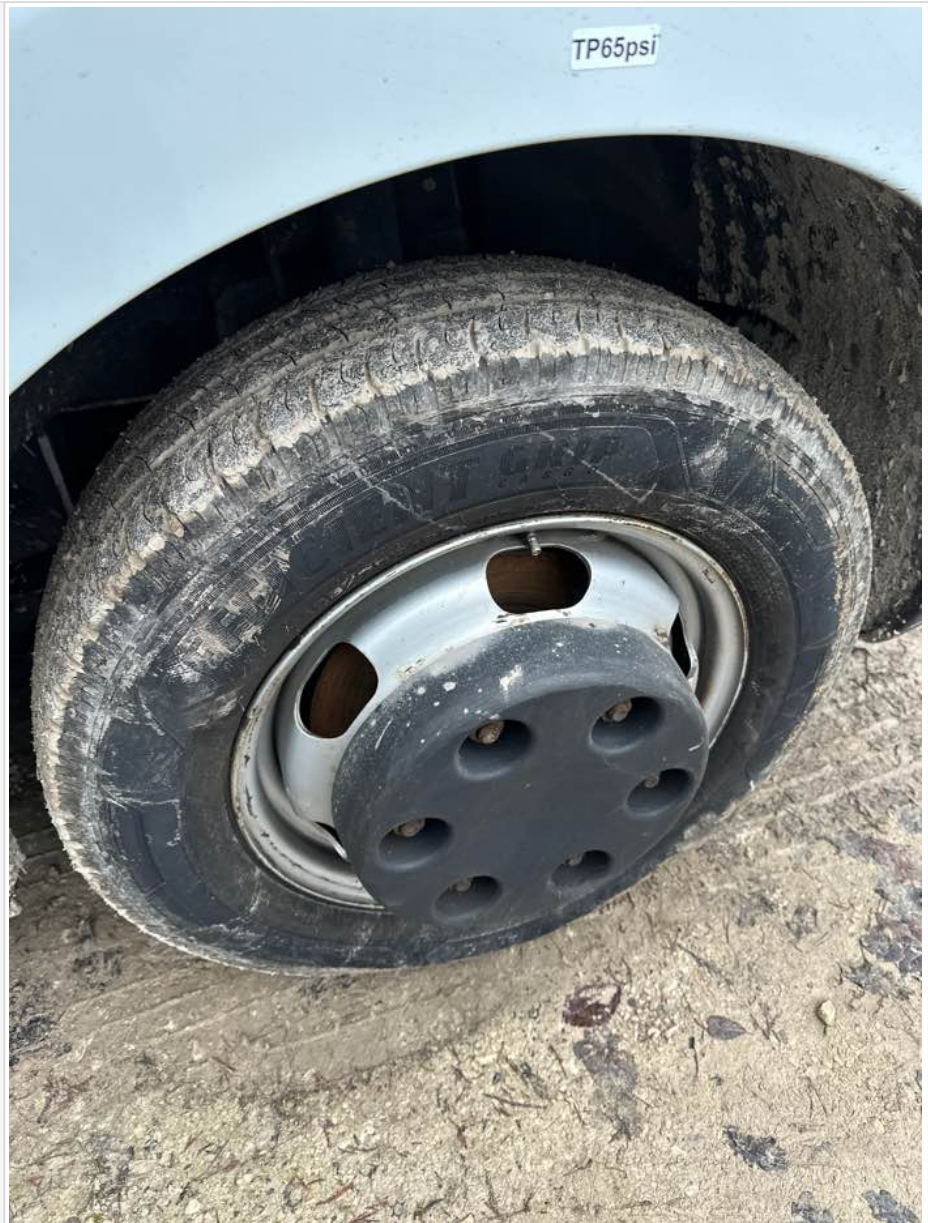
Off side front

Age (month/year) Manufactured	03/21
Make, brand.	Good Year
Tyre size	195/75/R16
Pressure 1	
Pressure 2	
Wearing / Perishing (inner)	none
Wearing / Perishing (outer)	None
tread depth (mm)	7
General comments	Hardly used

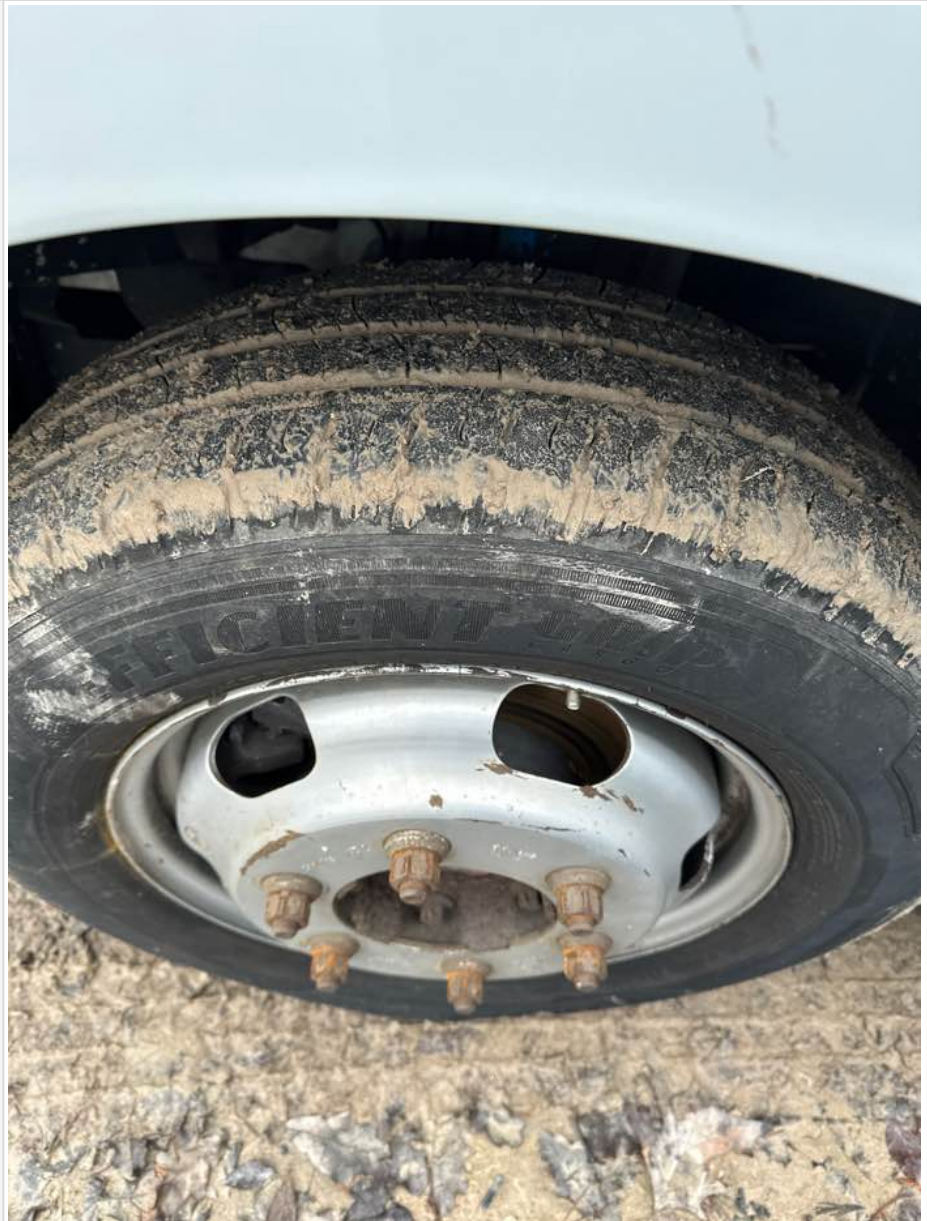
Near side front

Age (month/year) Manufactured	04/21
Make, brand.	Good Year
Tyre size	195/75/R16
Pressure 1	
Pressure 2	
Wearing / Perishing (inner)	none
Wearing / Perishing (outer)	None
tread depth (mm)	5
General comments	good tread

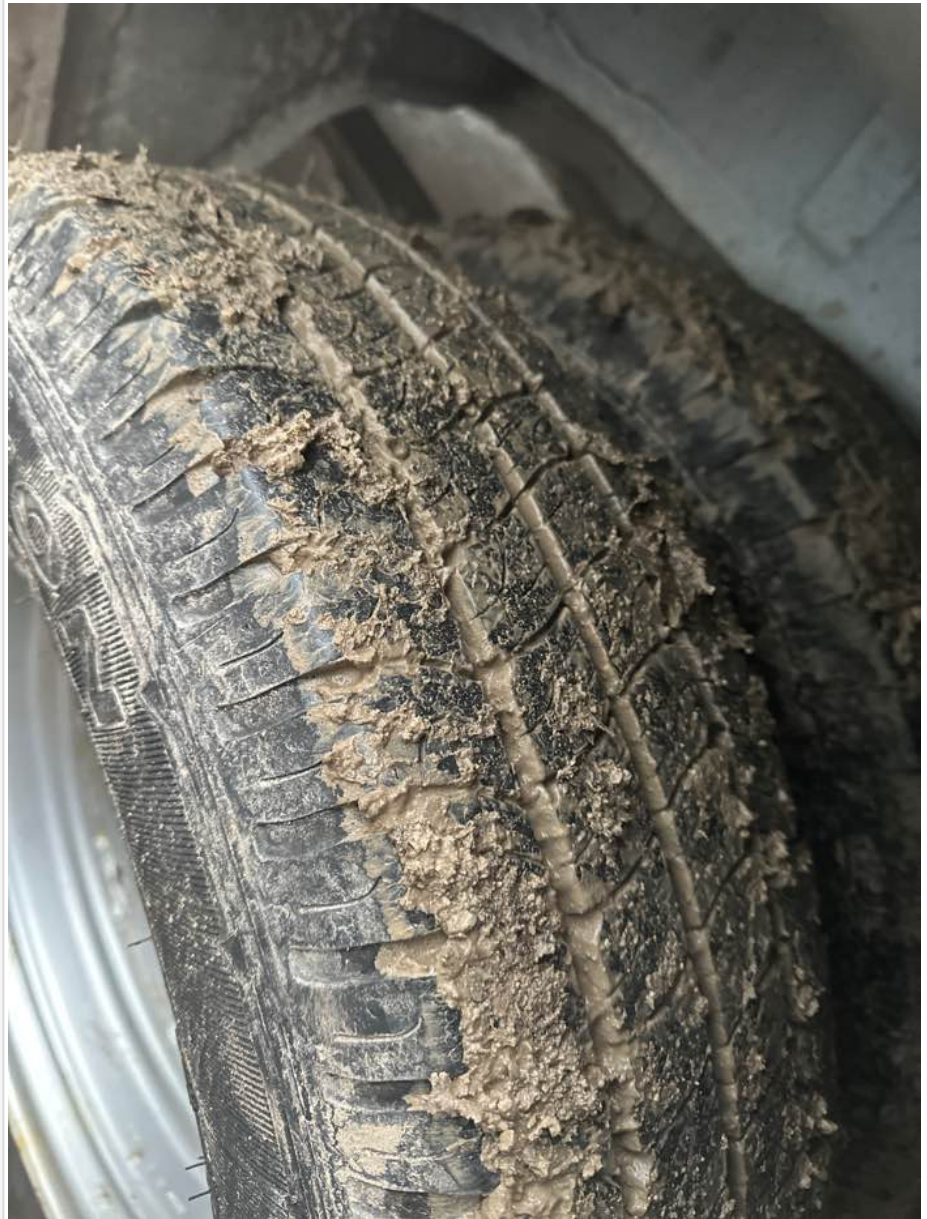
near side rear

Age (month/year) Manufactured	16/19
Make, brand.	Good Year
Tyre size	195/75/R16
Pressure 1	
Pressure 2	
Wearing / Perishing (inner)	none
Wearing / Perishing (outer)	None
tread depth (mm)	7
General comments	Barely used

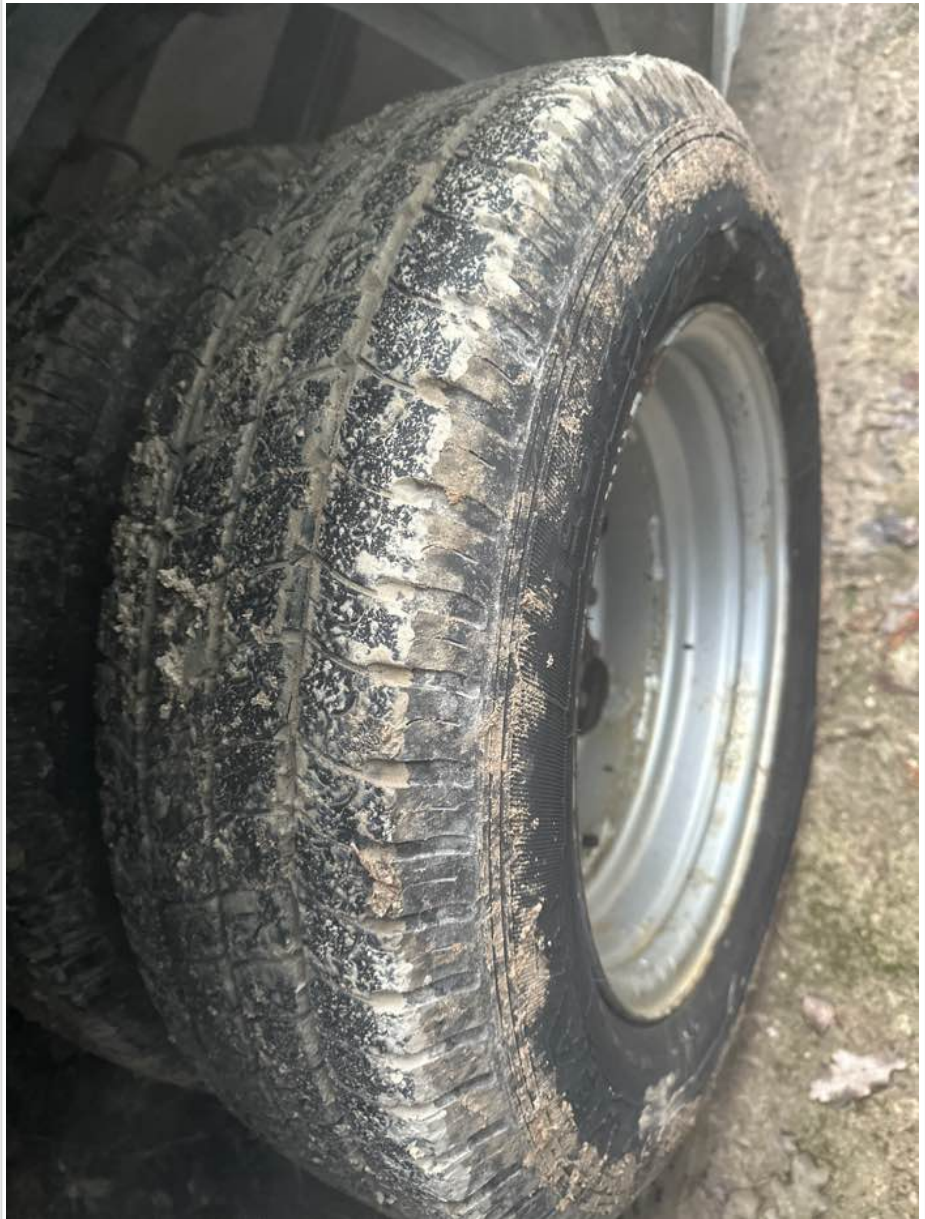
Off side rear

Age (month/year) Manufactured	16/19
Make, brand.	Good Year
Tyre size	195/75/R16
Pressure 1	
Pressure 2	
Wearing / Perishing (inner)	none
Wearing / Perishing (outer)	None
tread depth (mm)	7
General comments	hardly used

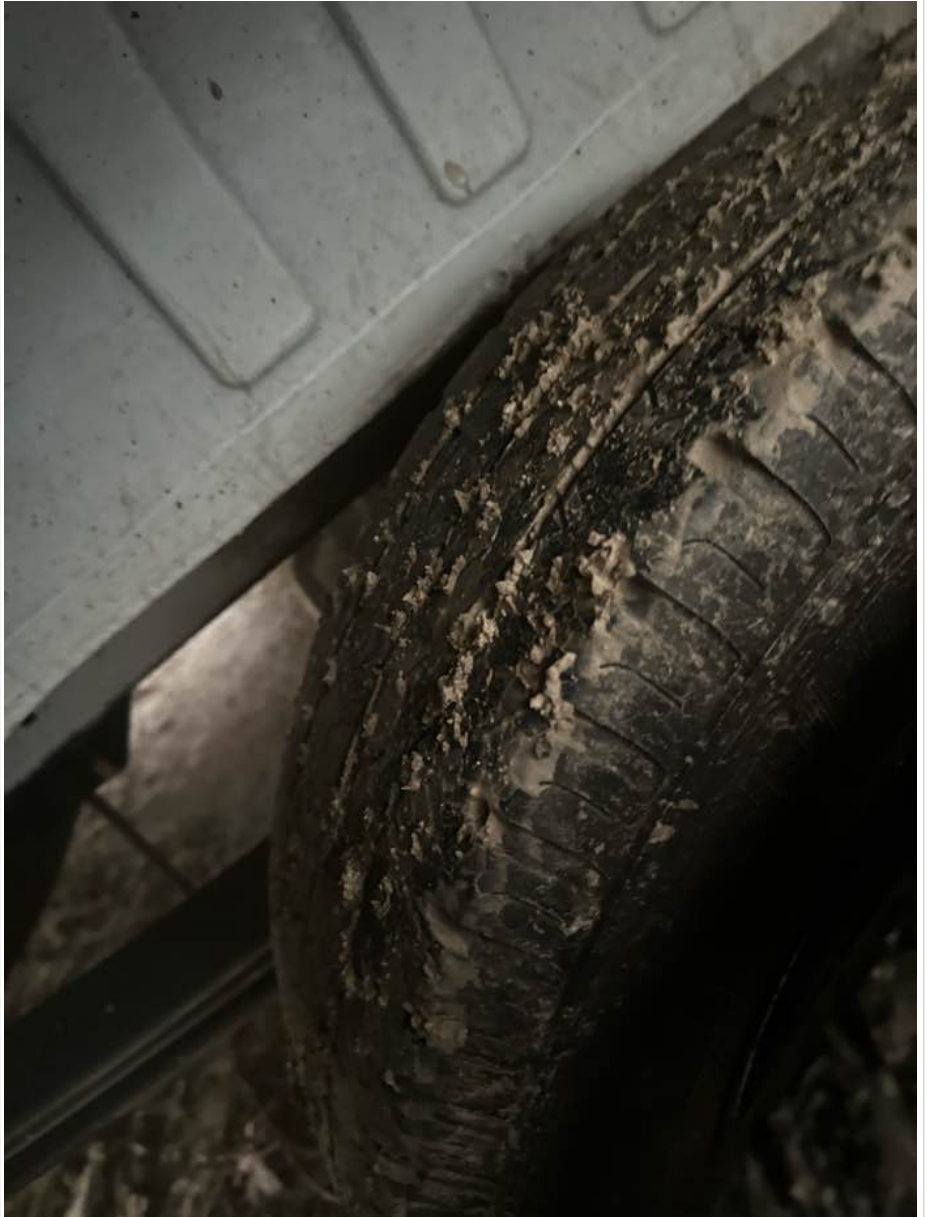
off side Inner (for twin wheel vans)

Is the vehicle a twin wheel axle? (if no don't fill out)	Yes
Age (month/year) Manufactured	16/19
Make, brand.	Good Year
Tyre size	195/75/R16
Pressure 1	
Pressure 2	
Wearing / Perishing (inner)	none
Wearing / Perishing (outer)	None

tread depth (mm)	7
General comments	hardly used
Images of tyre

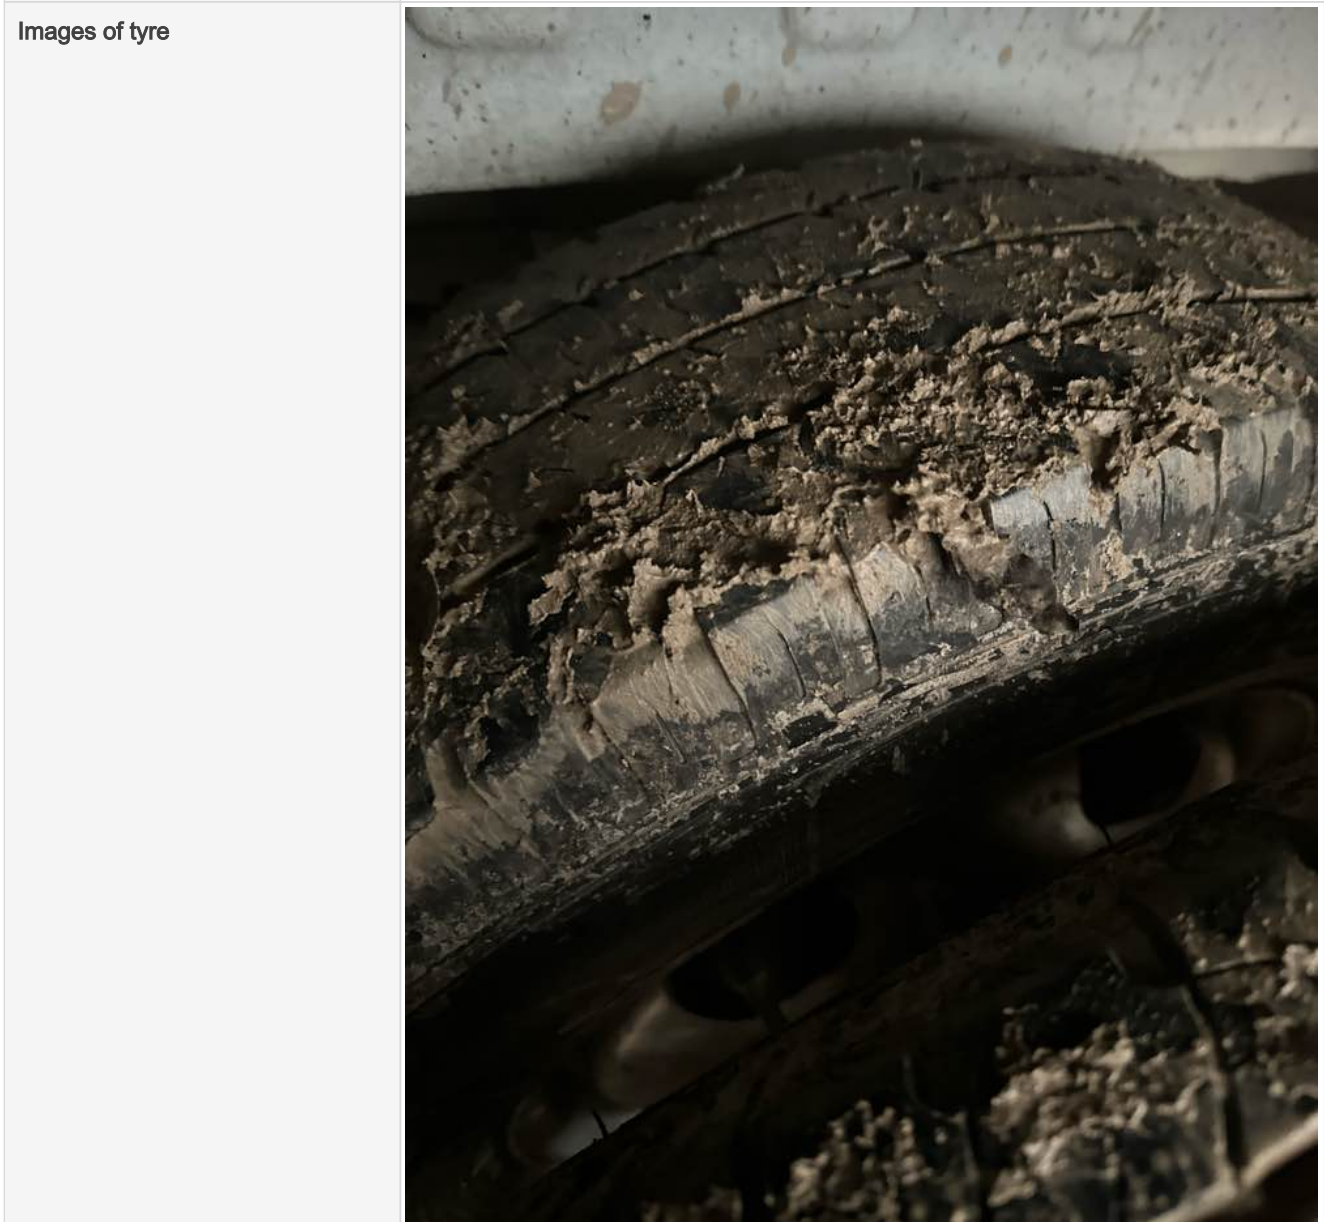
near side Inner (for twin wheel vans)

Is the vehicle a twin wheel axle? (if no don't fill out)	Yes
Age (month/year) Manufactured	
Make, brand.	Good Year
Tyre size	195/75/R16
Pressure 1	
Pressure 2

Wearing / Perishing (inner)	none
Wearing / Perishing (outer)	None
tread depth (mm)	7
General comments	good tread

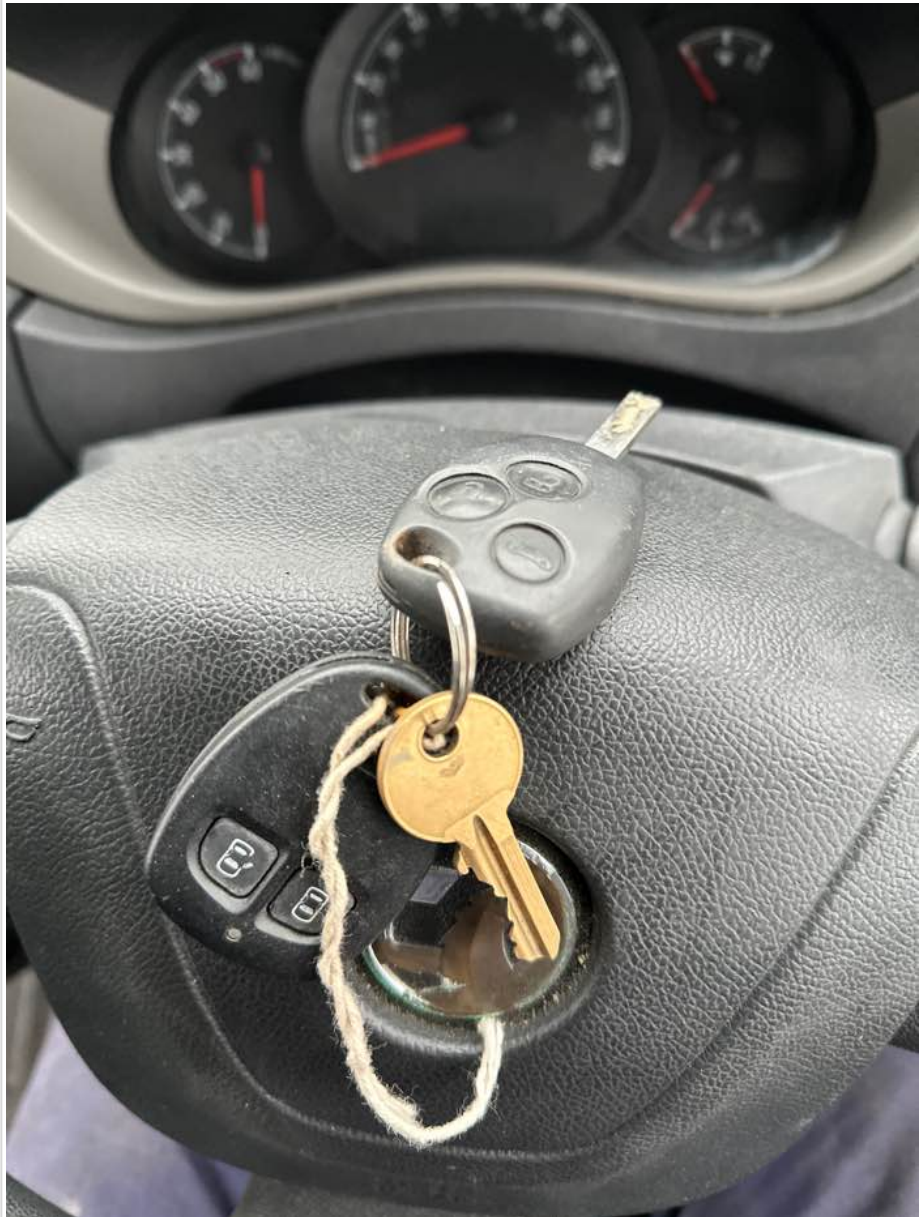
Vehicle locking

Factory central locking fitted?	Yes
Response from key fob?	Yes
Response from in-cab locking button?	Yes
Do all the doors lock from central locking function?	All
Select the following doors that lock.	N/S Front, O/S Front, N/S SL, N/S Rear, O/S Rear
Method of locking	Fob
In conclusion can all the doors be locked in some way and thus the vehicle can be left unattended at night safely?	Yes

works as infended

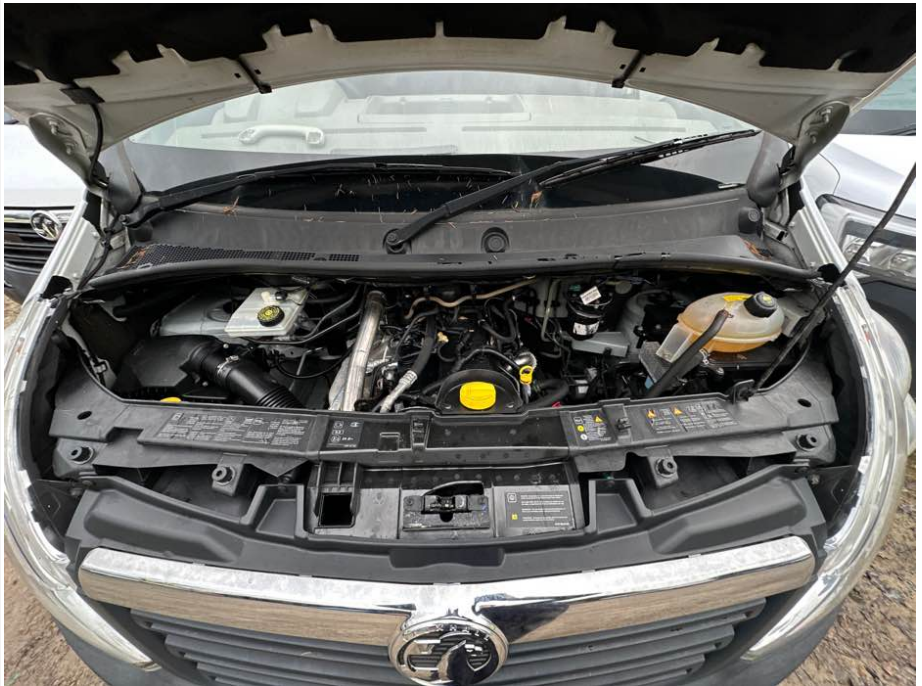
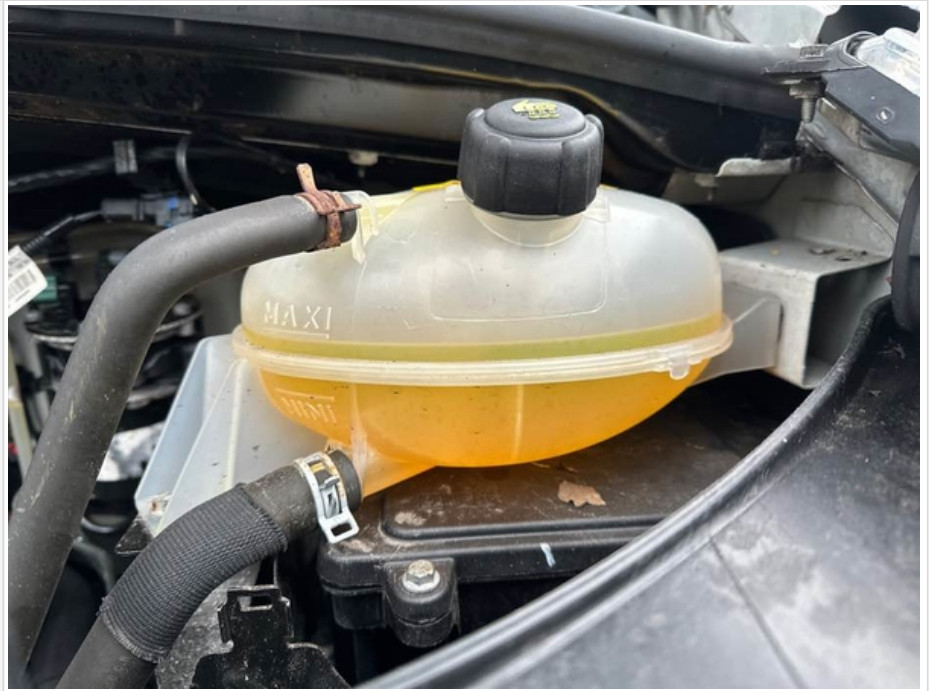
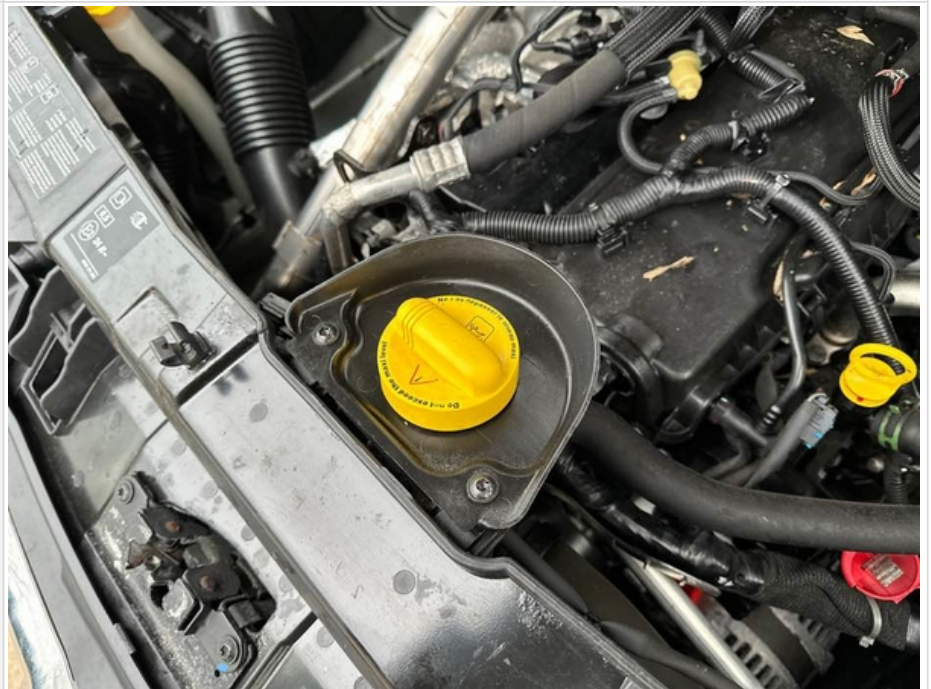
General mechanical checks

Fuel level	1/2 Full
Oil level	Full
Oil conditon	Clean
Start up, chassis battery check	Started without jump pack

Start-up from cold	Instant
Exhaust smoke from cold	Normal
Output Voltage of Alternator test	13.6
Chain or Belt driven engine?	Chain
If belt any proof of change?	n/a
Coolant condition	Clean
Coolant level	Full
Anti-freeze temperature check	-15
Washer fluid	Medium
Brake fluid	Full
Power steering fluid	Maximum
Dashboard warning light	No warning lights
OBD Scan results	
Engine bay photo

Really nice low mileage example!!
