## Basevan.com General Inspection

Name of inspector	Rupert Beeston
Date of inspection	26/01/2025
Signature

Vehicle registration	GN08OTA
Vehicle chassis no.	WV1ZZZ2EZ86024141
Miles (if in km, multiply by 0.62)	128,595
Make	VW
Model	Crafter CR50 2.5 MANUAL LWB
Transmission	6 speed
Factory immobiliser installed	Yes
Speed limiter installed	No
Drive configuration	RWD
Gross Vehicle Weight (kg)	5000
Towing capacity	2000
Tow bar installed	No

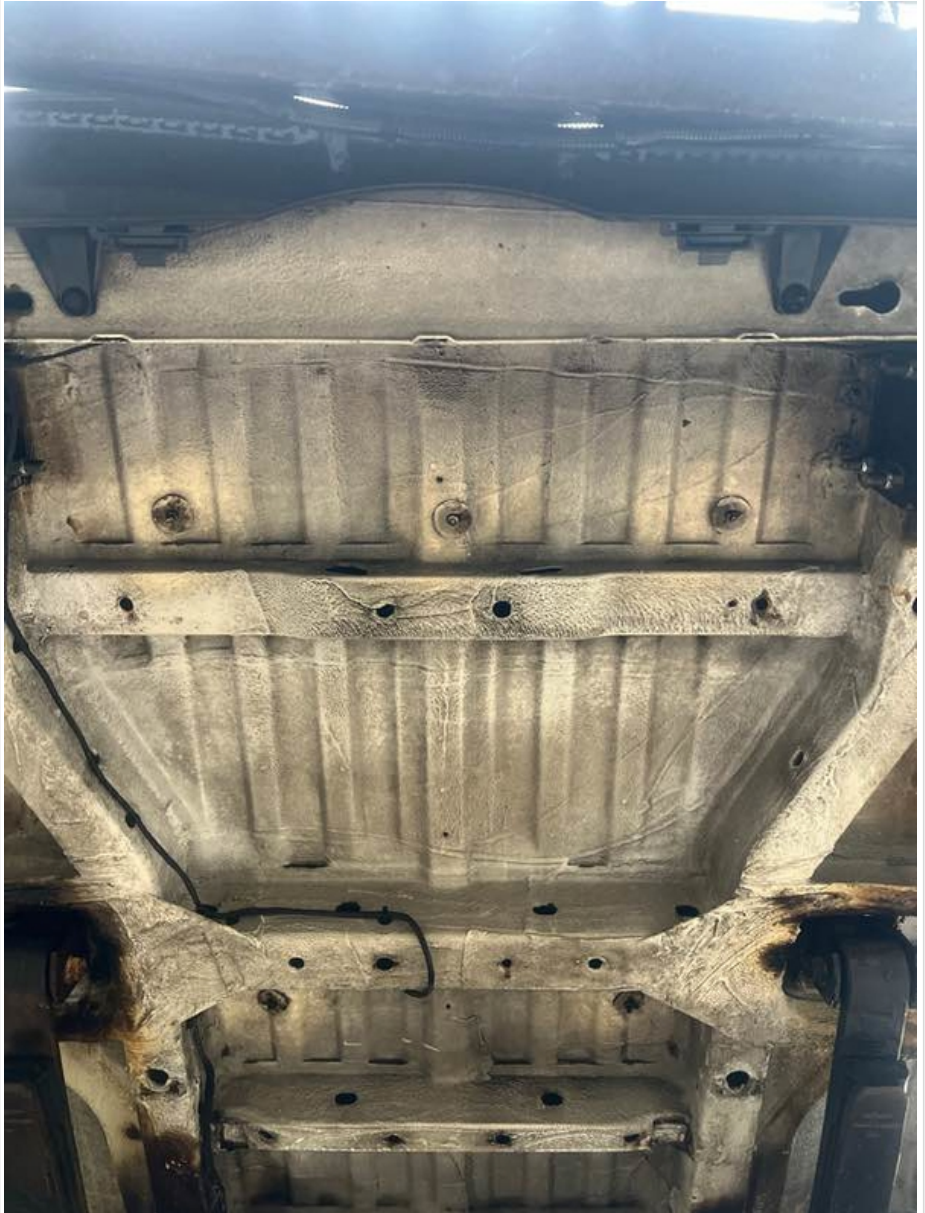
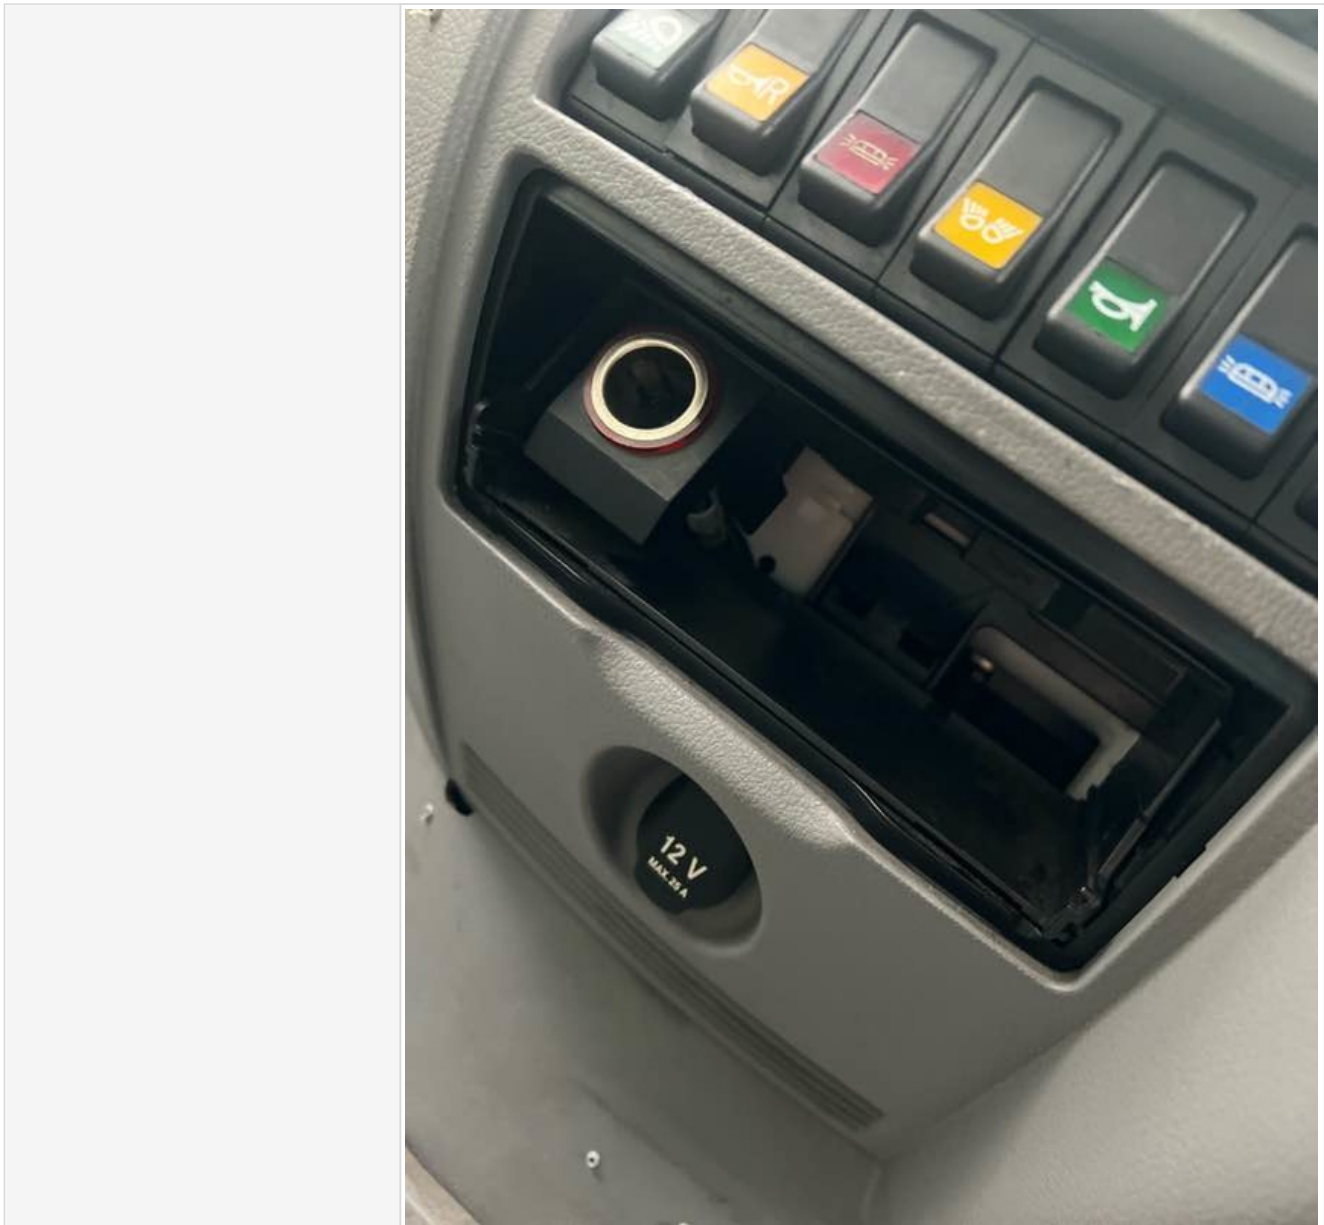
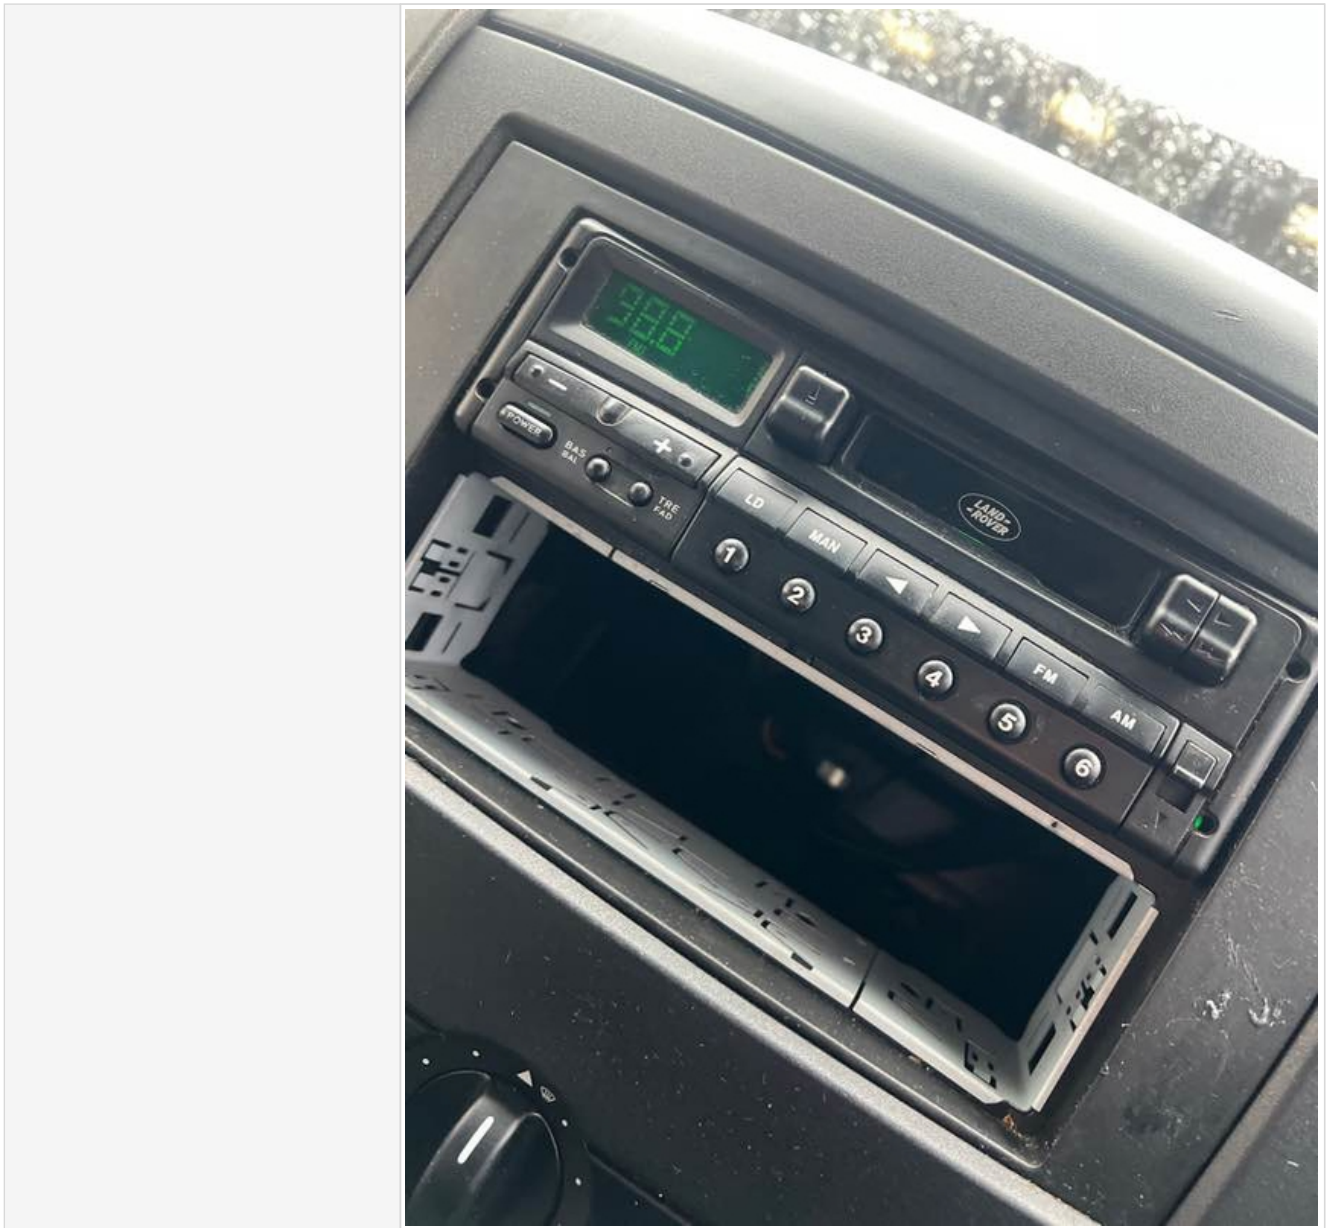
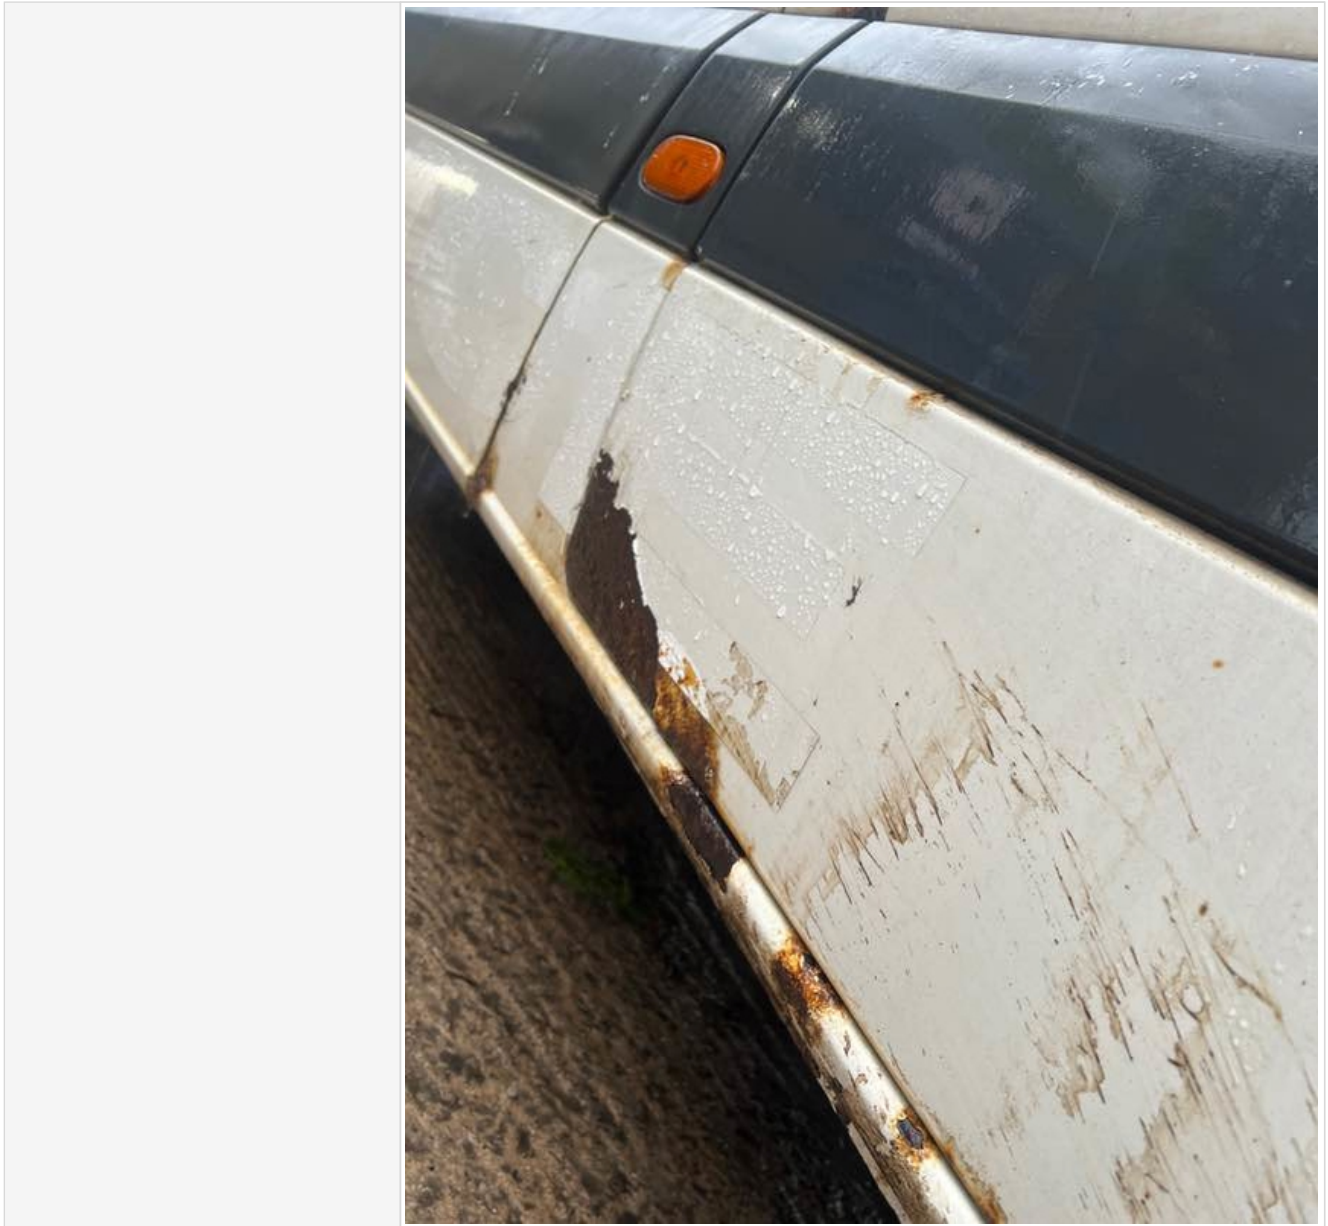
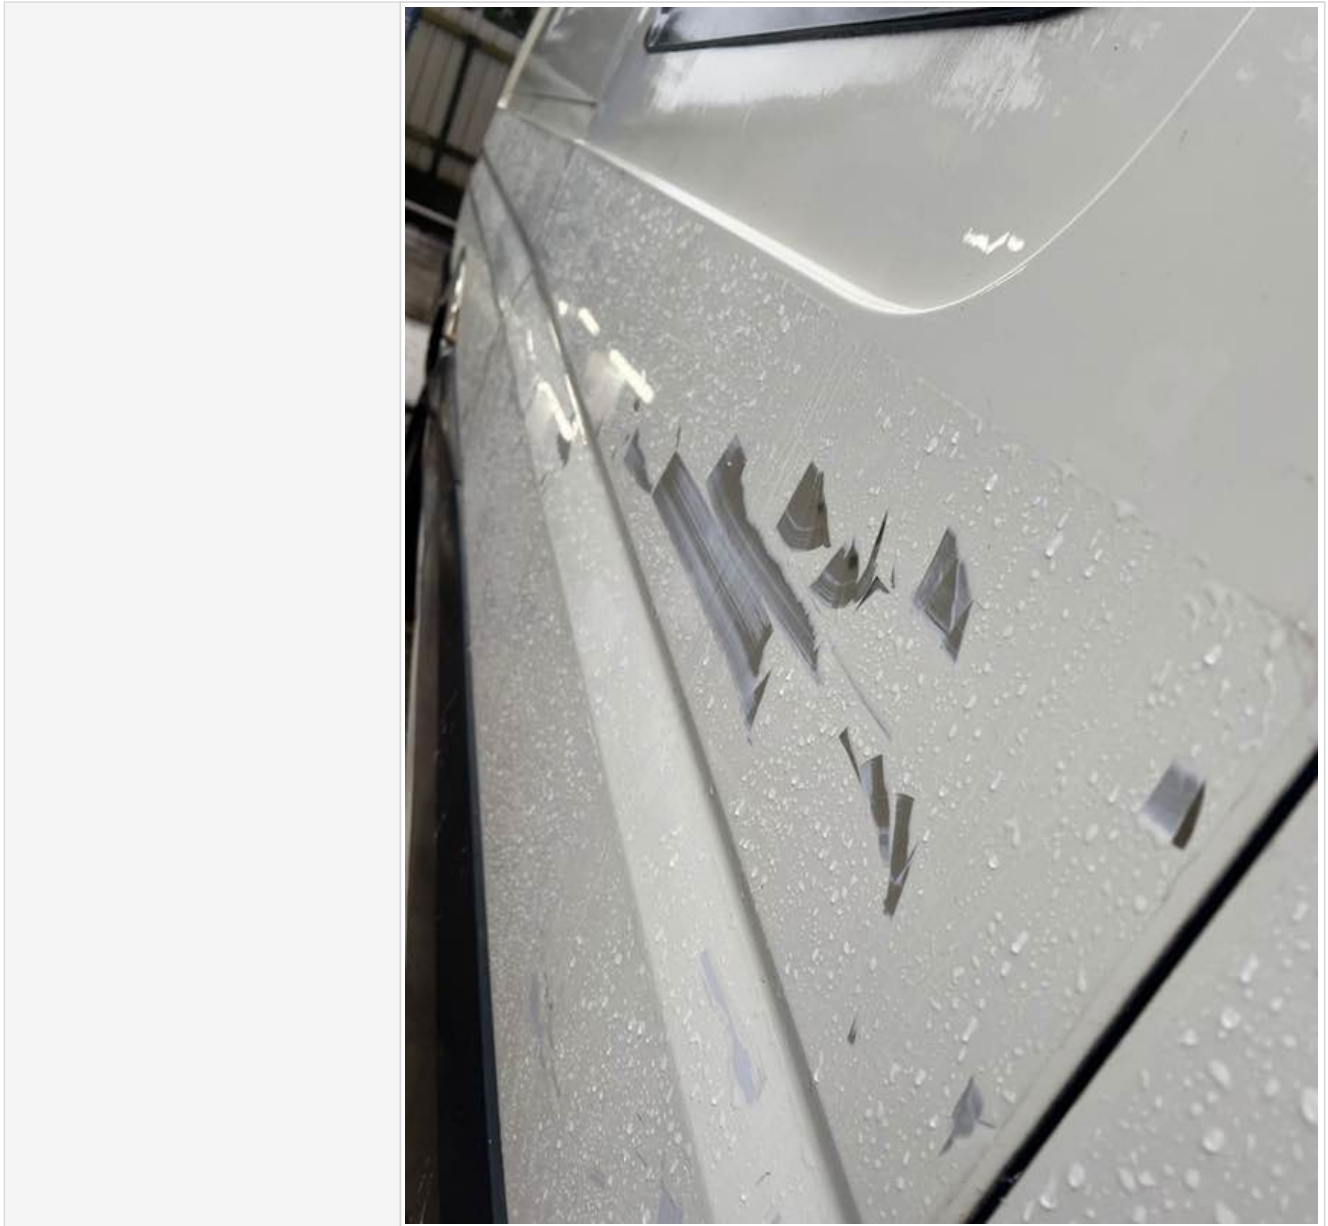
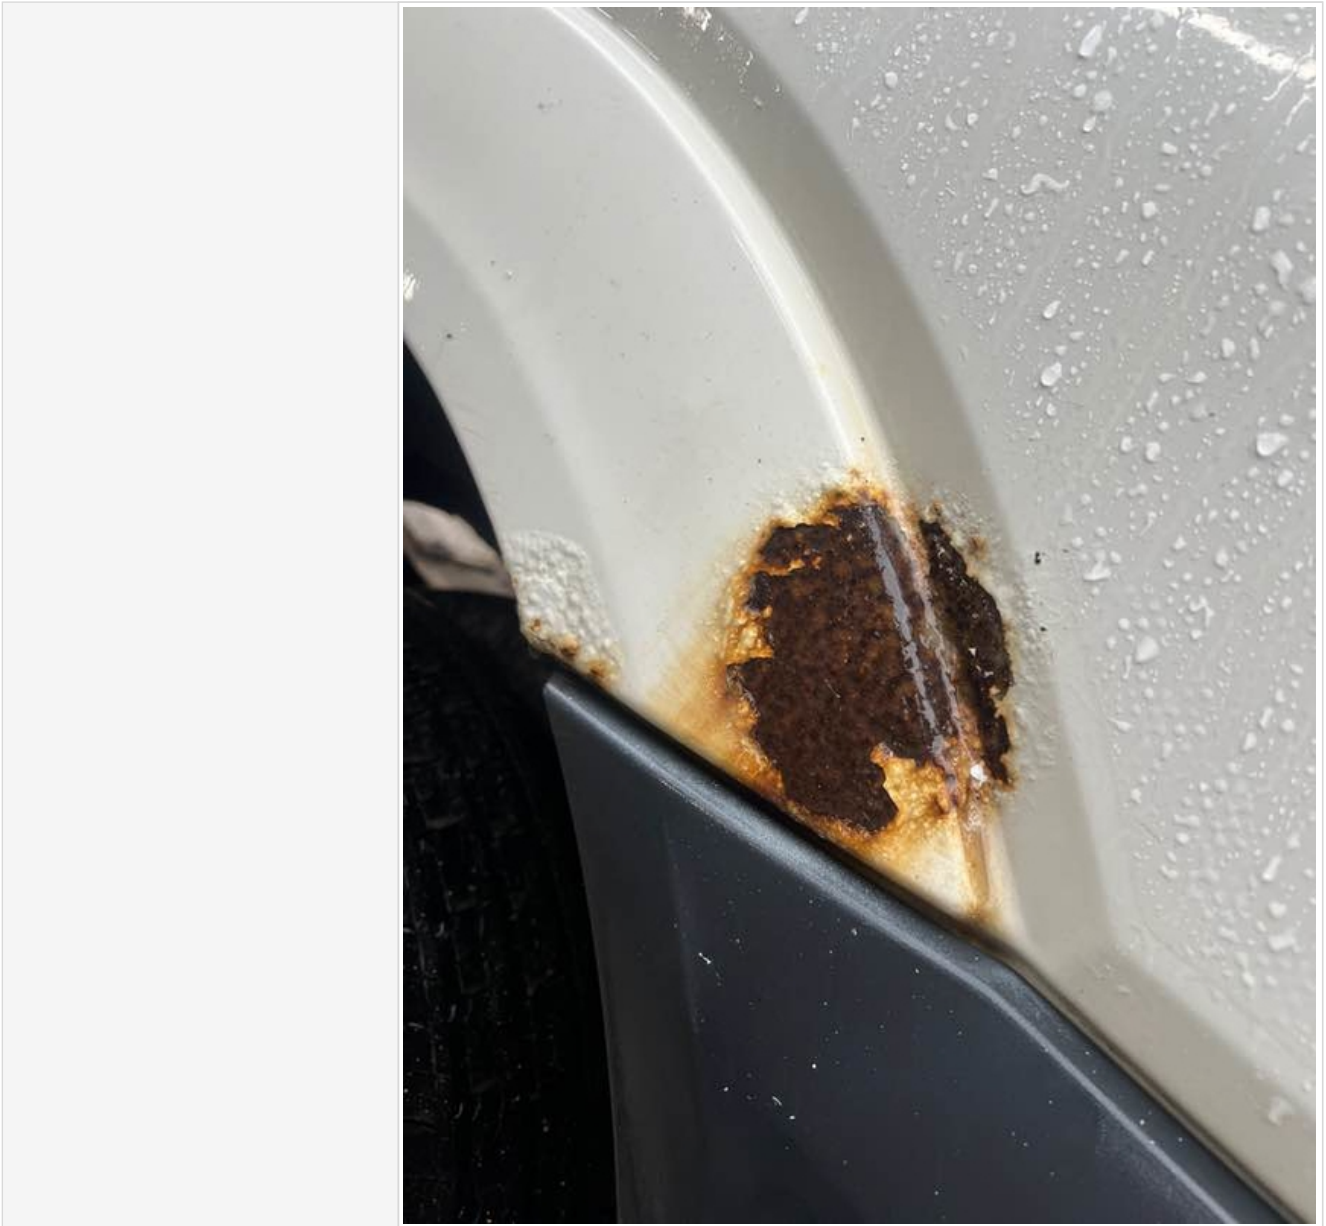
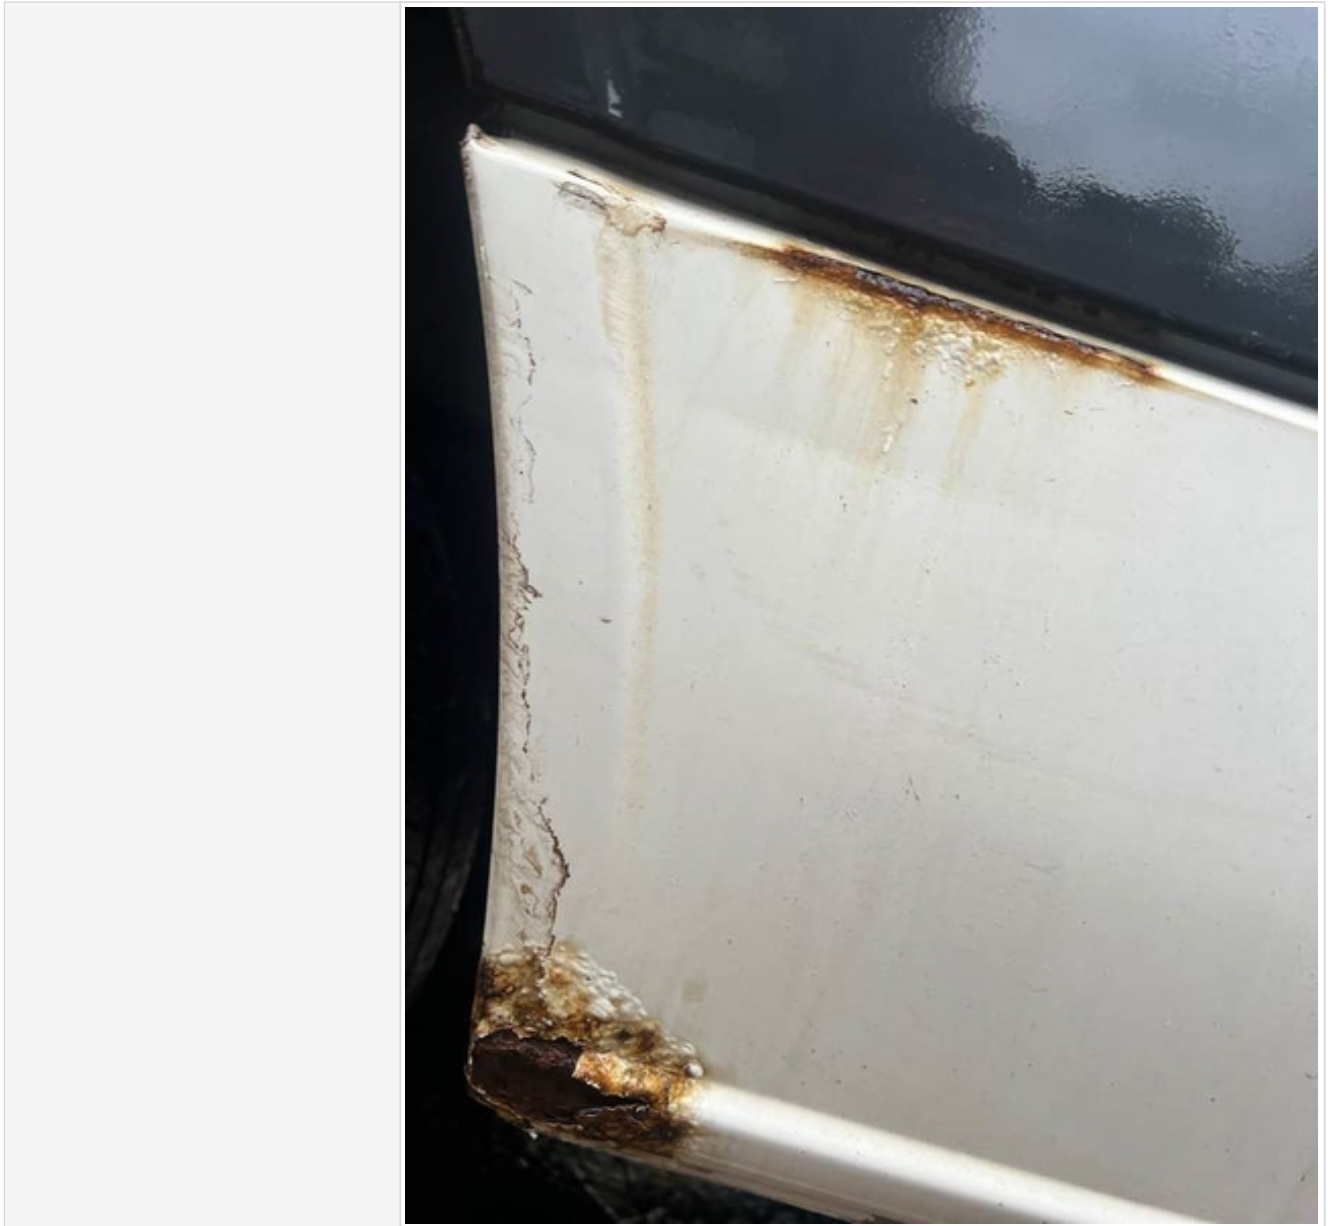
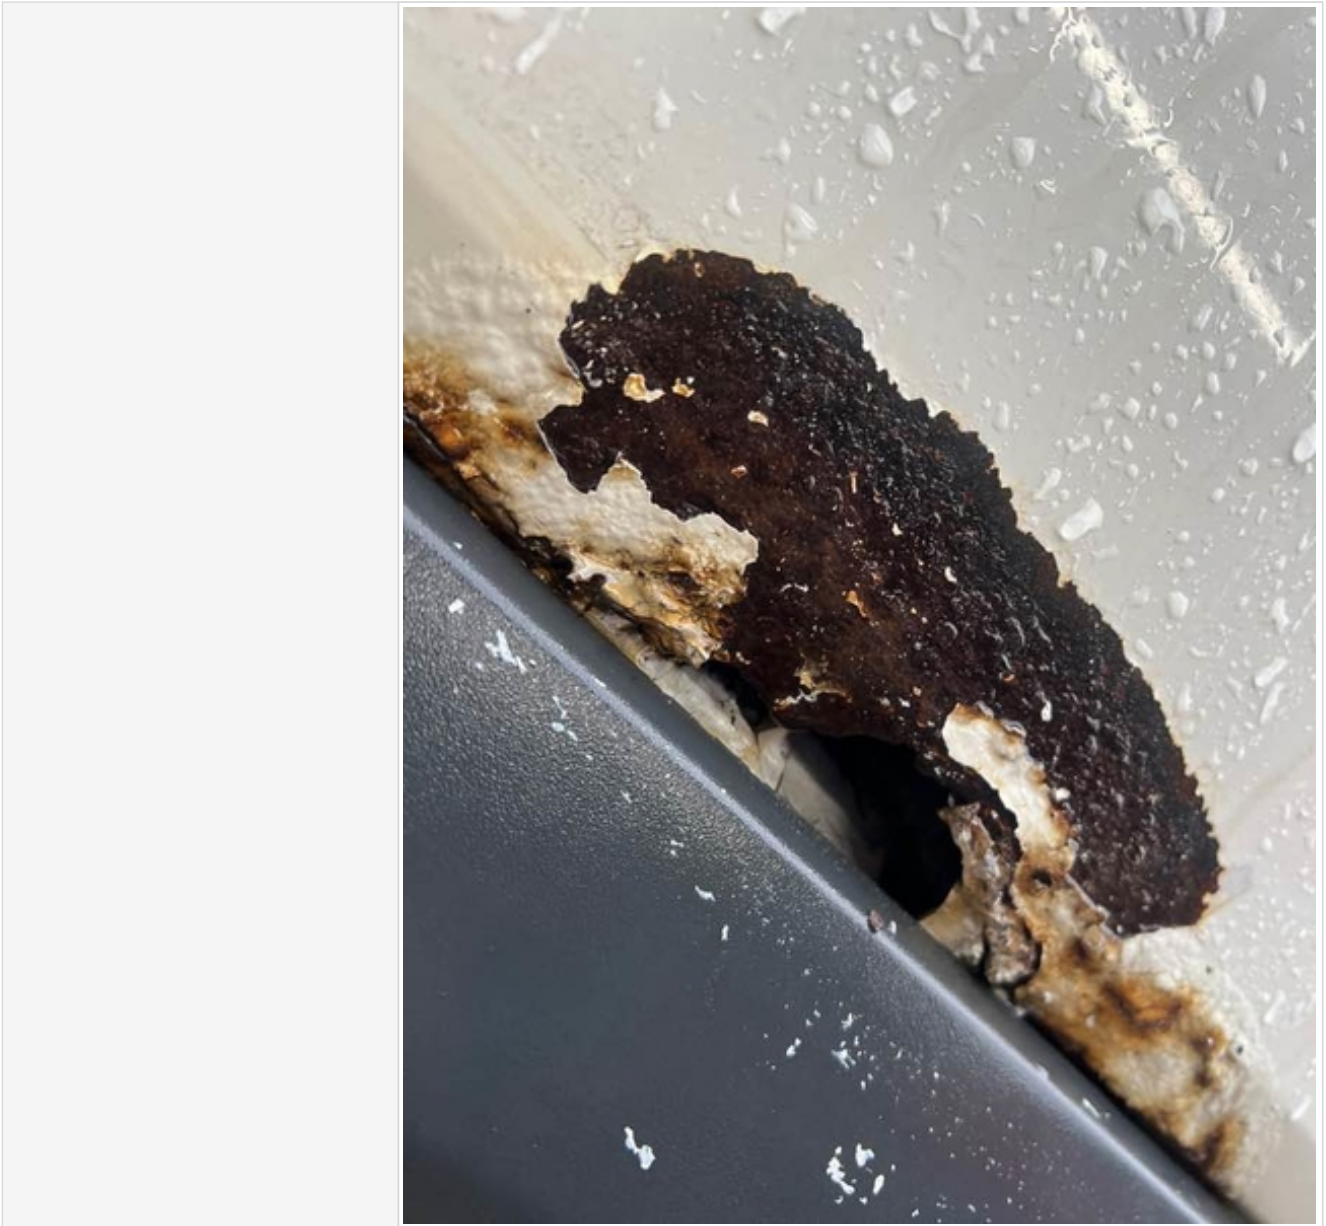
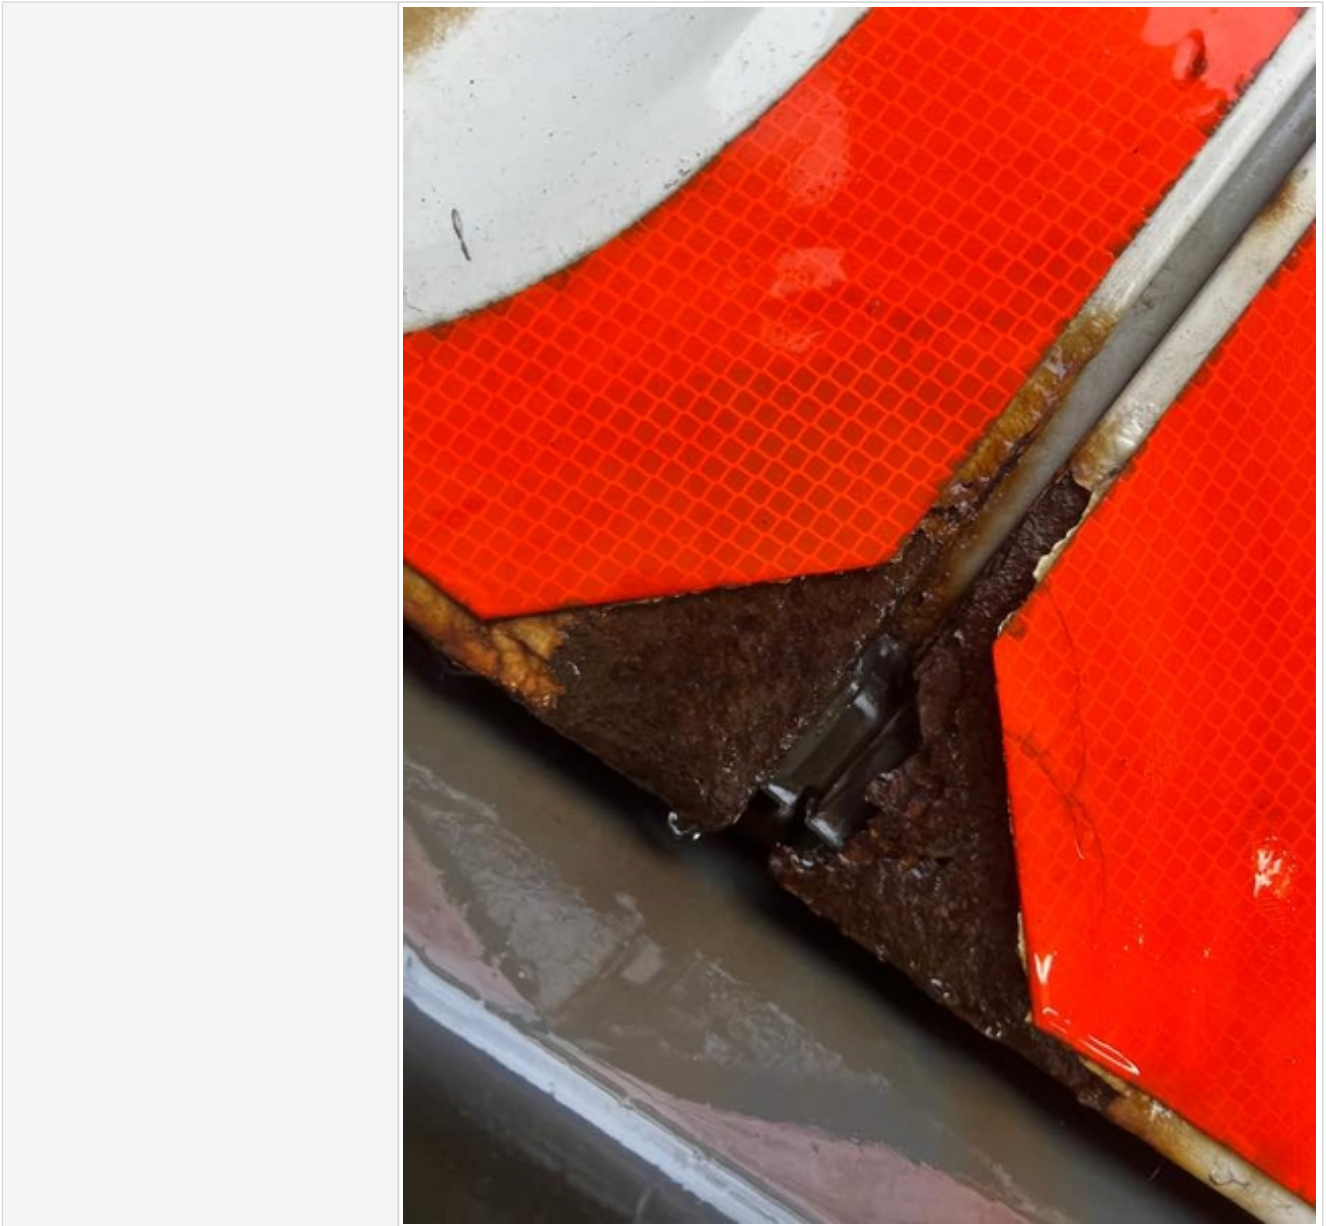
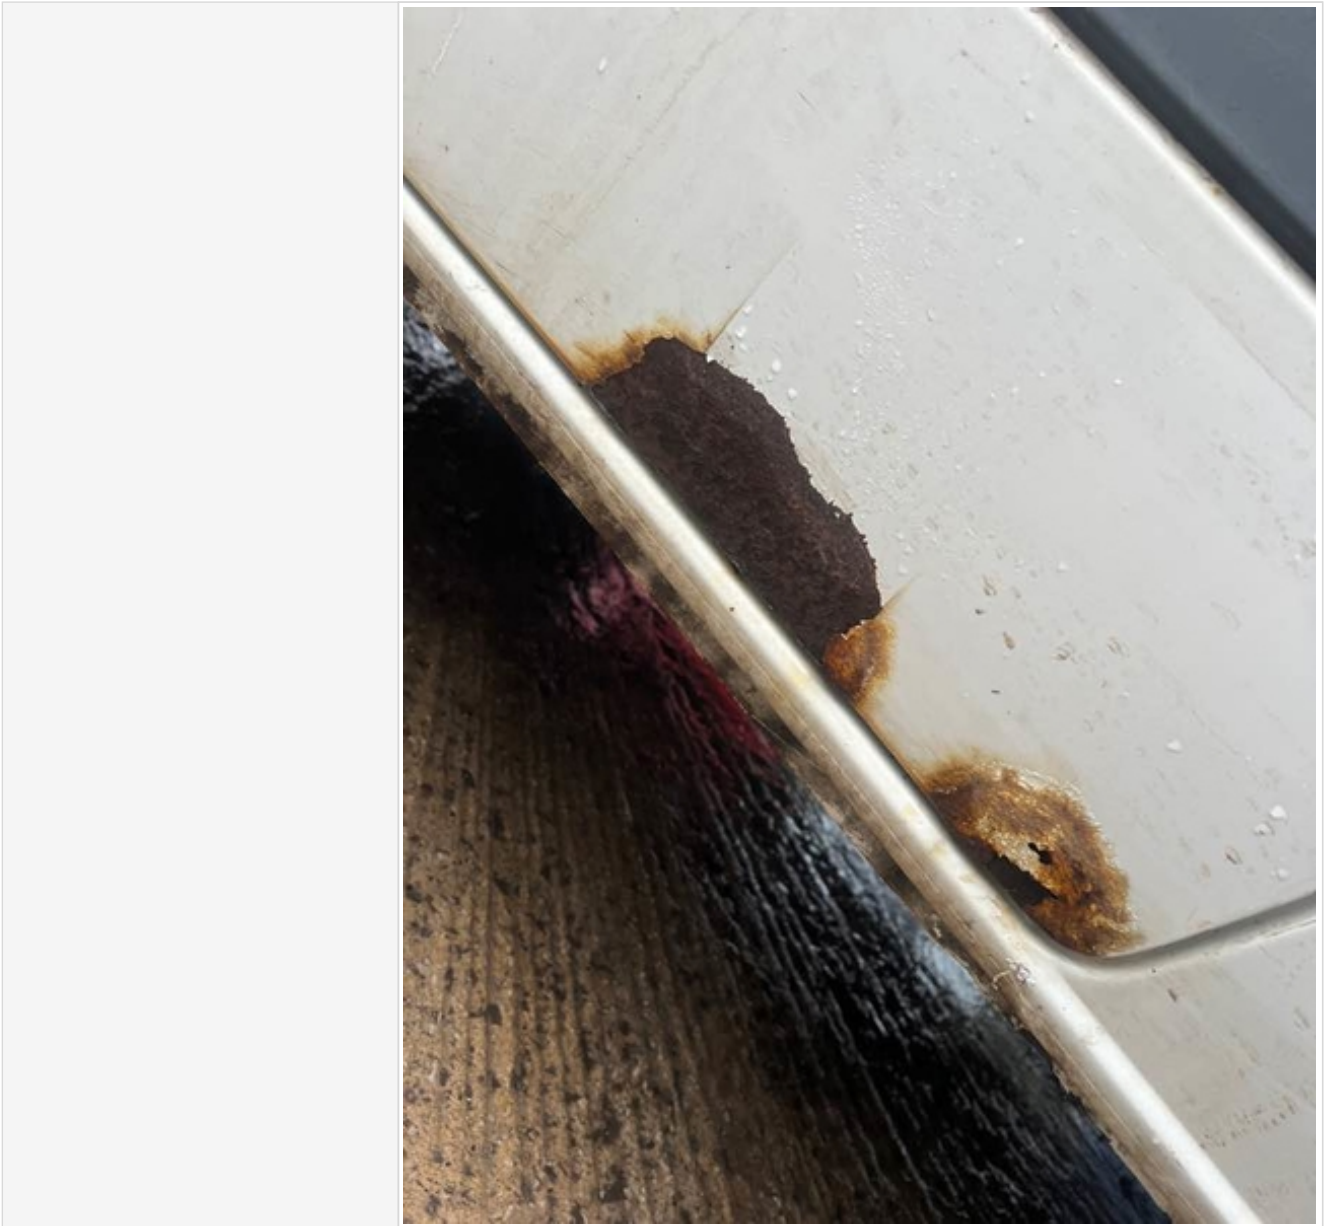
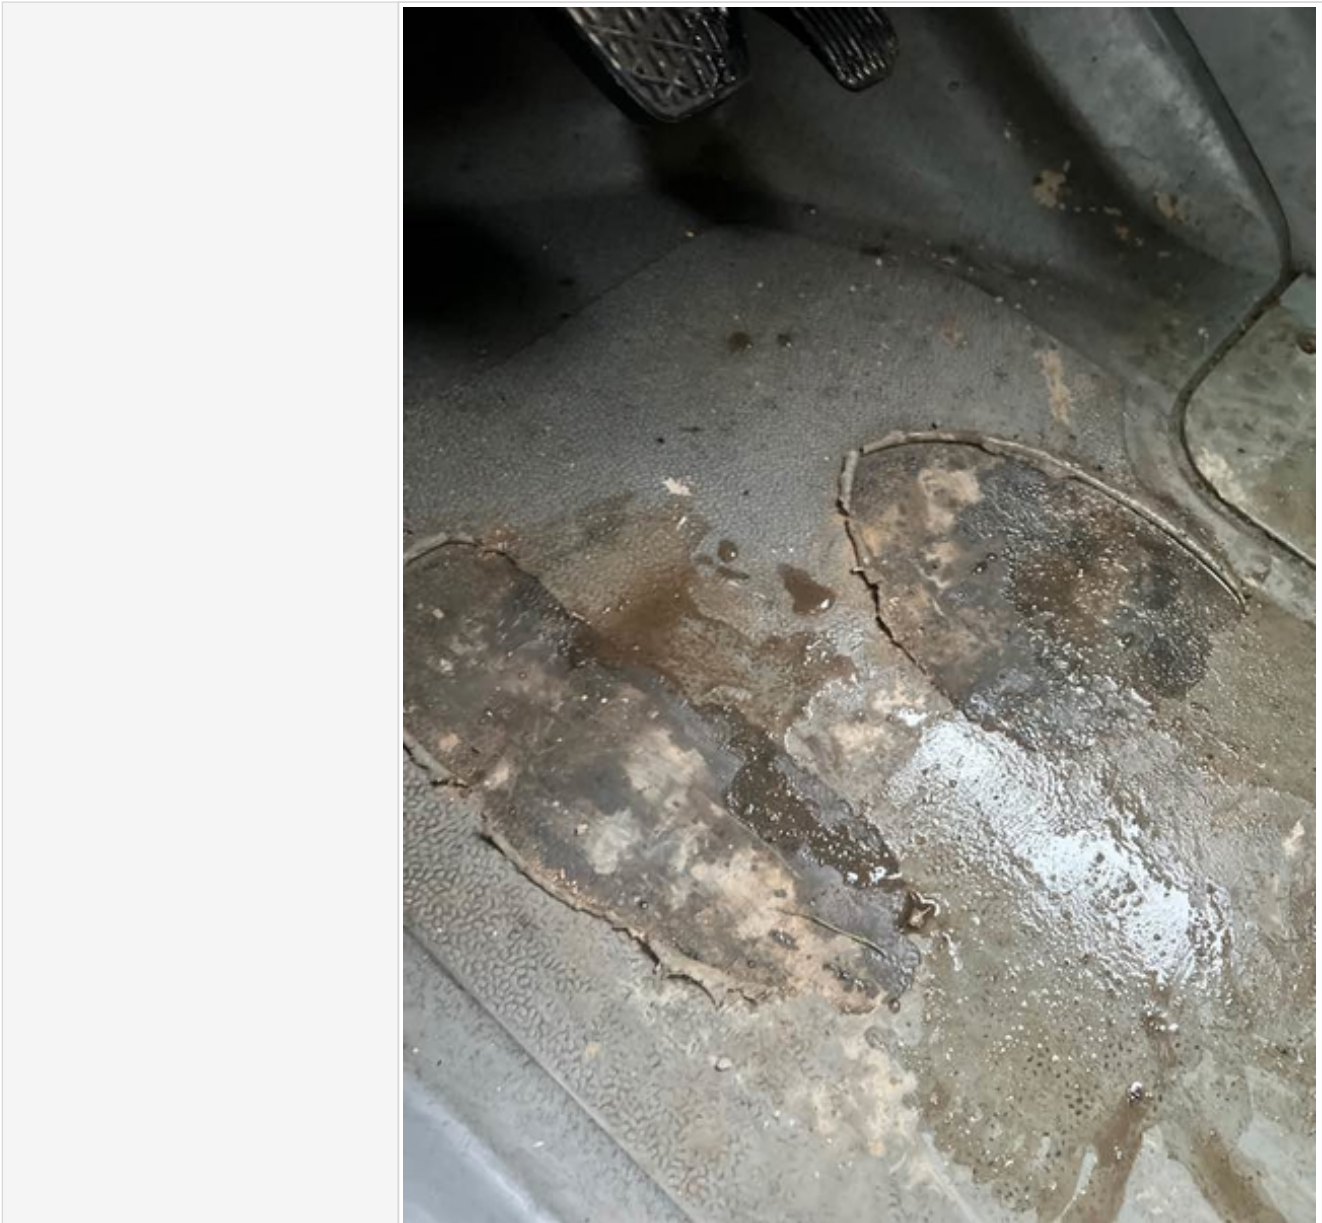
Function working?	Yes
Radio / Media system fitted?	Yes
Radio / media system check	Functions
Reverse camera present?	No
Reverse camera functioning?	N/A
Show any damage or missing items
