Basevan.com General Inspection

Vehicle registration	YJ55LSY
Vehicle chassis no.	WDB903662R866287
Miles (if in km, multiply by 0.62)	95779
Make	Mercedes
Model	Sprinter
Transmission	Manual, 5 speed
Factory immobiliser installed	Yes
Speed limiter installed	N/A
Drive configuration	RWD
Gross Vehicle Weight (kg)	3500
Towing capacity	2800
Tow bar installed	No

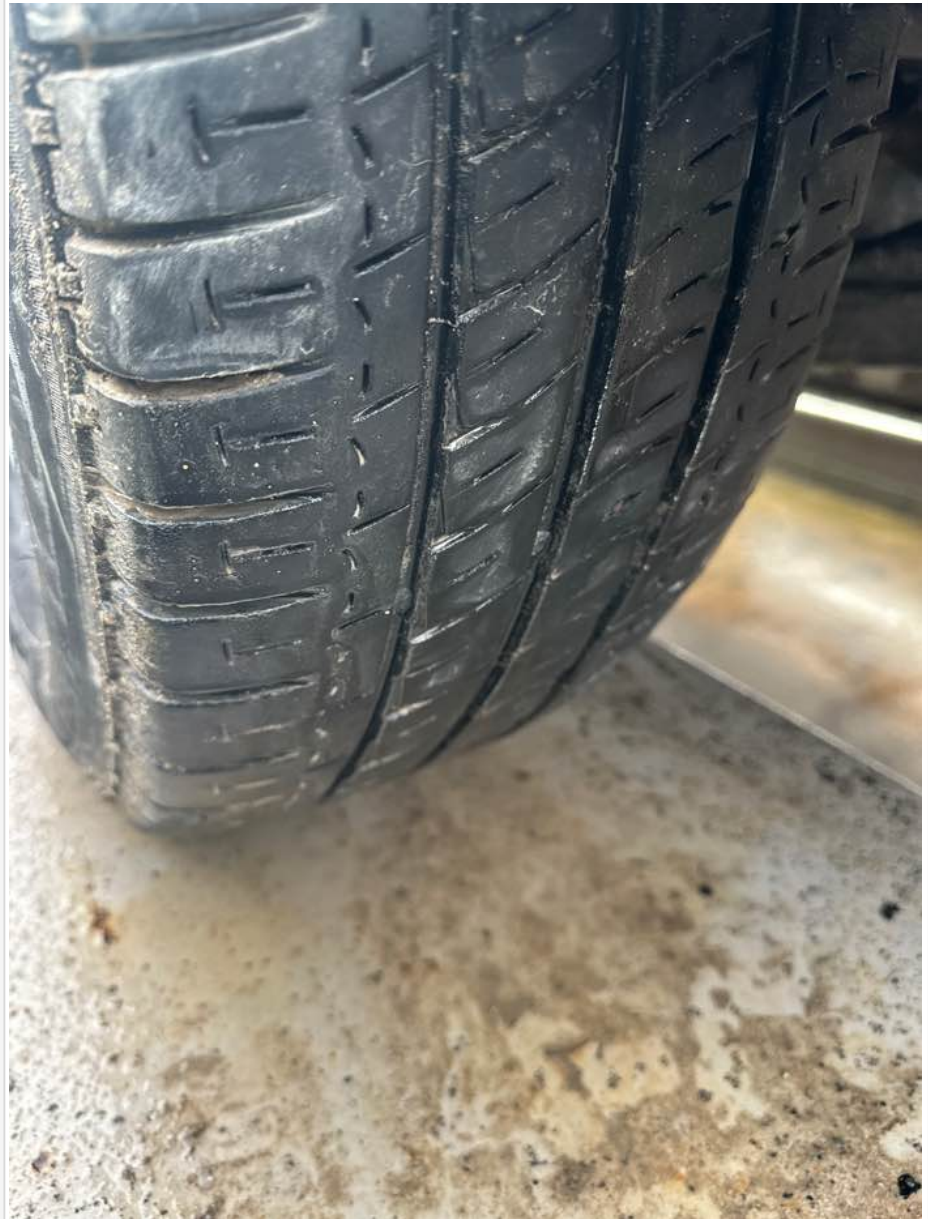
Off side front

Age (month/year) Manufactured	28/15
Make, brand.	Michelin
Tyre size	Not here (see comment)
Pressure 1	50
Pressure 2	
Wearing / Perishing (inner)	Slight
Wearing / Perishing (outer)	Slight
tread depth (mm)	6
General comments	225/70R15C

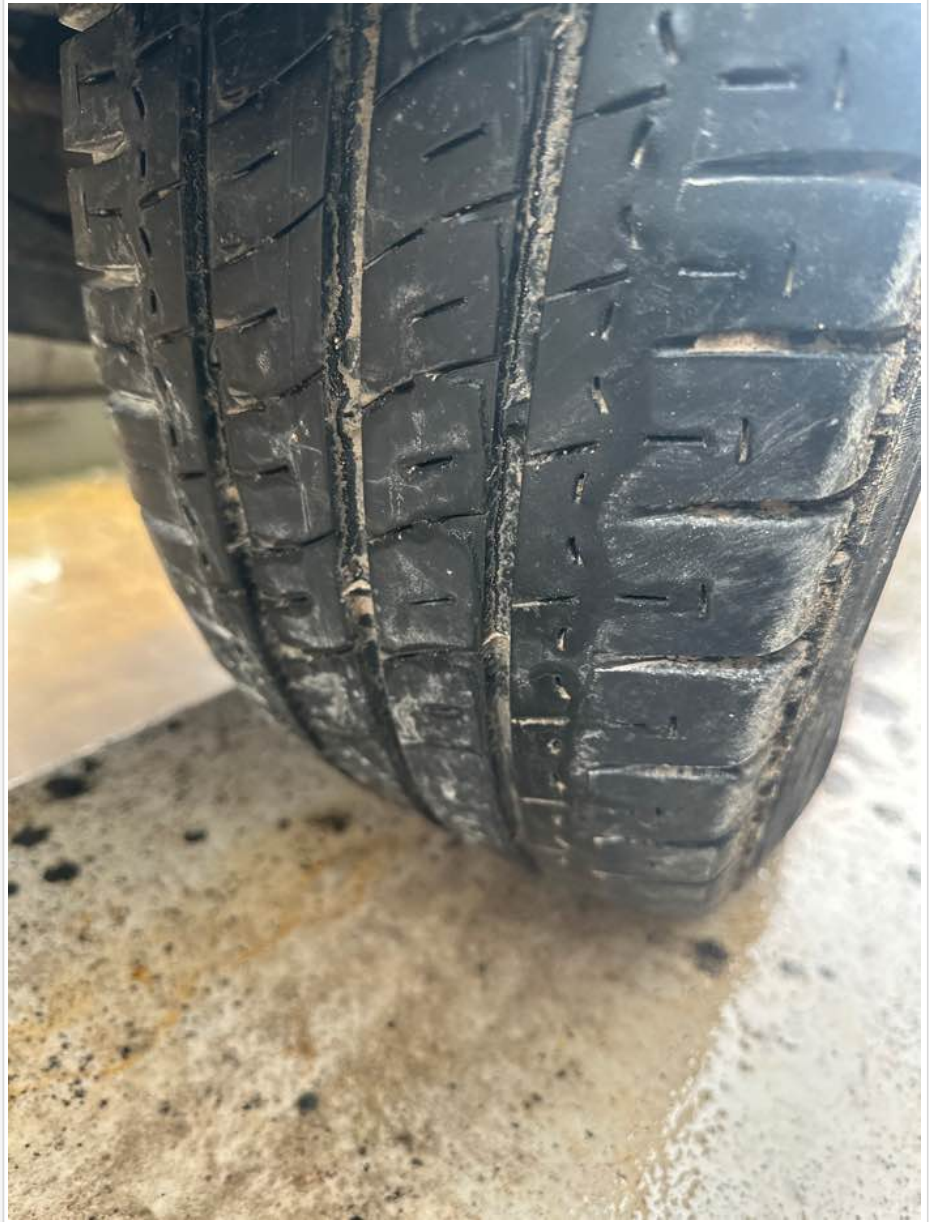
Near side front

Age (month/year) Manufactured	28/15
Make, brand.	Michelin
Tyre size	Not here (see comment)
Pressure 1	44
Pressure 2	
Wearing / Perishing (inner)	Slight
Wearing / Perishing (outer)	Slight
tread depth (mm)	7
General comments	225/70R15C

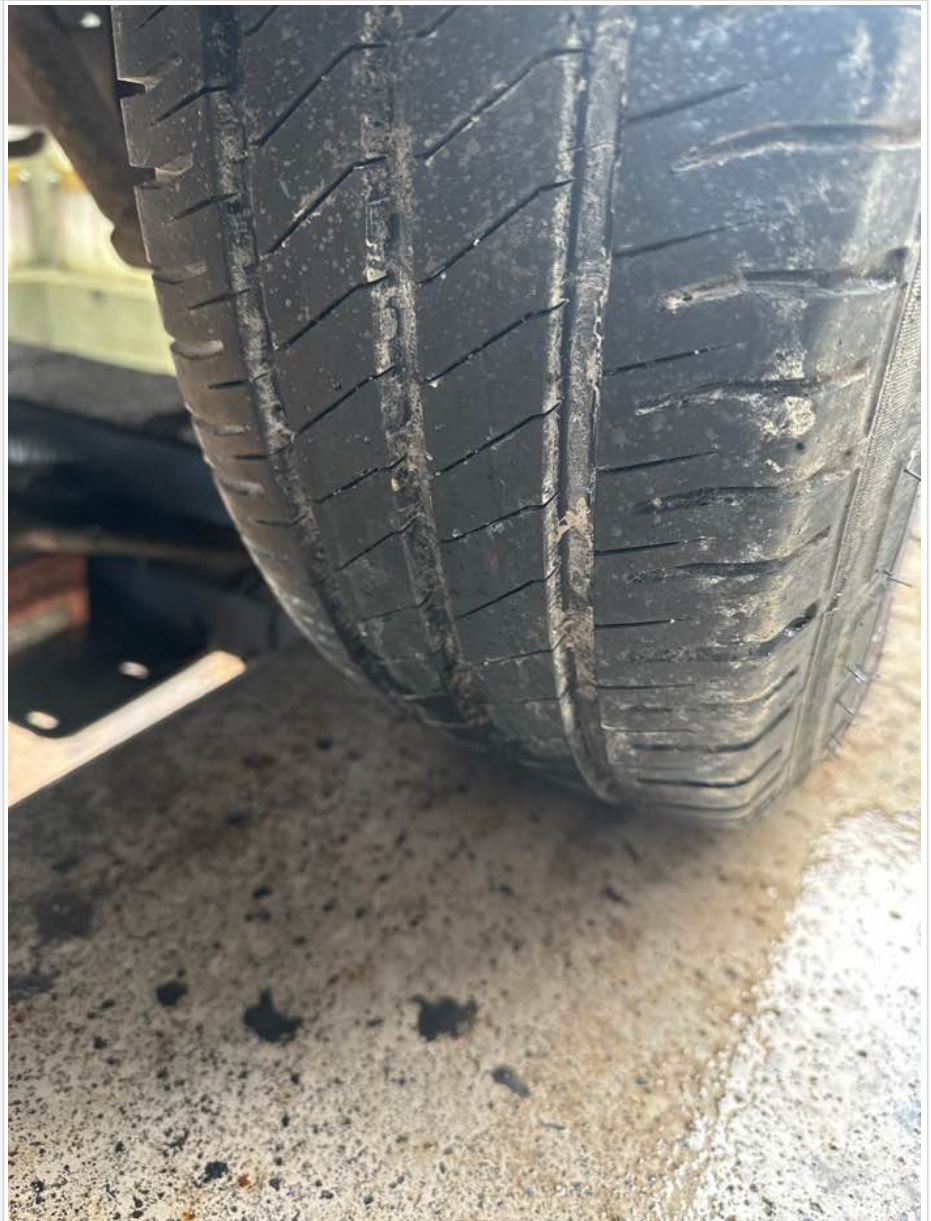
near side rear

Age (month/year) Manufactured	36/20
Make, brand.	Michelin
Tyre size	Not here (see comment)
Pressure 1	58
Pressure 2	
Wearing / Perishing (inner)	none
Wearing / Perishing (outer)	None
tread depth (mm)	9
General comments	225/70R15C

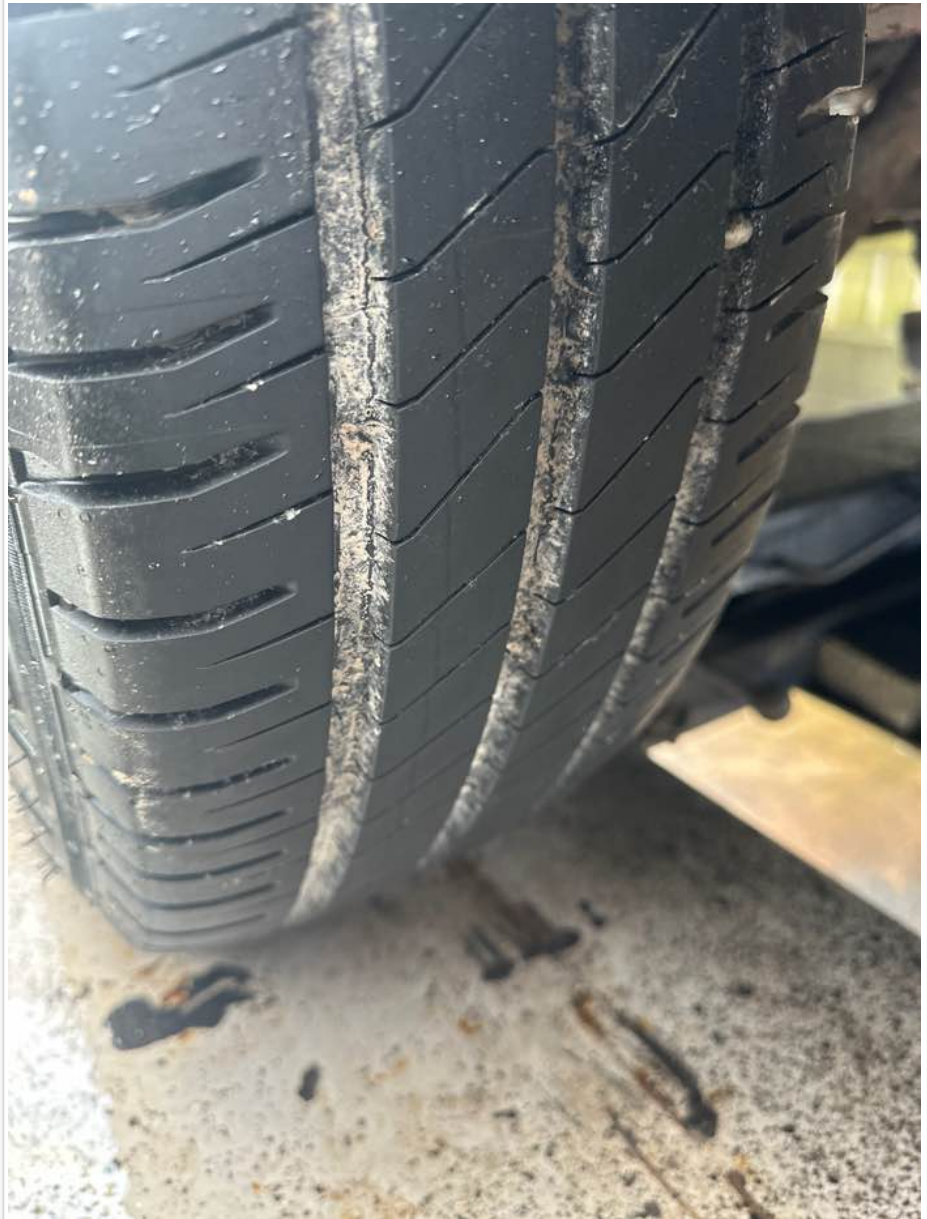
Off side rear

Age (month/year) Manufactured	09/21
Make, brand.	Michelin
Tyre size	Not here (see comment)
Pressure 1	60
Pressure 2	
Wearing / Perishing (inner)	none
Wearing / Perishing (outer)	None
tread depth (mm)	9
General comments

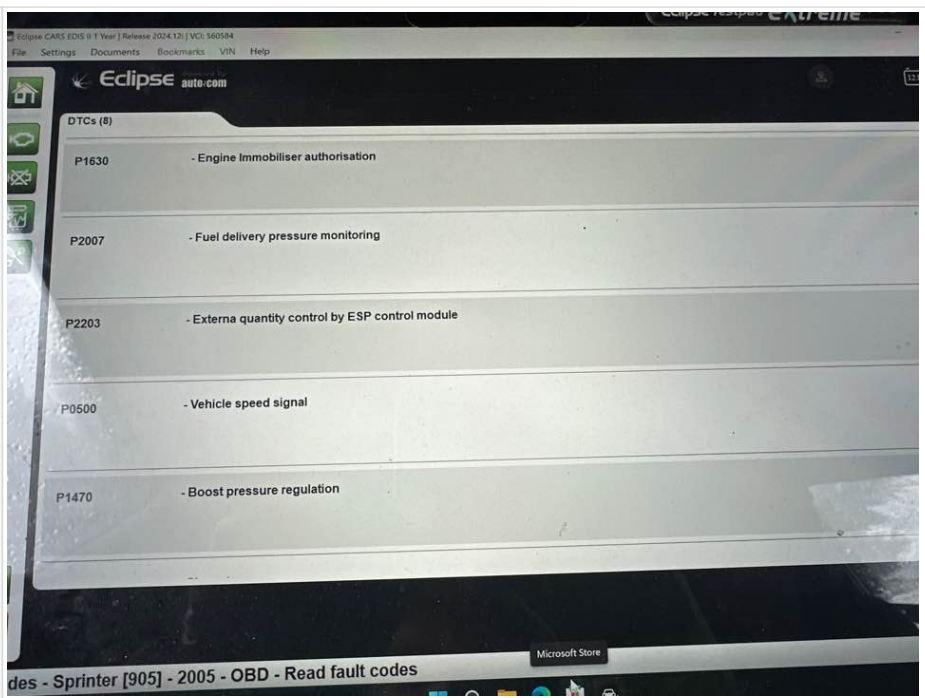
<p>OBD Scan results</p>

<p>DTCs (8)</p> <ul style="list-style-type: none">P1630 - Engine Immobiliser authorisationP2007 - Fuel delivery pressure monitoringP2203 - Externa quantity control by ESP control moduleP0500 - Vehicle speed signalP1470 - Boost pressure regulation
<p>Engine bay photo</p>

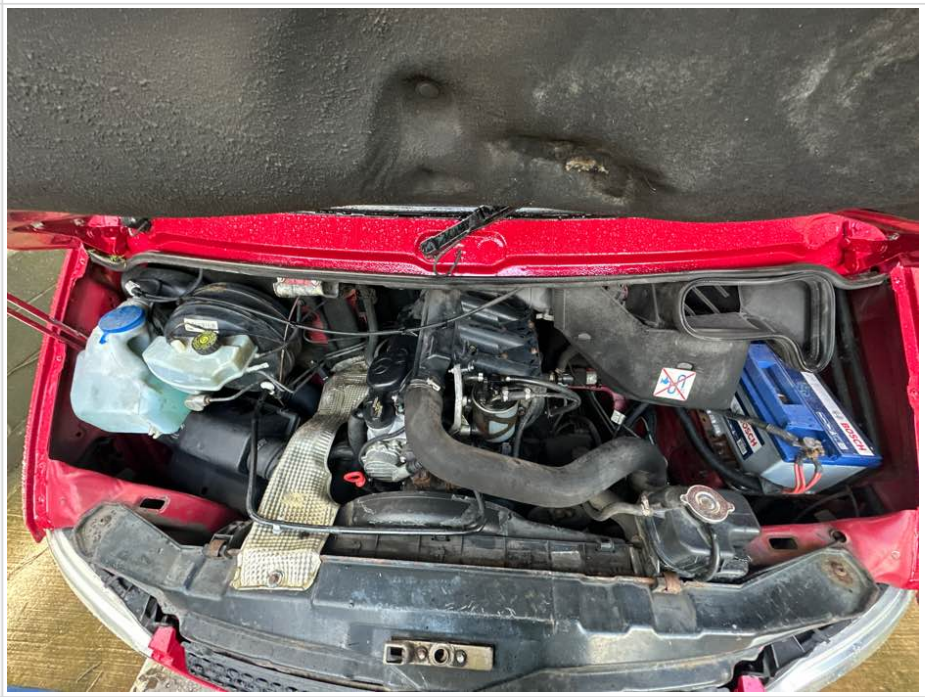
Fuel level	1/2 Full
Oil level	Full
Oil condition	Clean
Start up, chassis battery check	Started, but required boost pack
Start-up from cold	3 seconds
Exhaust smoke from cold	Normal
Output Voltage of Alternator test	14
Chain or Belt driven engine?	Chain
If belt any proof of change?	N/A
Coolant condition	Clean
Coolant level	Low
Anti-freeze temperature check	
Washer fluid	Full
Brake fluid	Full
Power steering fluid	Minimum
Dashboard warning light	EML present
